Appendix A

Town of Henniker Municipal Buildings IR Report

*As part of the Level II Energy Audit for the
Town of Henniker*

Town Hall IR Report

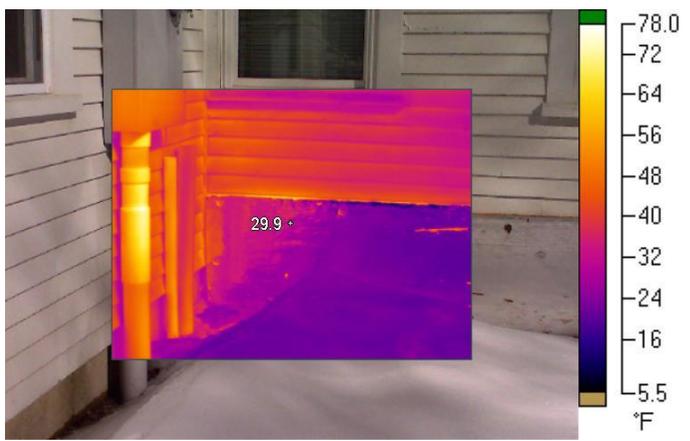
This photo is of the back of building where some insulation was added to the foundation. The insulation is working but should be permanently installed and covered with protective siding.

*Note: on an April 7th site visit this insulation had been removed.

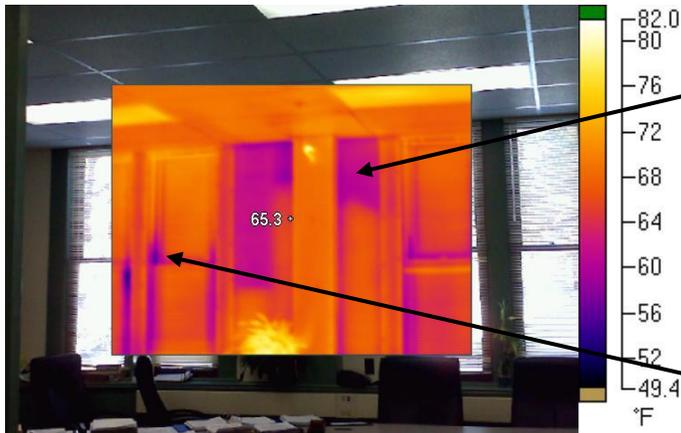
In the Selectmen Meeting Room it appears that the insulation in the walls is settling in the bays, decreasing its effectiveness in the upper portion of the walls.

Also in the meeting room the areas around the windows show that cold air is infiltrating from the outside.

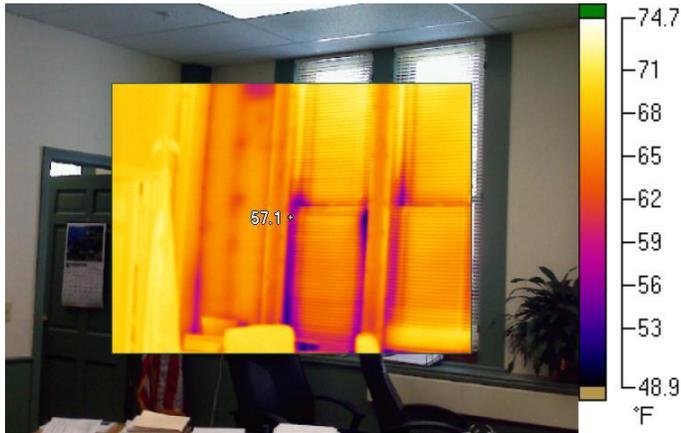
Air leakage occurring around the windows in the meeting room.

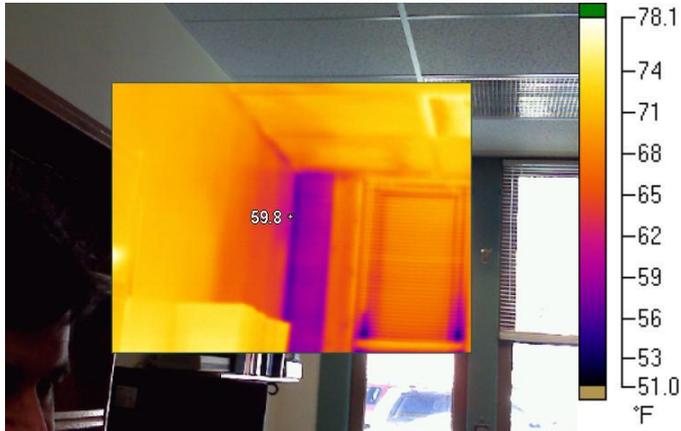
Town Administrator's Office. The bay to the left of the window may be missing insulation.

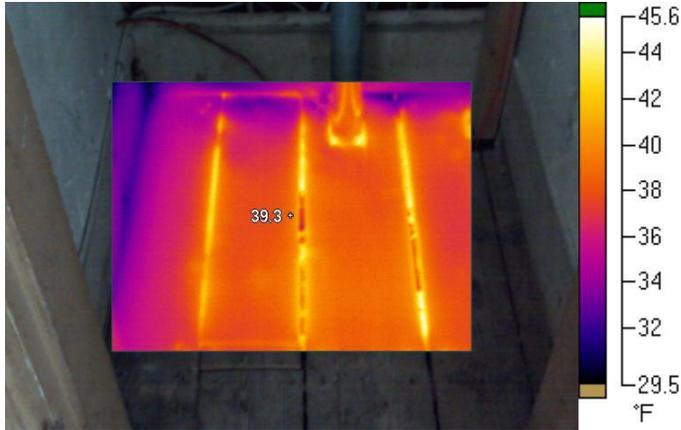
More evidence of heat coming up from the blow conditioned office space.

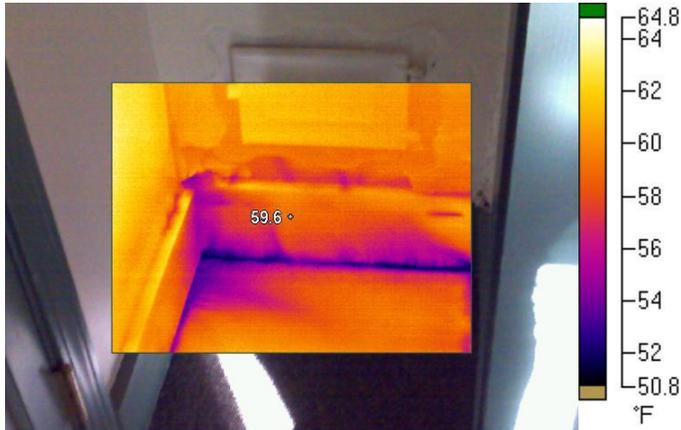
Looking down at the floor of a closet on an exterior wall. Showing cold moving from the crawl space below the 1st floor. There is no insulation or air barrier beneath the 1st level floor.

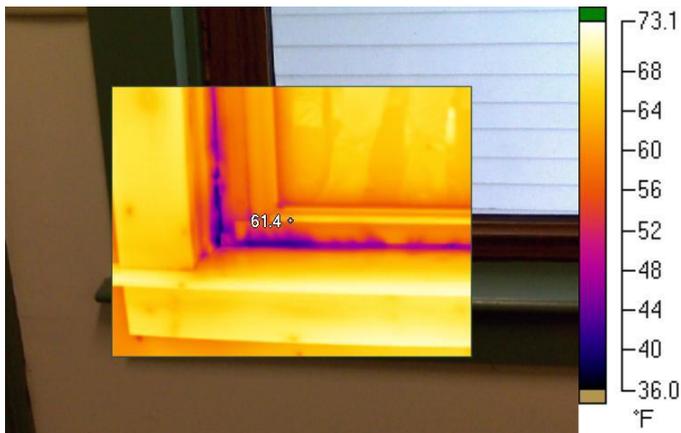
Air infiltration around a window in employee lounge area.

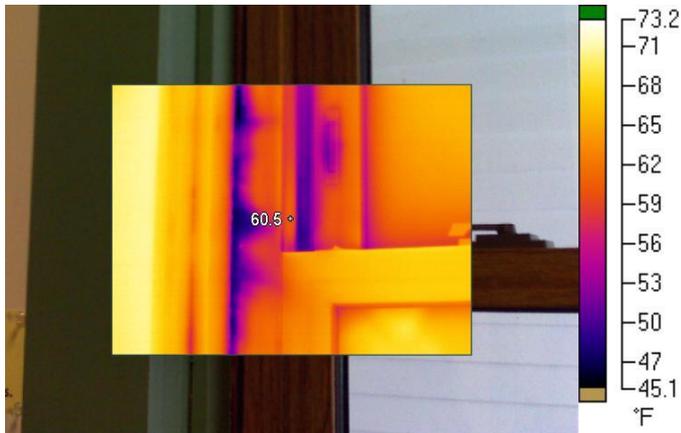
Window in employee lounge area showing air infiltration at a different part of the window.

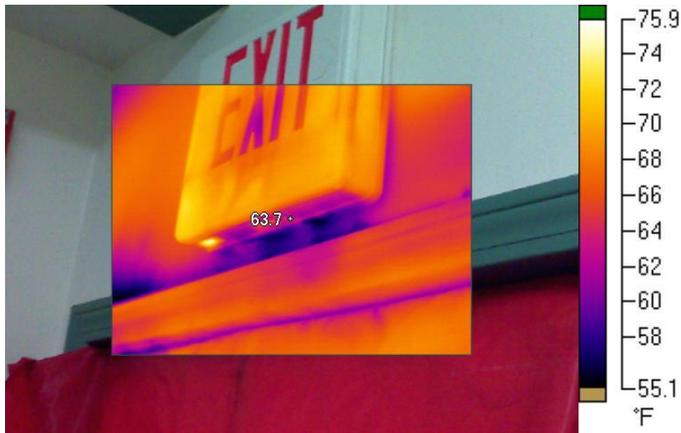
Leakage around the back door exiting the employee lounge area. Again this air is coming in around the trim indicating air movement within the walls.

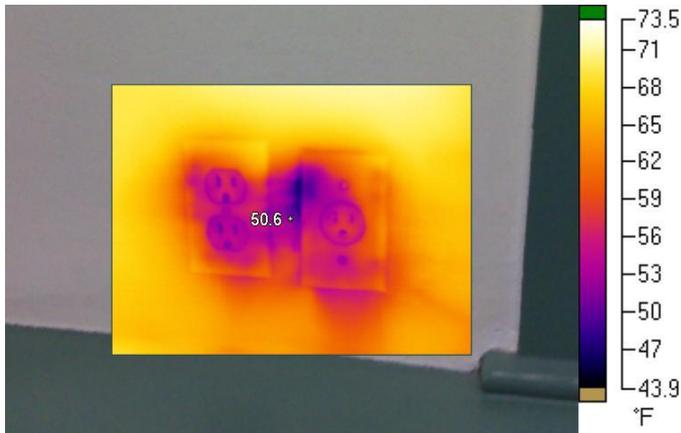
Leaky electrical sockets are another indication of cold air movement within the walls.

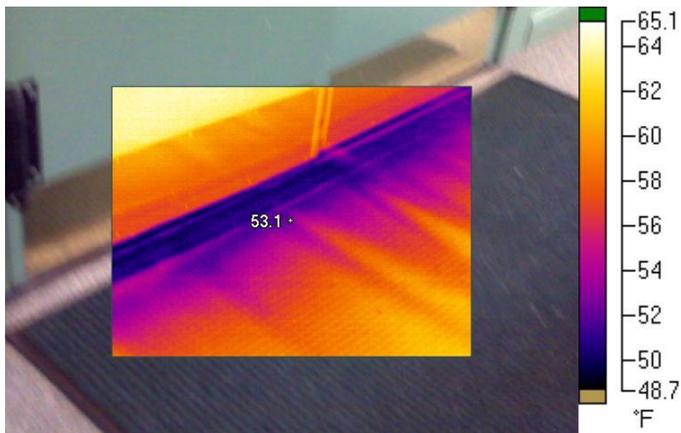
The double swing doors to the office are allowing a lot of air movement from the unconditioned stairwell into the warm office spaces. We recommend these get replaced with thermally broken, insulated and weather stripped doors.

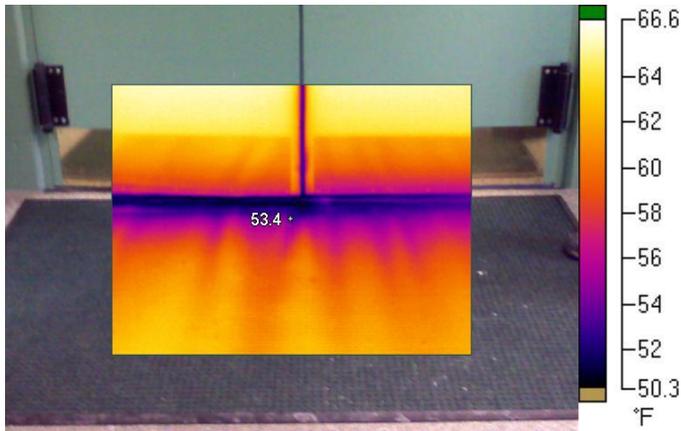
These are the interior double swing doors. They are not doing a good job of keeping the cold air from the stairwell out. There was a visible gap between the doors and between the doors and the floor. These doors allow a significant amount of cold air into the conditioned office spaces.

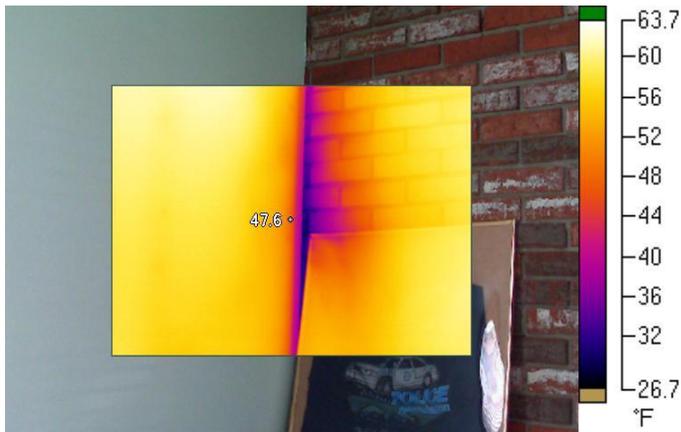
On the interior the corner of the brick façade of the garage and the wall of the lobby area. This area has cold air infiltration.

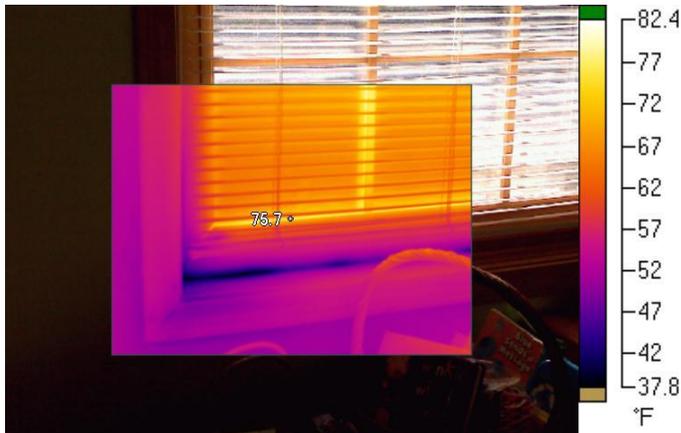
A typical window in one of the office areas. Many of the window corners were found to be cold. This could be due to poor insulation and air sealing around the window frame when it was installed.

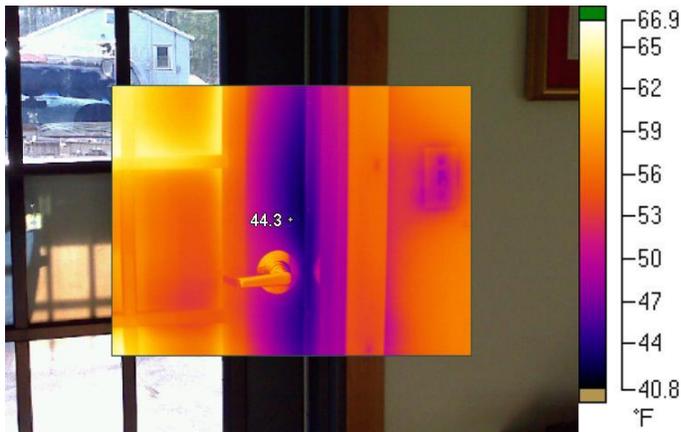
Main entrance door to the Police Station. Cold air is able to enter the conditioned space due to a poor seal around the door.

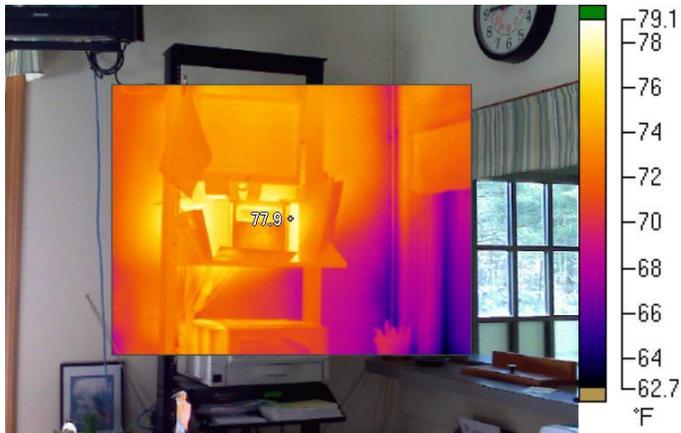
Front office space. There is excess heat given off of the office equipment. (Note that the temperature of the equipment is nearly 80 degrees.) This can increase energy used by air conditioning used in the cooling months. Tuning off unused office equipment in the summer while not in use will help.

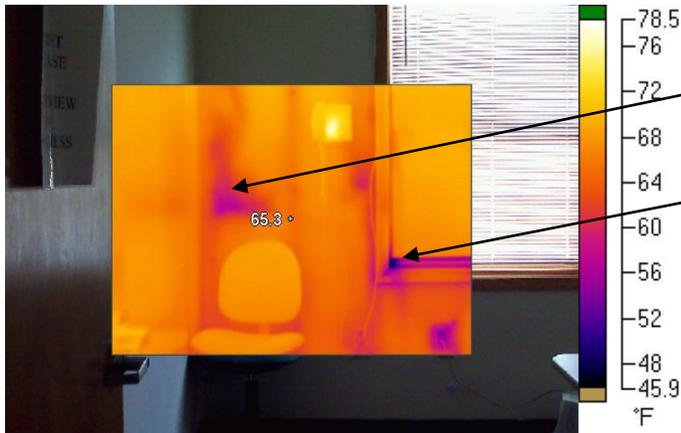
The interview room shows some cold spots on the wall. The cooler area above the chair may be caused from a batt of insulation that is pushed back or has settled in the bay. Also note the cold at the corner of the window.

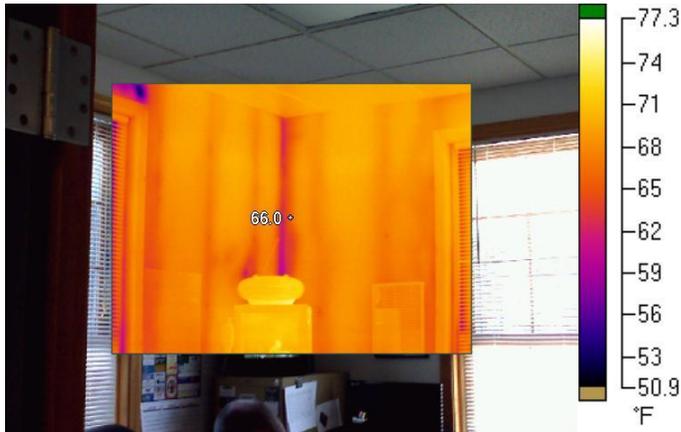
Another exterior corner where cold is being conducted to the interior conditioned space through the framing members.

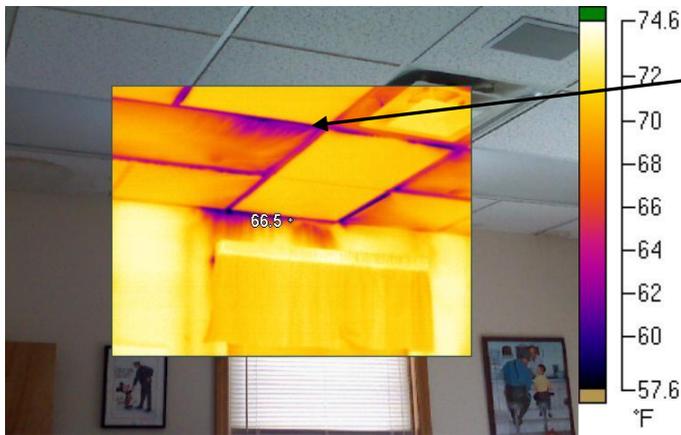
Cold air is able to move through and around the batts from the attic space to above the ceiling tiles and into the conditioned spaces.

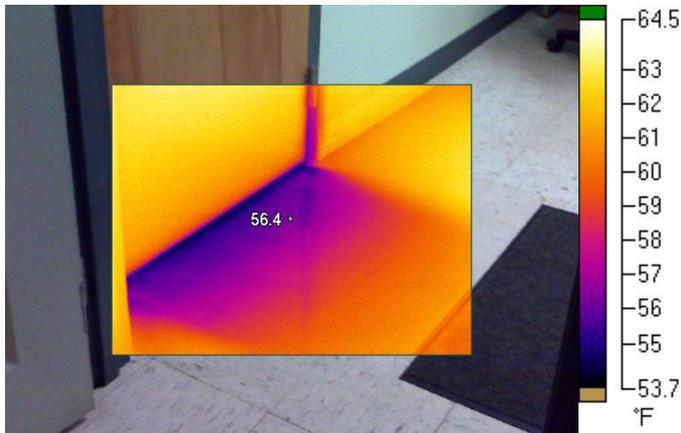
Door leading to the garage from the holding room. This door is not performing well due to lack of weather stripping along the bottom. Cold is not the only thing the door is letting in. Carbon Monoxide that is produced by cars in the garage will leak into the building through places like this, affecting indoor air quality as well.

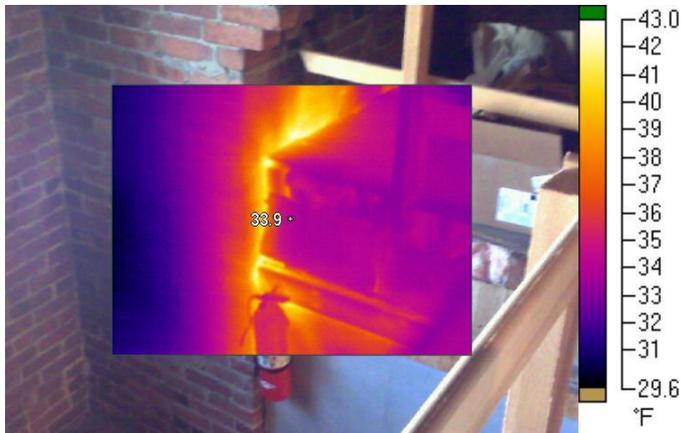
Floor to wall connection in the attic. Air sealing should be done in the attic to prevent air movement between the unconditioned attic and the conditioned space below. Currently the warm conditioned air from the main floor is traveling up into the attic space.

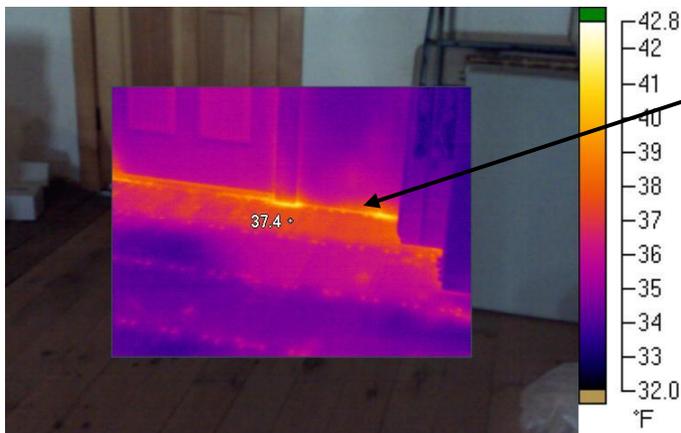
Entrance to small finished space in the attic, a break in the insulation line or level of insulation was found here.

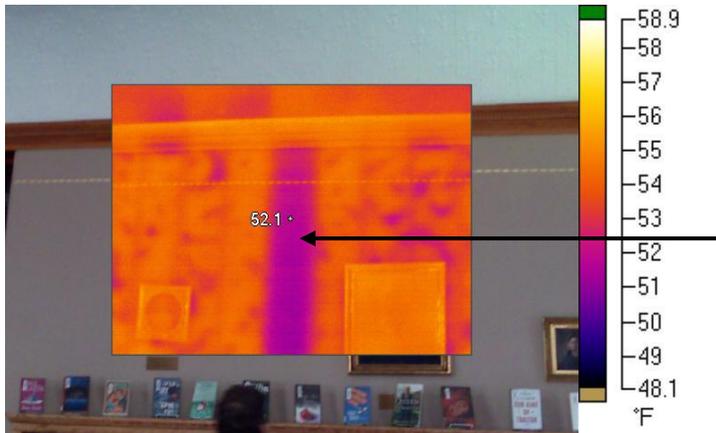
Another section of wall in the New Hampshire Room. The unconditioned stairwell to the attic is behind this wall. The colder area on the wall could be caused by inconsistent insulation in the attic and lack of air sealing. Cold air from the attic is able to enter the area between these two studs and travel down.

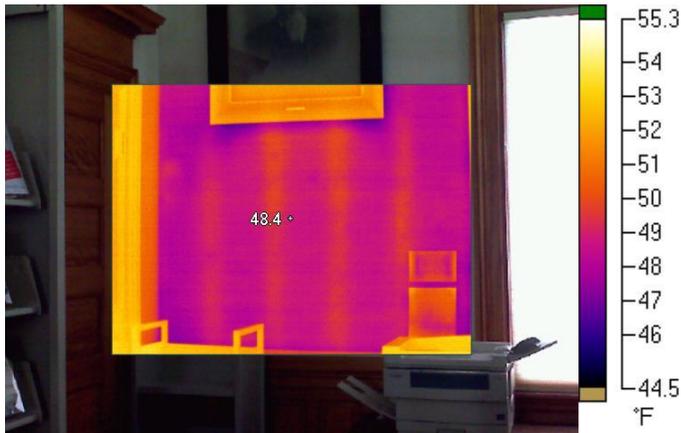
Non-fiction room exterior wall where lathe and plaster wall construction is visible. We found no signs if insulation in any walls.

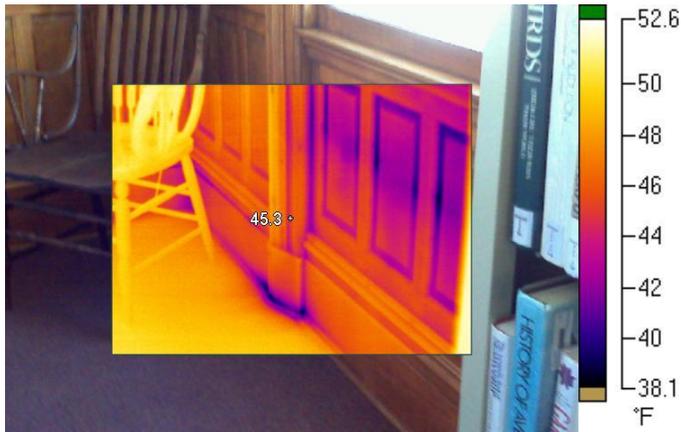
Wall sections under windows were found to be especially leaky and cool.

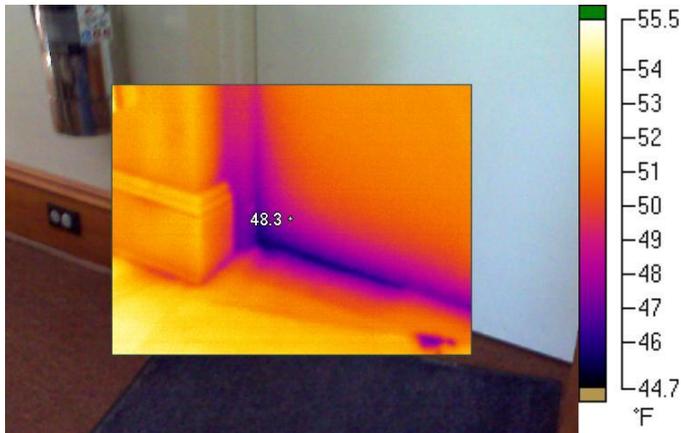
Door leading from the fiction room to the unconditioned stairwell. Cold air from the stairwell is leaking into the conditioned spaces. Doors to the stairwell should be weather stripped to prevent the cold unconditioned air from entering.

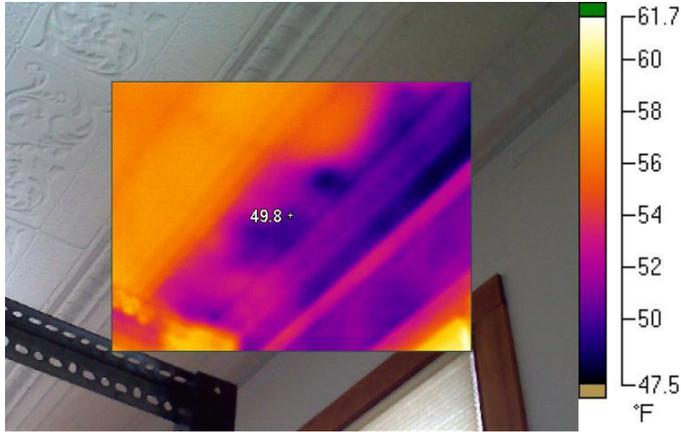
Another view of the wall to ceiling connection. It is apparent that the insulation does not go to the edge of the ceiling here. This may be one cause of the ice dams.

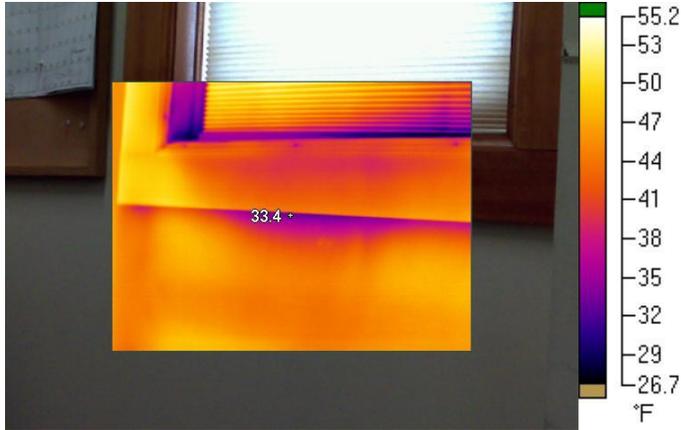
Newer window in the computer room shows leakage below and behind the trim.

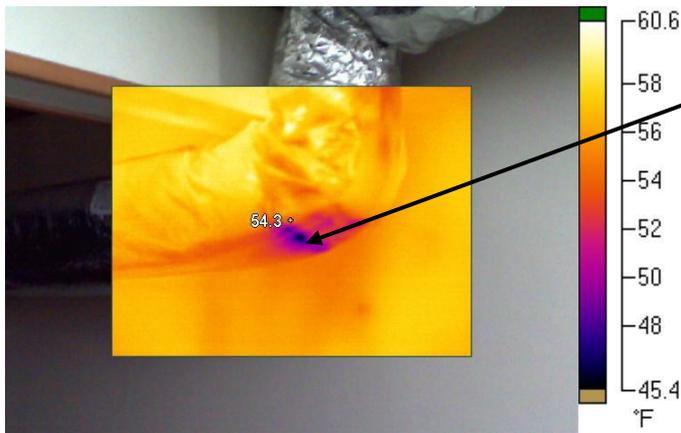
Supply and/or return vent from the ERV. Only small leaks were found in the ducting.

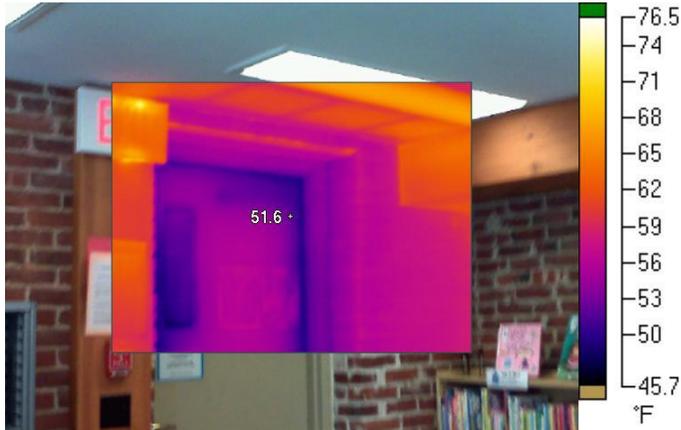
There is cold air infiltrating into the Children's Room from the door leading to unconditioned stairwell.

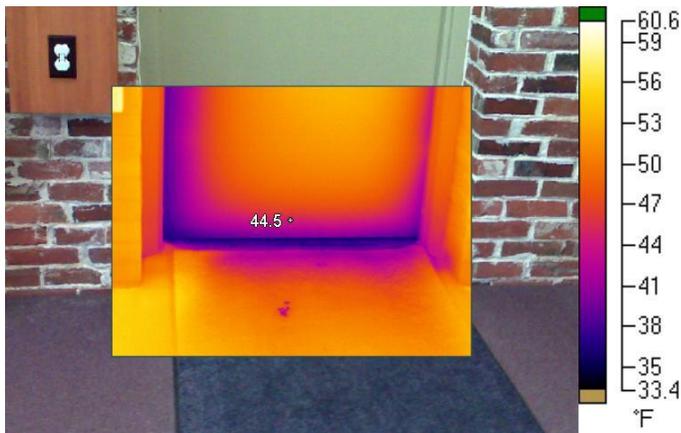
Bottom of door leading to stairwell in the Children's Room. Again we see cold air entering the conditioned space from the stair well.

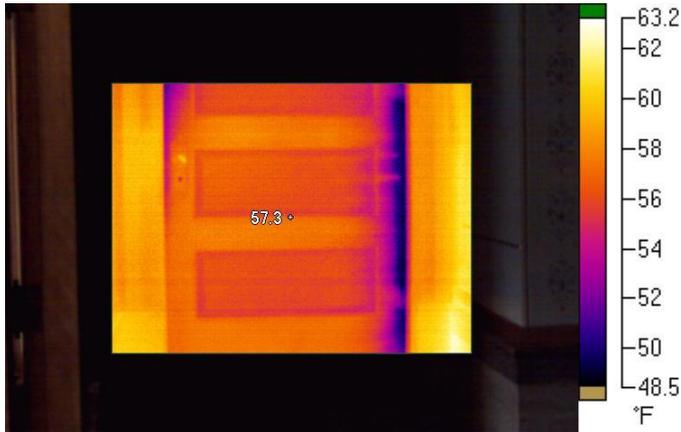
Colder air from the attic is entering the conditioned space, from around the door.

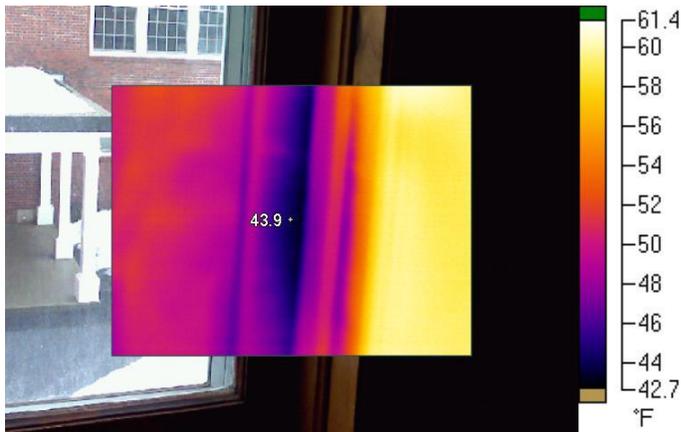
Leaky window where cold air is coming in.

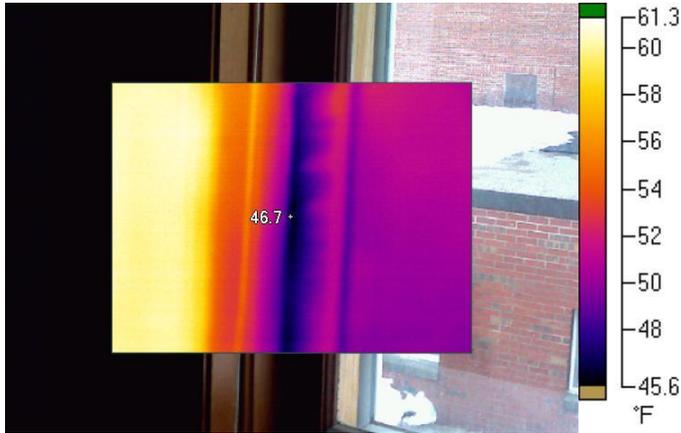
Another window allowing cold air movement into the conditioned space.

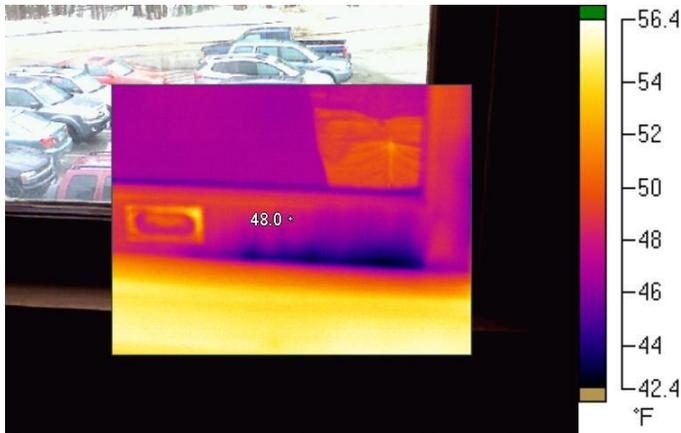
Window on southern side of the building with cold air leaking in.

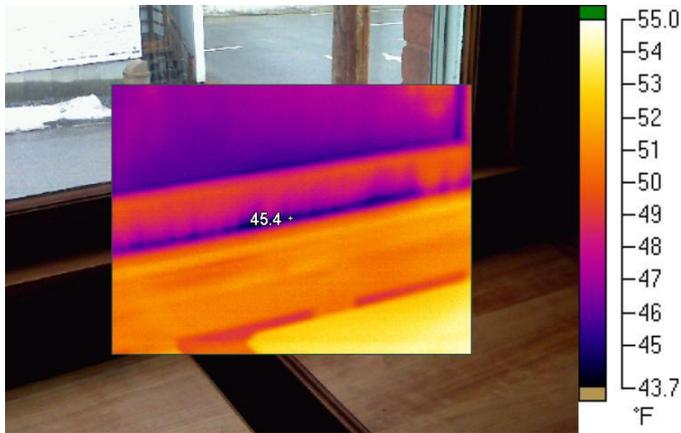
Another leaky window in the New Hampshire Room.

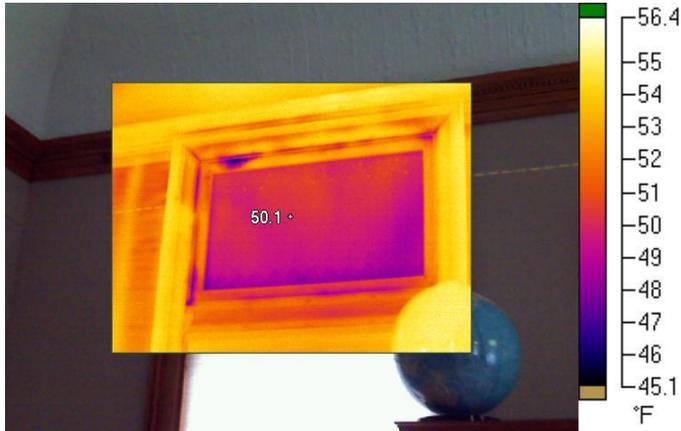
Another awning window showing air leakage around the edges.

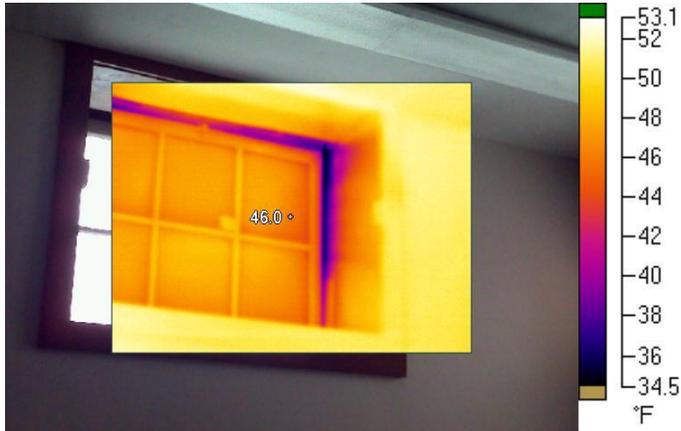
A hopper window from the juvenile room showing a lot of air movement along the edges, possibly caused by inability to properly close.

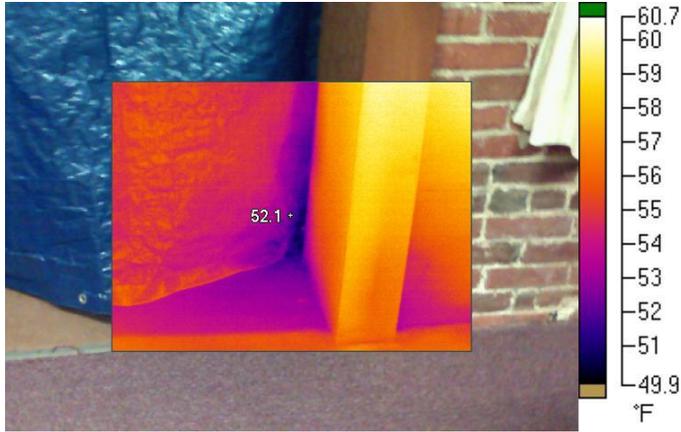
We attempted to block off the employee lounge / kitchen area before performing the test so as not to include the unheated storage space between the boiler room and the employee lounge.

Note the cold that is able to enter the conditioned kitchen area.

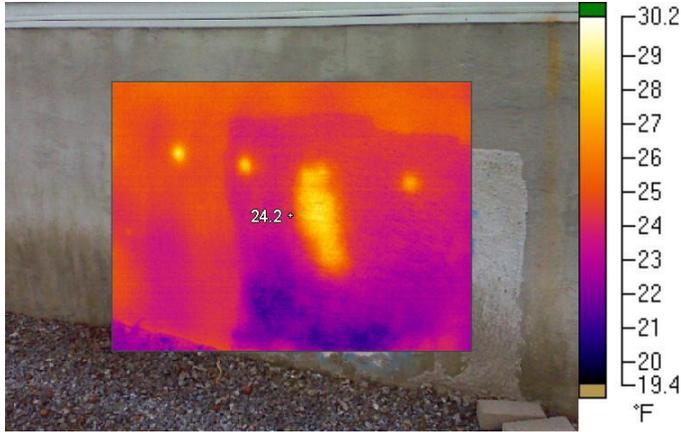
Foundation wall along north side of the building. The darker spots are moisture/mold in and on the concrete foundation. Moisture in a building material drastically increases heat loss through that material, and the presence of mold means that the material is not drying as quickly as it should, but this is a small area not to be of much concern.

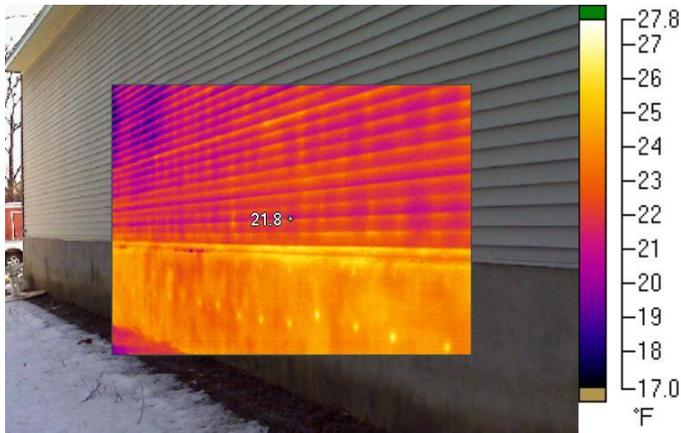
North side of the building. The foundation wall is showing a high level of heat loss, as well as the wall to foundation connection.

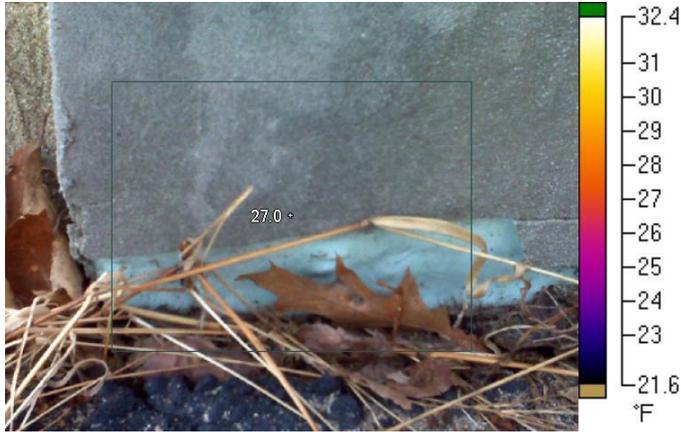
Here we see exposed foundation insulation. The plans called for the rigid insulation on the interior of the footing, but here it is present on the exterior. It is preventing heat loss though the foundation well here however other areas still have a large amount of heat loss though the foundation.

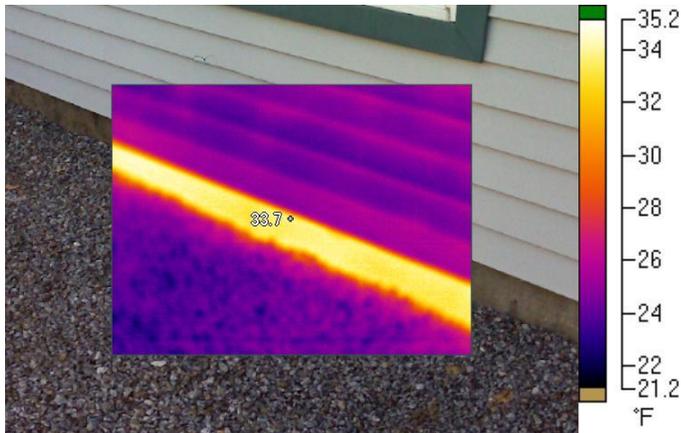
On the Western or front façade of the building the foundation to the fire house is showing heat loss.

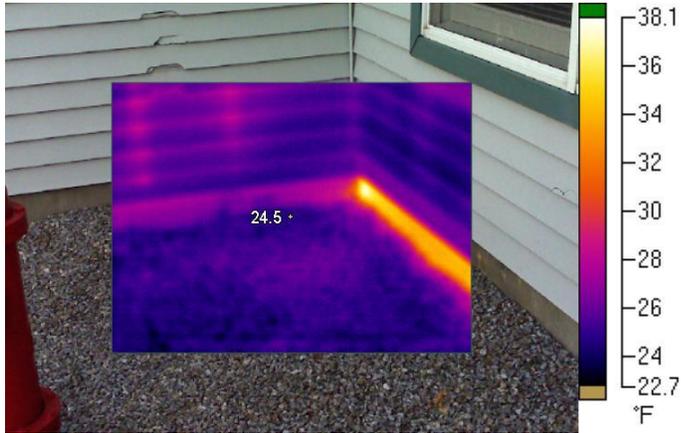
Front façade of the building where the fire house and the garage meet. The fire house slab is showing much more heat loss than the garage slab. Possibly because the fire station section is being heated to higher temperatures, or there may be discontinuity in the foundation insulation.

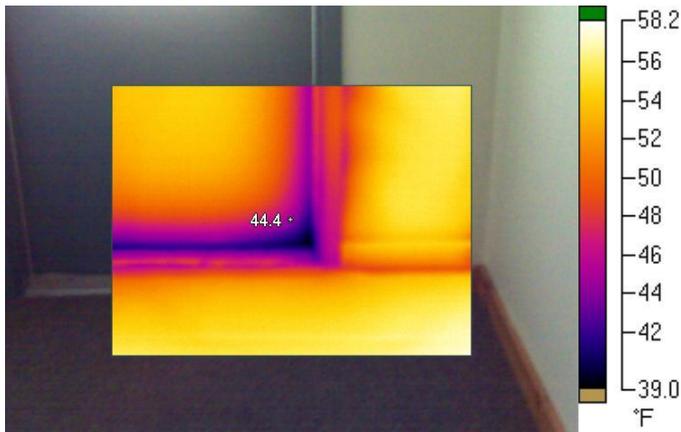
Main entrance door to the fire house. From the interior the door shows cold air infiltration around the bottom. Especially in the corners of the doorway.

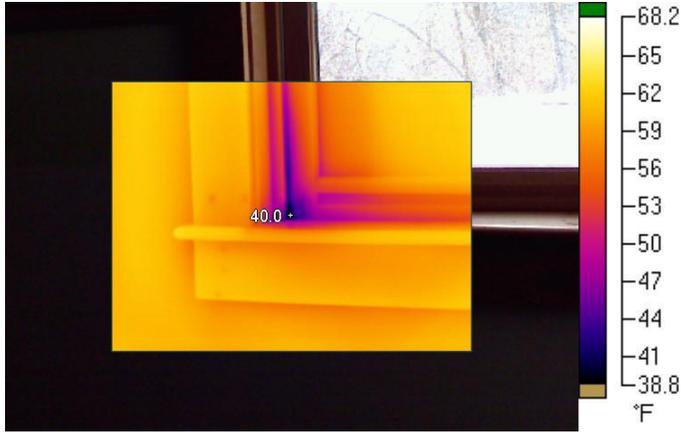
Typical window in the fire station showed cold air infiltration around the corners.

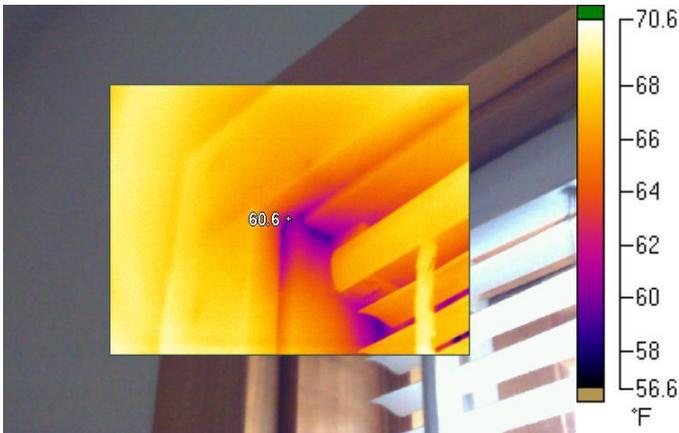
Another window showing cold air infiltration at the corner.

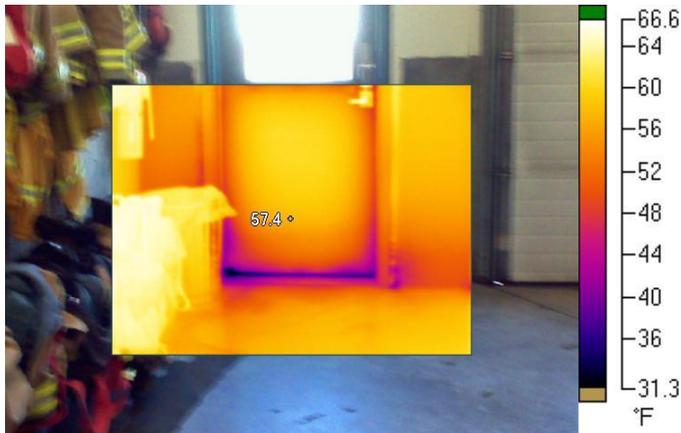
Door to the garage that is planned to be replaced. There is a lot of cold infiltrating along the bottom of the doorway. This door was also rusting along the bottom.

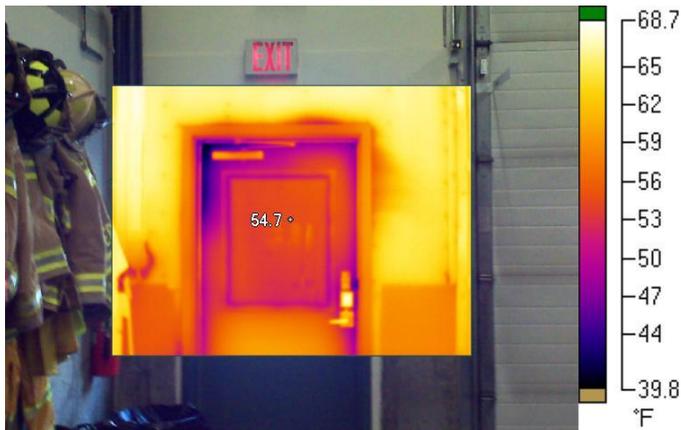
This photo shows the lack of insulation around the framing of the door. When this door is replaced it would be an ideal time to spray foam around the framing.

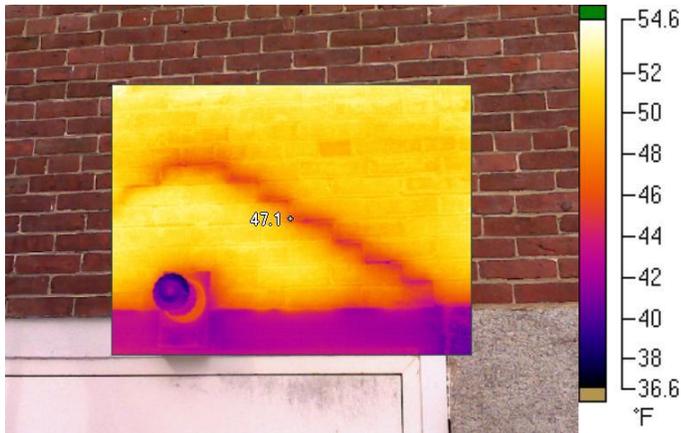
This is a crack in the exterior brick work above the Teen Center door, on the front façade. Heat is able to move through the wall and escape to the outside here.

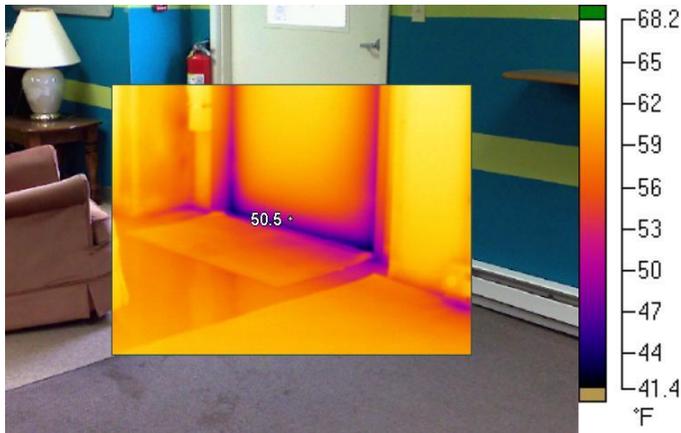
Side entrance door to the Teen Center. Around the door there is cold air infiltration.

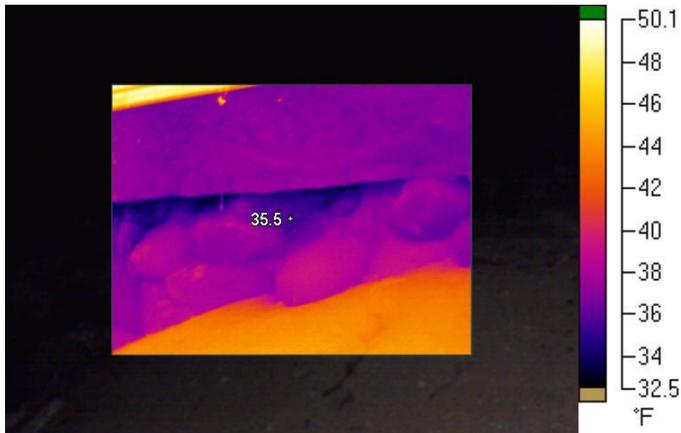
Behind the closet in the Teen Center is a dirt floor crawlspace. It is not conditioned, and it is the same as the outdoor temperature. The floor above is un-insulated (main floor of the Community Center) and there are vents venting the crawlspace to the main floor of the Community Center above. This crawlspace should be insulated and vents from this space should be closed off to prevent heat loss to this unconditioned space.

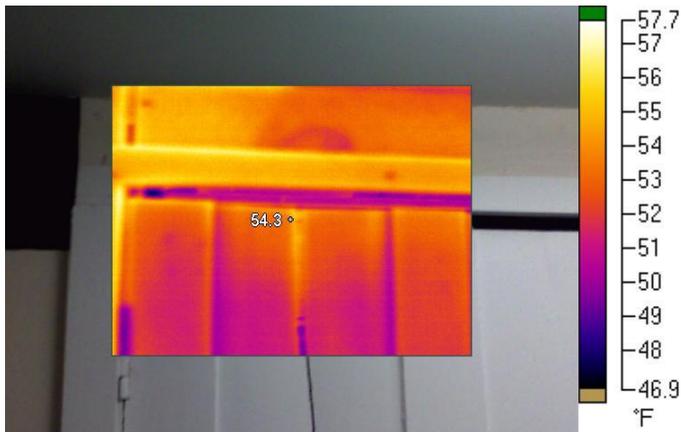
Door that leads to crawlspace. Cold is entering the closet space through this poorly constructed wood door, this should be replaced with an insulated door with weather stripping.

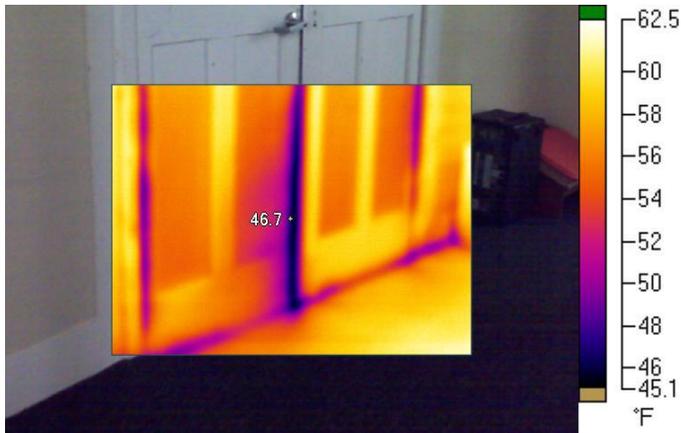
Double doors to the main entrance (up the granite staircase). Daylight was visible from the inside and cold air was infiltrating from the outside, both from between the doors and around the edges.

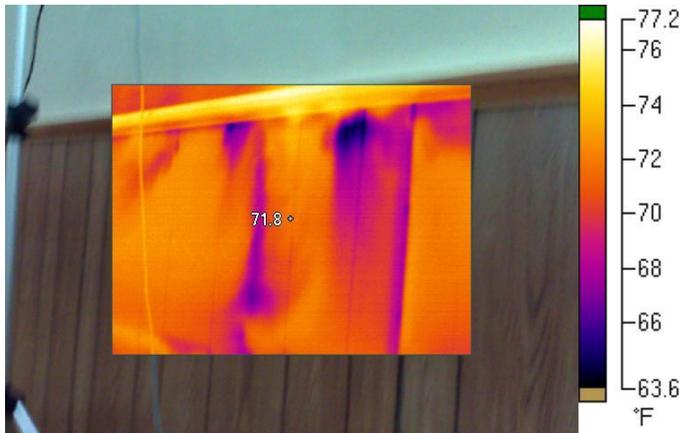
One surprising area we found a large amount of air movement was through and around the wood paneling on the walls.

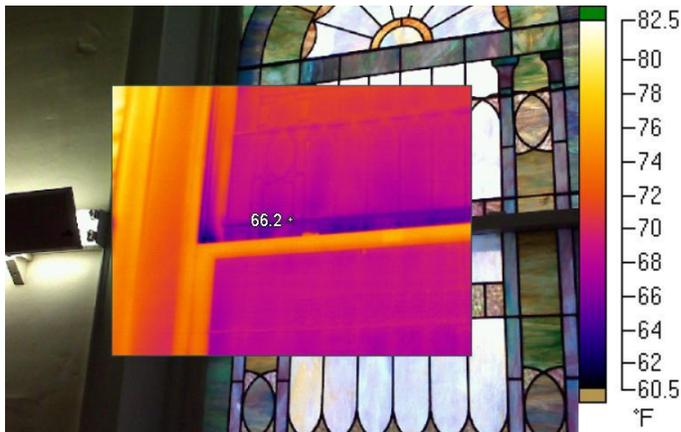
The window sash also shows air infiltration moving up the pane.

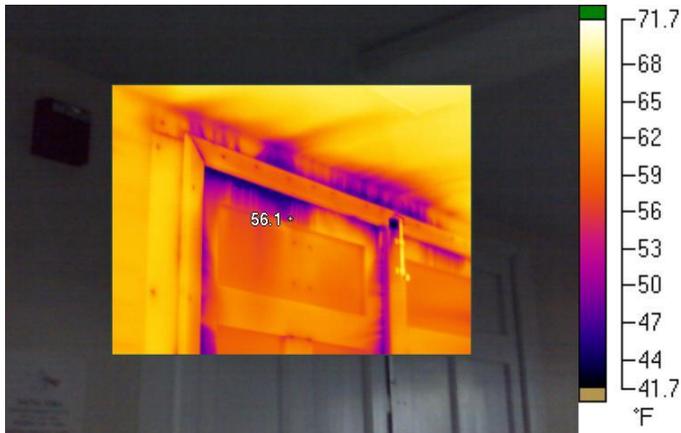
Main entrance double doors. The leaks that were visible before are now intensified by the blower door testing.

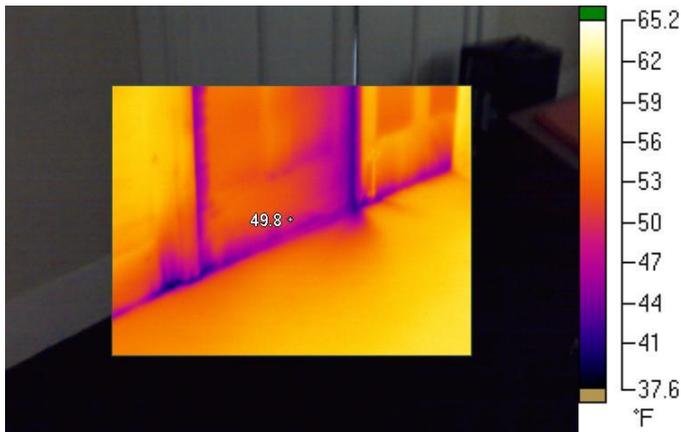
More air infiltration at the main entry double doors.

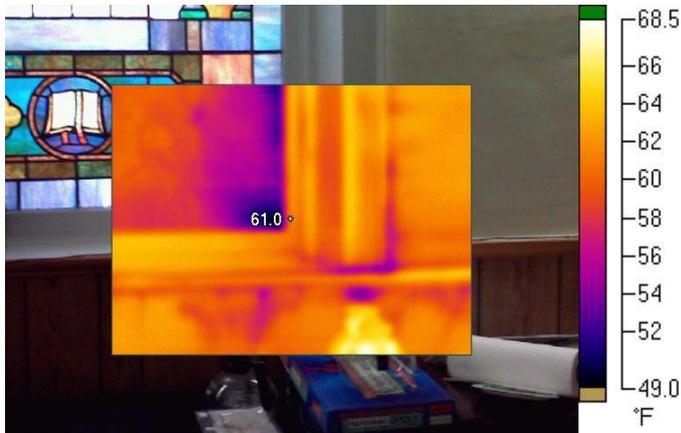
A window with cold air infiltration at the window edges.

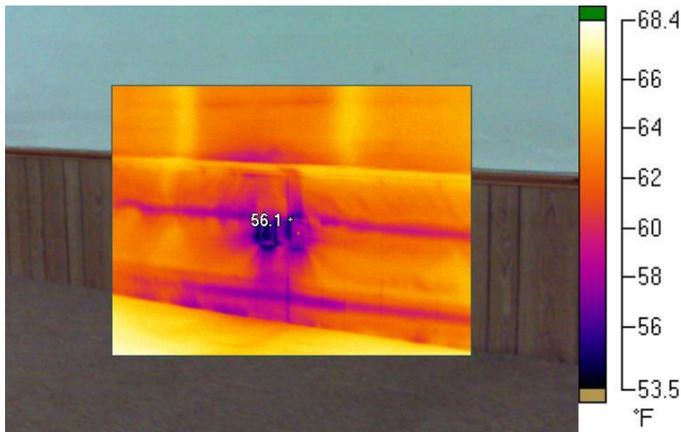
Very leaky electrical sockets indicating air movement in the walls.

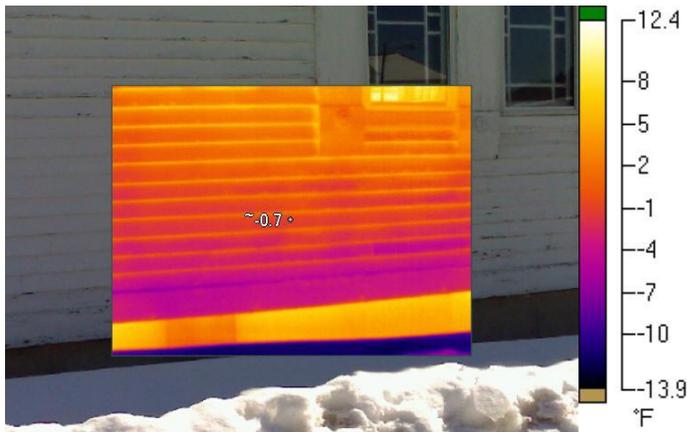
A side view of the western façade of the Grange Building shows heat is being conducted out through the foundation wall, which is un-insulated.

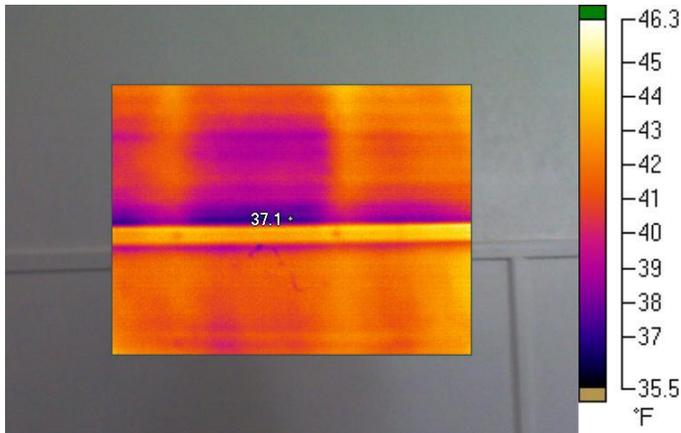
We found that there is no insulation in the walls here, the lathe and plaster is visible.

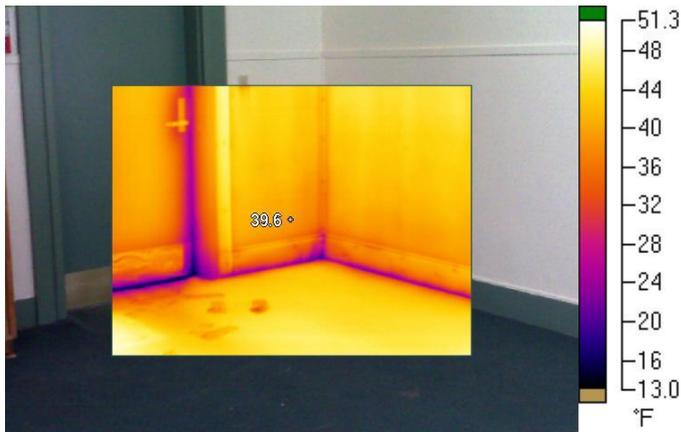
Back door of the Grange Building. The door is allowing cold air inside, and the floor to wall connection is appearing cold, likely due to the foundation wall conducting cold to the inside.

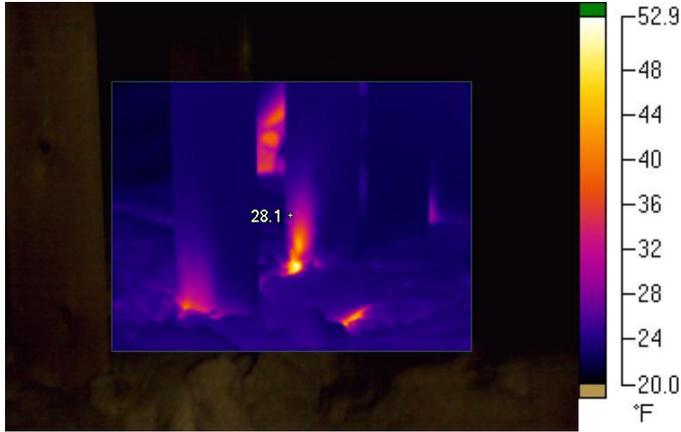
Inside the attic space not being used as storage. We found 8 to 10 inch bats of fiberglass placed in the attic. The framing members are conducting heat up into the attic and gaps in the insulation are also letting heat into the attic.

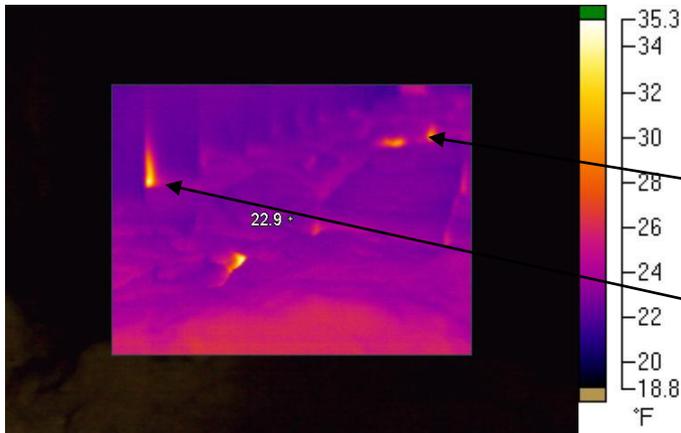
Another view of the attic and heat loss areas caused by the gaps between the bats of insulation and the framing conducting heat into the attic.

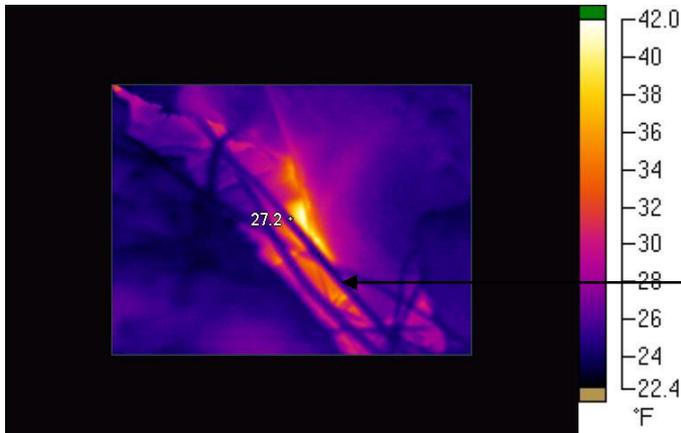
Looking down onto the floor of the attic at a gap between batts, 20 degrees difference leads to a great deal of heat loss.

Also this wiring should be checked to ensure it is not a fire hazard.

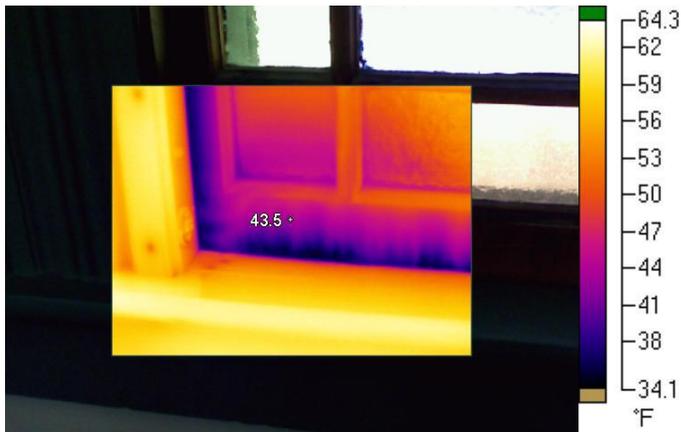
Another corner of a window, also showing a high level of cold air infiltration.

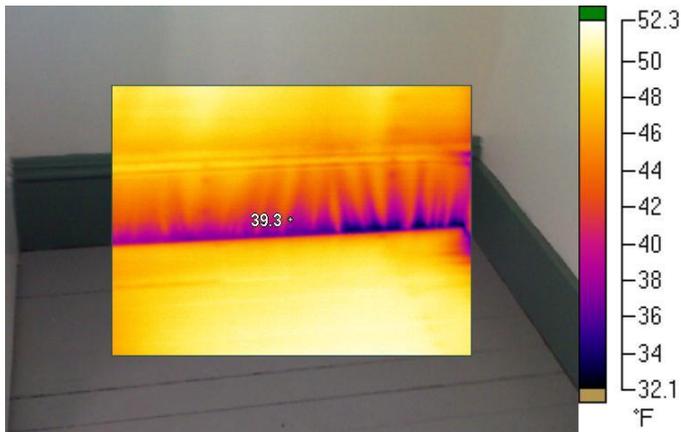
Air movement along the floorboards was present during testing. This is caused by air moving up from the basement / food pantry.
