Appendix A

Town of Henniker Municipal Buildings IR Report

*As part of the Level II Energy Audit for the
Town of Henniker*

Town Hall IR Report

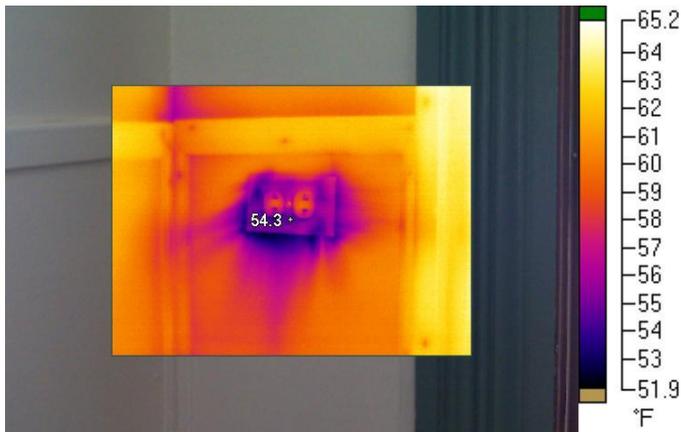
Another very leaky electrical socket indicating air movement within the walls. This is typical especially of un-insulated spaces.

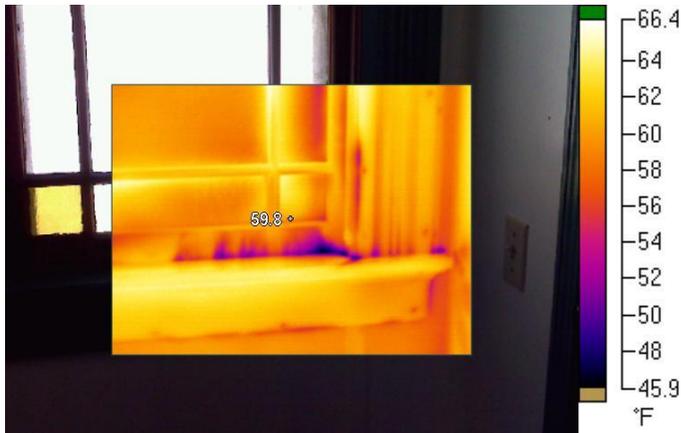
Cold infiltration at window.
