Appendix A

Town of Henniker Municipal Buildings IR Report

*As part of the Level II Energy Audit for the
Town of Henniker*

Town Hall IR Report

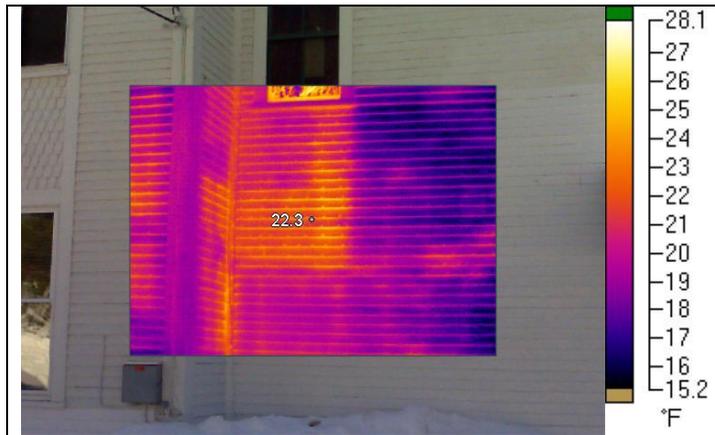
IR001352.IS2
3/3/2011 1:55:35 PM

In this photo the exterior of the building is showing variances in temperature. There appear to be warmer and cooler areas due to the location of insulation..

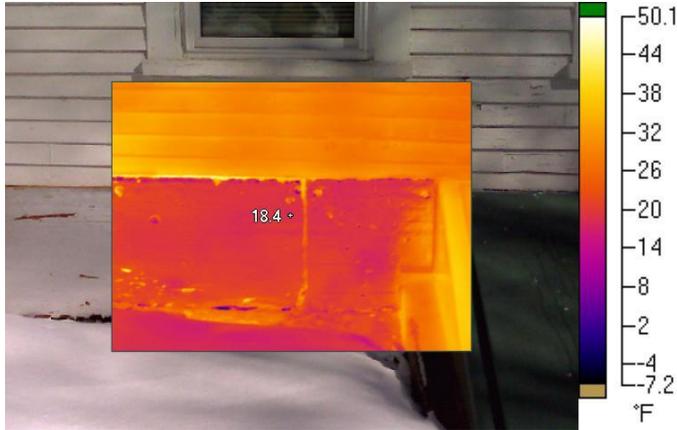
IR001355.IS2
3/3/2011 1:56:30 PM

Another shot of the foundation wall with added exterior insulation near the bulkhead doors preventing heat loss through the foundation.

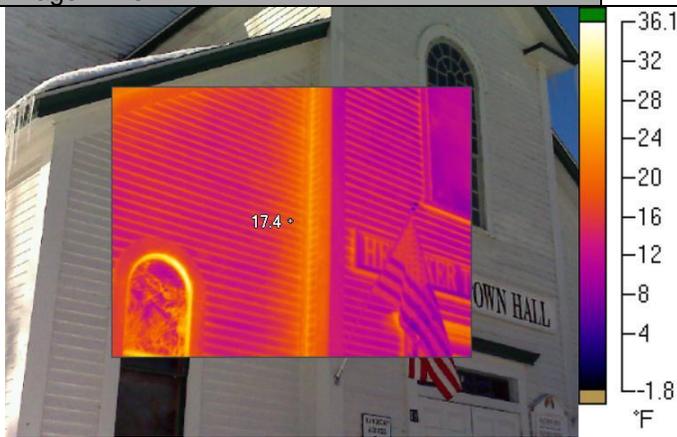
IR001367.IS2
3/3/2011 2:01:12 PM

There is unheated space behind these walls so we see very little temperature differences in the wall.

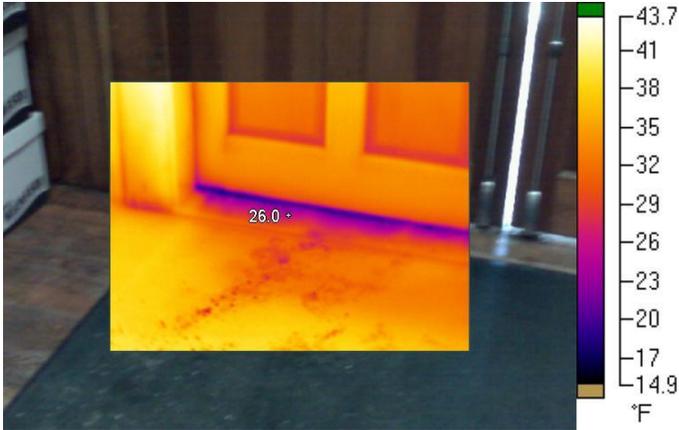
IR001370.IS2
3/3/2011 2:02:57 PM

Inside the double exterior doors have large gaps at the bottoms and between the doors where cold air comes in.

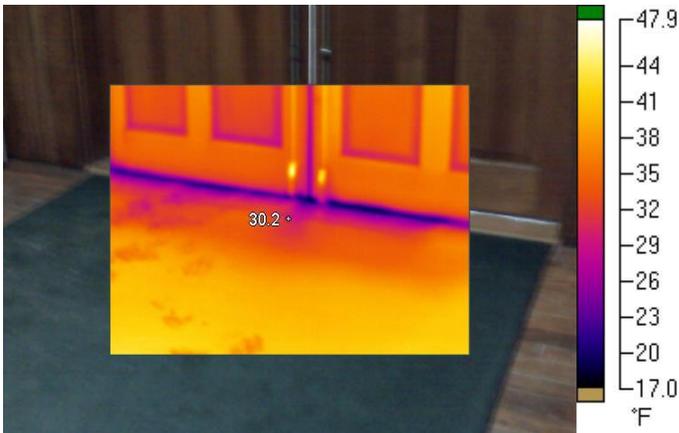
IR001371.IS2
3/3/2011 2:03:09 PM

Note the cold entering at the bottom of the doors and traveling across the floor due to the large gaps.

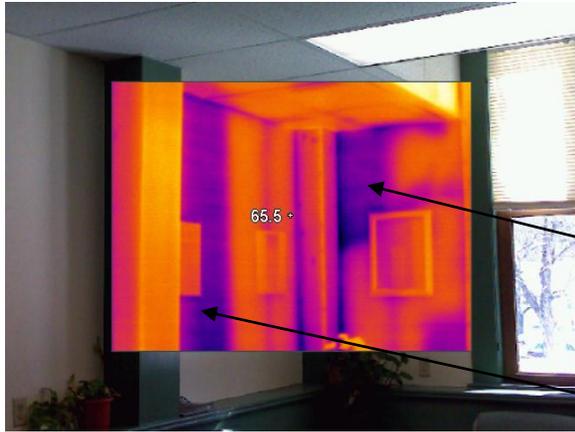
Wall of sitting / waiting area. This image shows gaps and inconsistencies in the insulation. Indicating possible missing or settling batt insulation. If the bats were not properly tacked in they can start to settle within their bay, decreasing their effectiveness.

The batt has settled to the bottom of this bay.

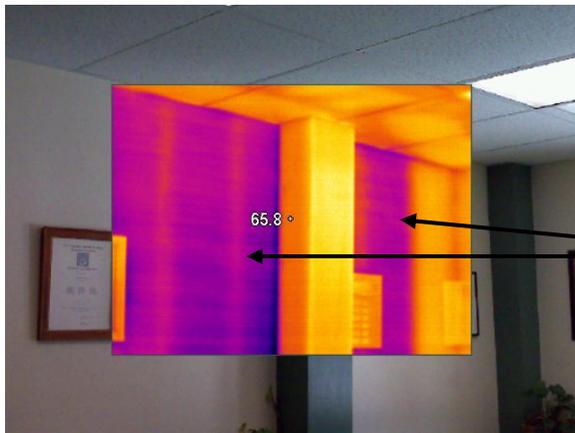
This wall separates the office space, which is conditioned, from the main entrance and stairwell, which is not. This wall is showing cool and is lacking insulation. Note the original lathe.

Un-insulated wall

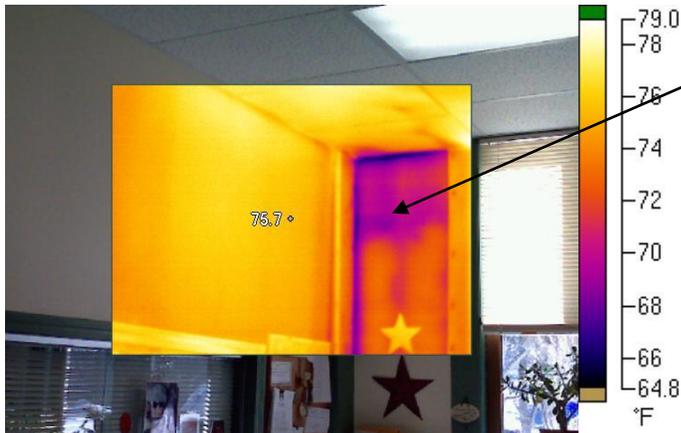
IR001381.IS2
3/3/2011 2:07:13 PM

Assessing office wall. Again the fiberglass bats may be settling, allowing cold to conduct through the empty spaces.

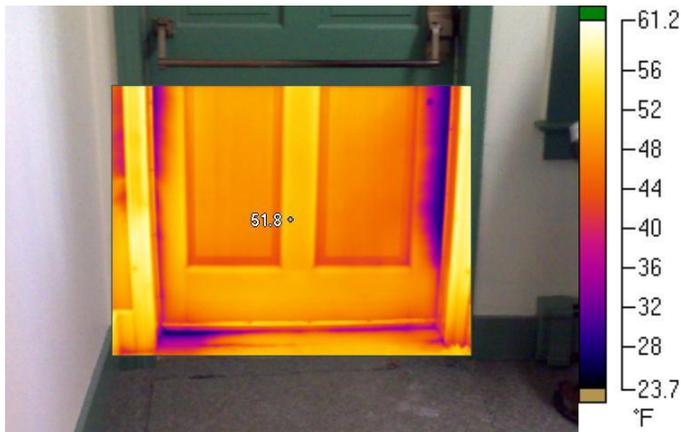
IR001385.IS2
3/3/2011 2:11:45 PM

Back exterior door. Cold air is coming in and long the bottom and sides of door. Note the air coming in is close to 23 degrees.

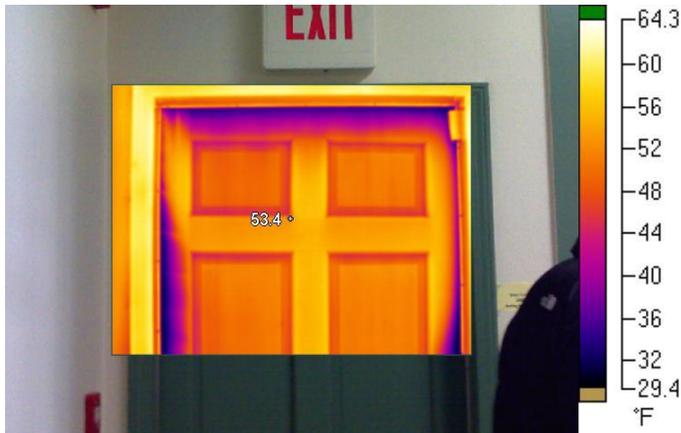
IR001386.IS2
3/3/2011 2:11:51 PM

Back exterior door. Cold air is coming in through the top as well.

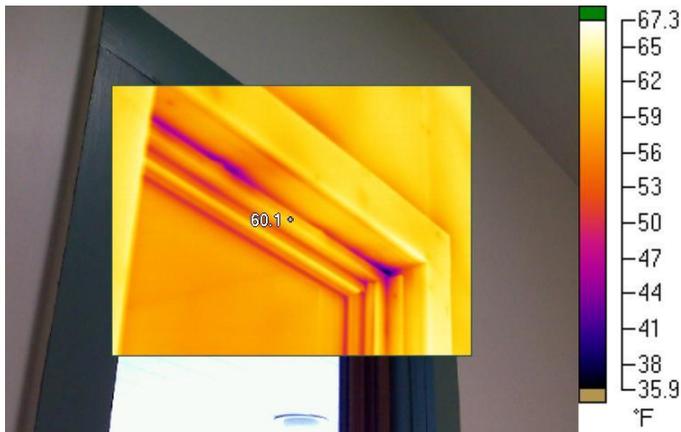
IR001387.IS2
3/3/2011 2:12:17 PM

Interior doorway. Cool air along top may indicate cold moving down from the unconditioned upstairs.

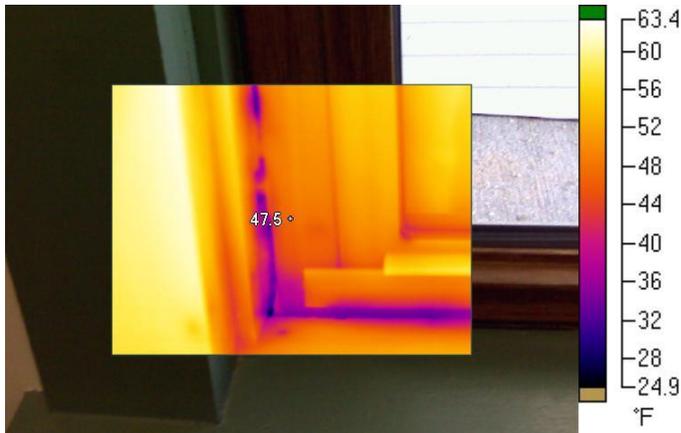
IR001388.IS2
3/3/2011 2:12:38 PM

Window in the employee lounge area. This window is letting cold air in around the window seal.

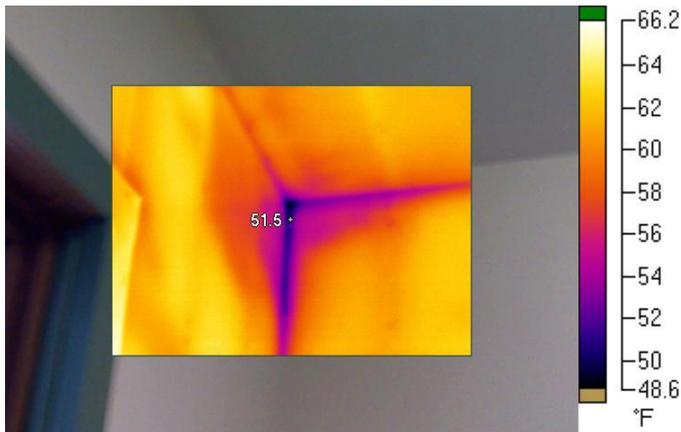
IR001389.IS2
3/3/2011 2:12:52 PM

Corner of a room showing cold.

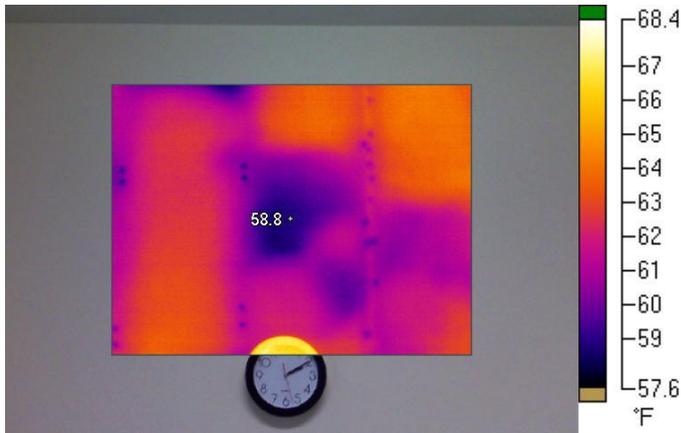
IR001390.IS2
3/3/2011 2:13:03 PM

Cold spot in the wall again indicates that the fiberglass bats may be settling within their bays, or is pushed back and not touching all sides of the wall allowing for cold to "pocket" in the wall.

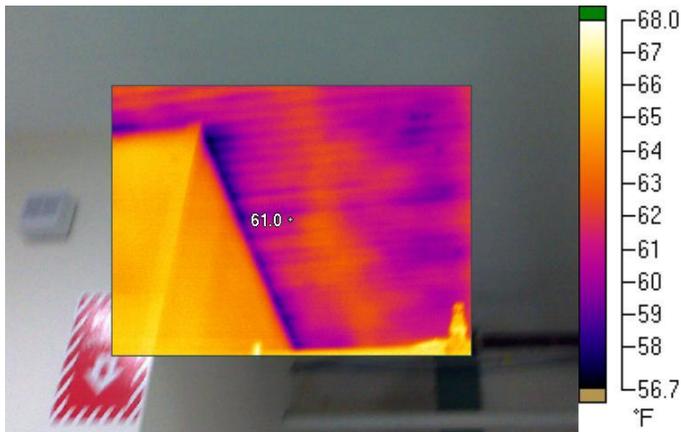
IR001395.IS2
3/3/2011 2:14:35 PM

Wall to ceiling connection where cold is conducting through the floor of the space above, which is unconditioned.

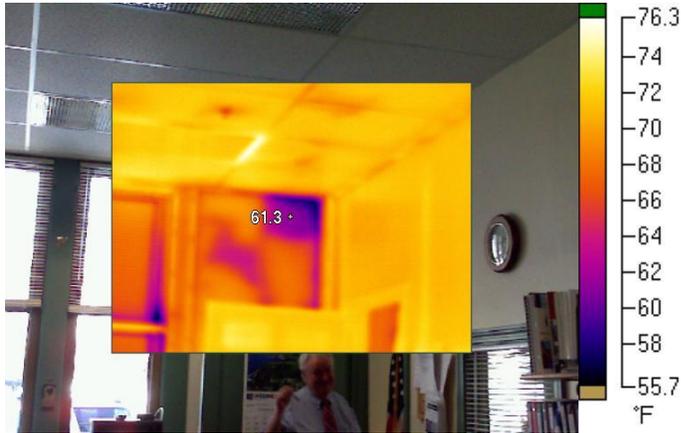
IR001396.IS2
3/3/2011 2:15:40 PM

Town Administrator's Office where there is again evidence of settling of fiberglass bats in the top right portion of the wall. There also appears to be cool air coming in around the window sashes.

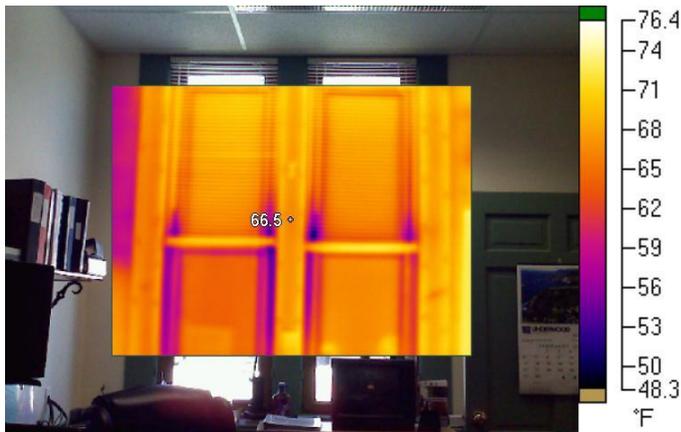
IR001397.IS2
3/3/2011 2:18:18 PM

Town Administrator's Office windows. Air is coming in around the windows.

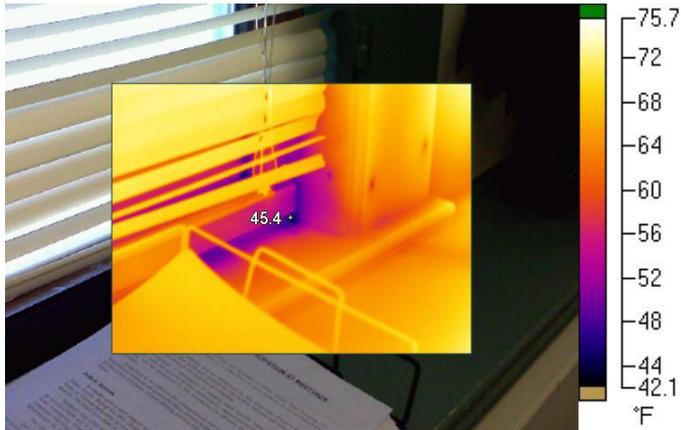
IR001399.IS2
3/3/2011 2:22:38 PM

Cool coming in at a window corner.

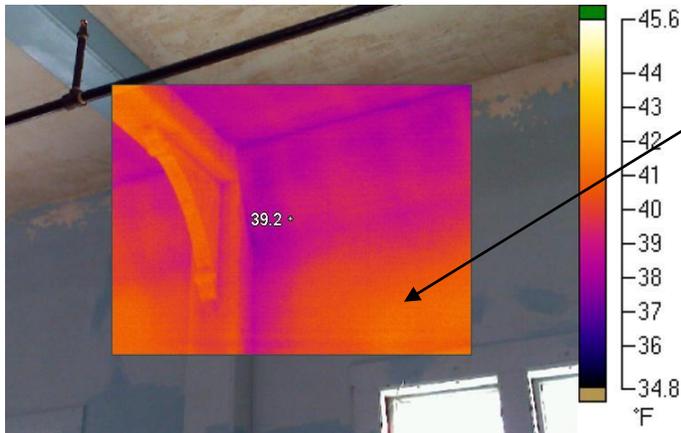
IR001412.IS2
3/3/2011 2:31:09 PM

Warm areas on the walls of this unconditioned space are heated from the sun.

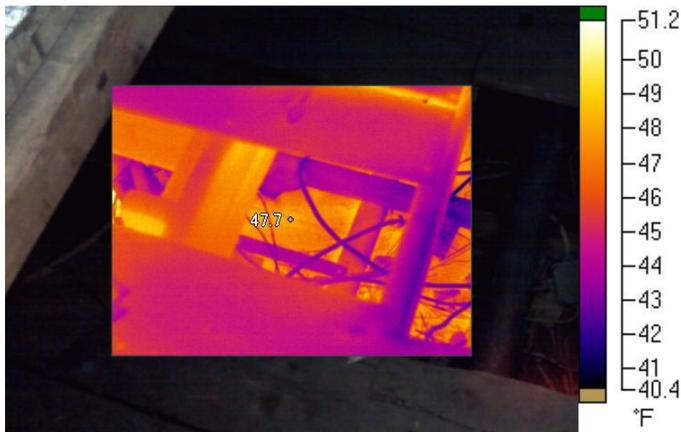
IR001415.IS2
3/3/2011 2:34:01 PM

View under the trap door on stage. Heat can be seen coming up from below.

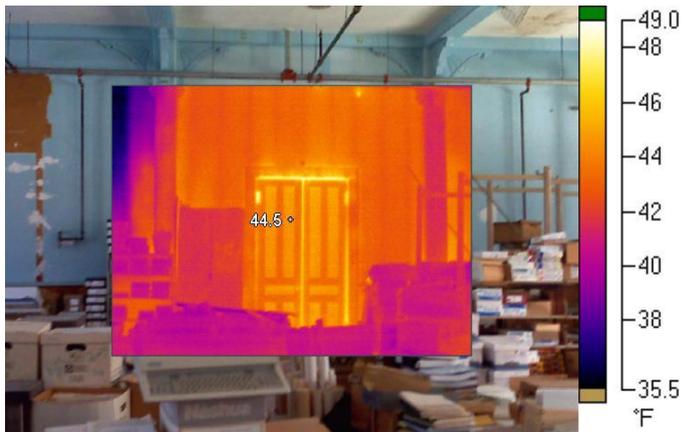
IR001421.IS2
3/3/2011 2:40:51 PM

Heat escapes the office space downstairs and makes its way into the entry where it rises. This may be why the door is showing 10 degrees warmer than some of its surroundings.

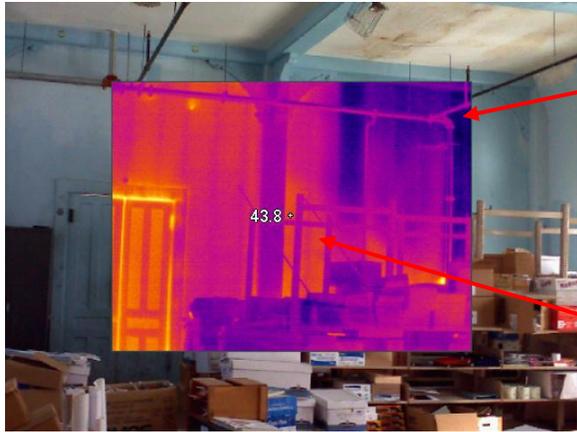
On the other side of this wall is the outside

This part of the wall has interior space on the other side.

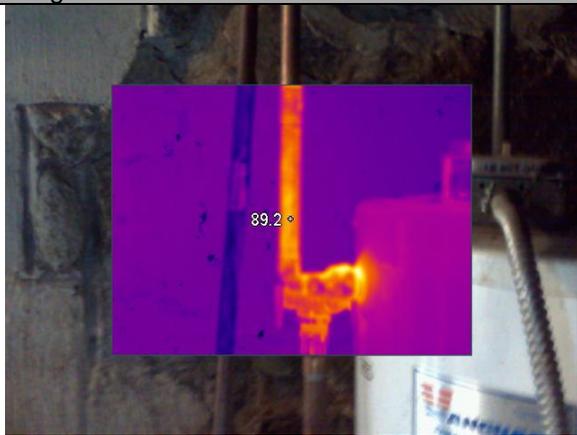
IR001427.IS2
3/3/2011 2:56:57 PM

Un-insulated hot water pipe in basement.

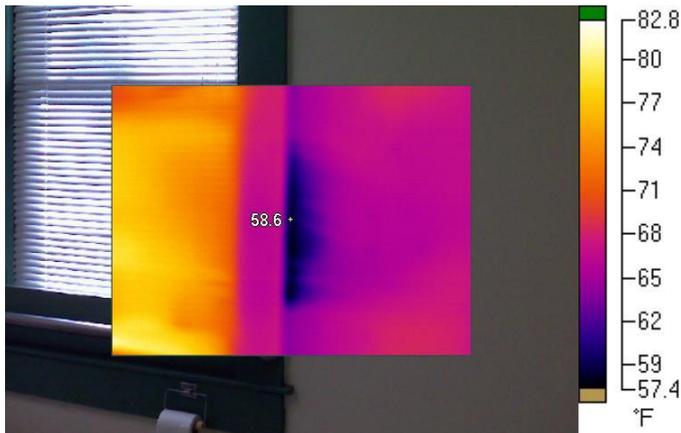
IR001432.IS2
3/3/2011 3:37:15 PM

This bathroom window shows air movement from behind the trim, not from the window itself, indicating cold air movement within the wall.

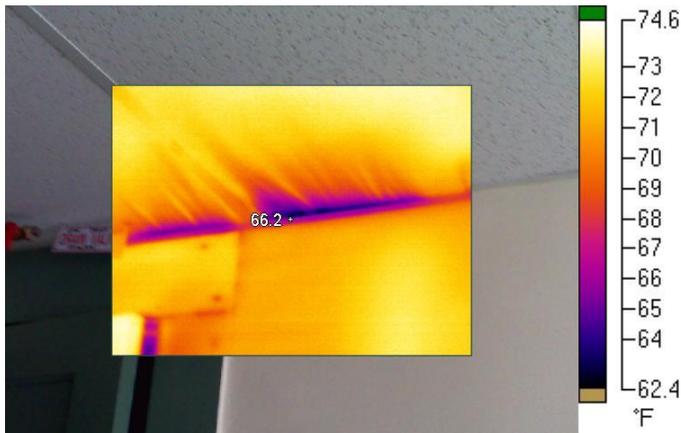
IR001435.IS2
3/3/2011 3:38:12 PM

Air movement from above the drop ceiling indicating cold air coming in from the space above.

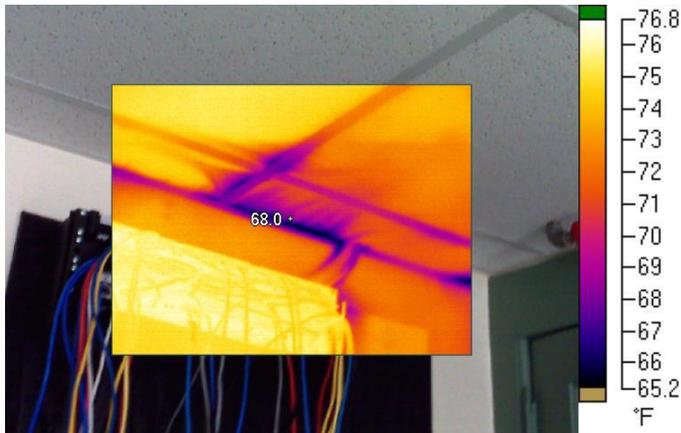
IR001436.IS2
3/3/2011 3:38:17 PM

Air movement from above the drop ceiling indicating cold air coming in from the space above.

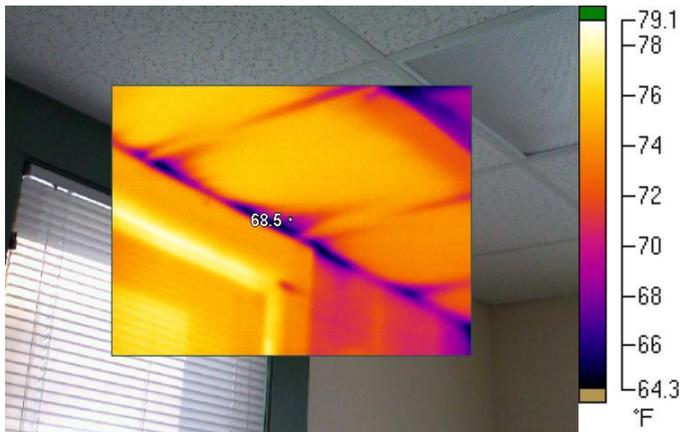
IR001437.IS2
3/3/2011 3:38:26 PM

More air movement above the drop ceiling.

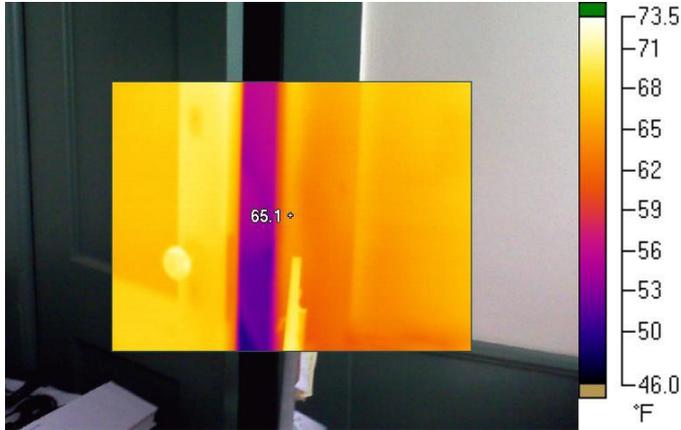
IR001440.IS2
3/3/2011 3:39:17 PM

Cold closet in an office space. The wall and closet show nearly a 30 degree difference.

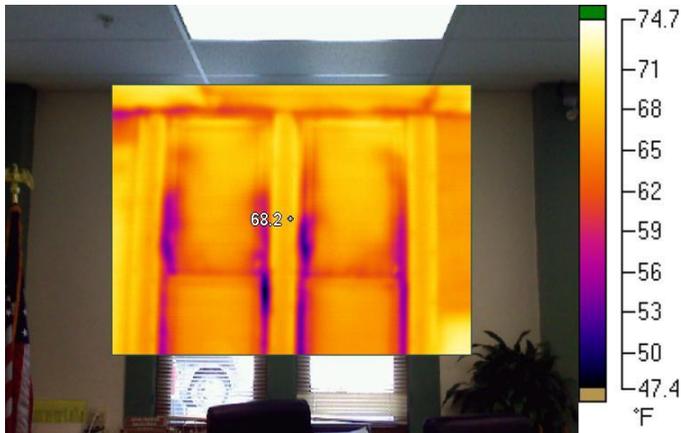
IR001444.IS2
3/3/2011 3:40:14 PM

Air movement around windows in Town Administrator's Office.

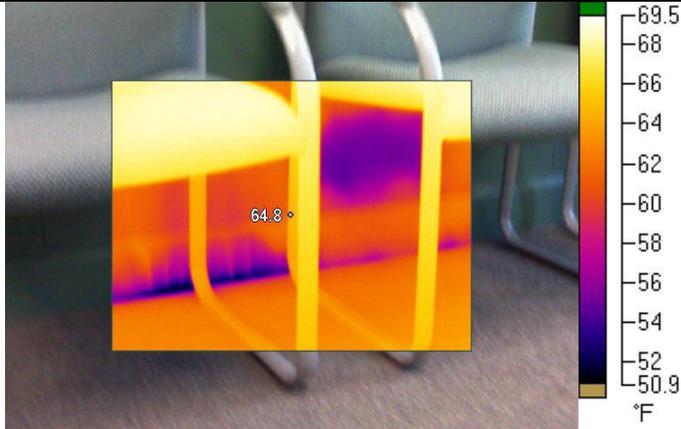
IR001452.IS2
3/3/2011 3:42:08 PM

Floor boards along the waiting area show a lot of air movement. Cold air moving up from the crawlspace below.

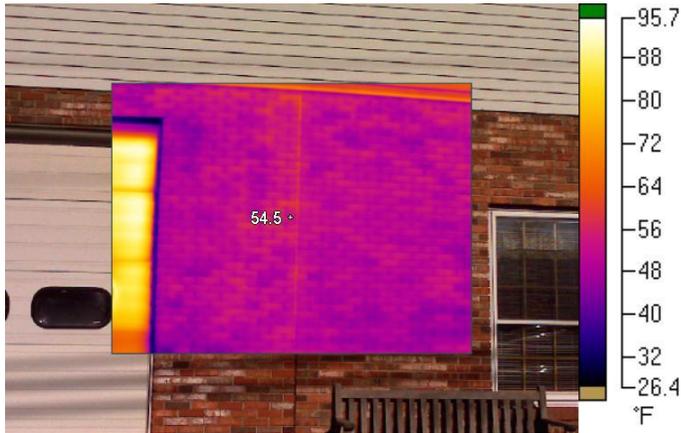
IR000810.IS2
2/24/2011 8:53:26 AM

Exterior connection of the garage to the police station. It does not appear that there is much heat loss occurring at the connection.

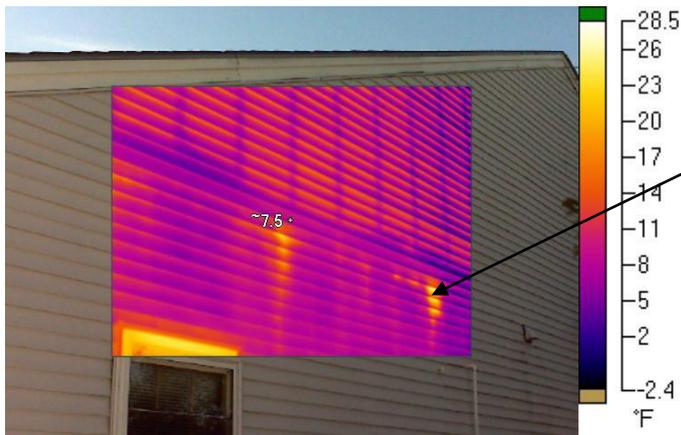
In the rear of the building the framing members in the attic are visible due to warm air moving up into the attic space. Warm spots on the building are gaps between the batt insulation where heat is escaping.

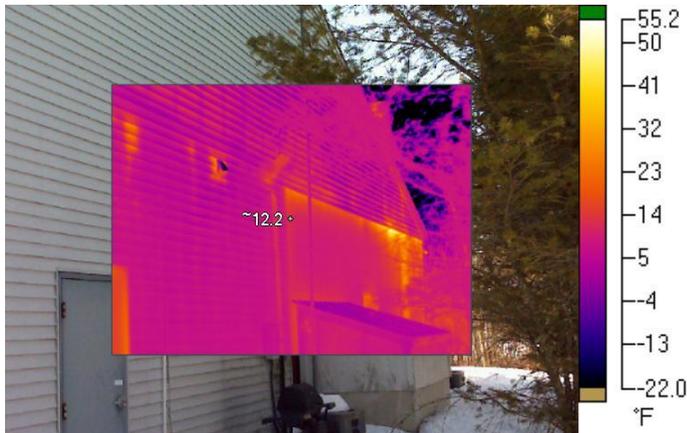
IR000826.IS2
2/24/2011 8:57:30 AM

Another image of the rear of the building. There is more heat loss occurring at the back wall area that is the boiler room.

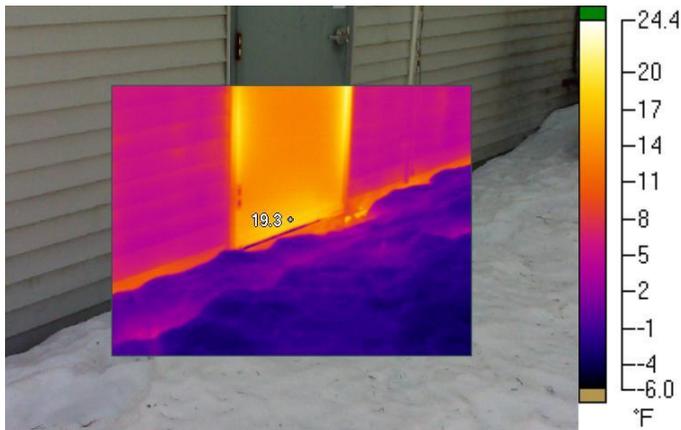
IR000828.IS2
2/24/2011 8:57:47 AM

Exterior metal door showing heat loss. The slab edge in this image is also showing some heat loss. Heat from the inside of the building is easily conducted outward by the concrete slab.

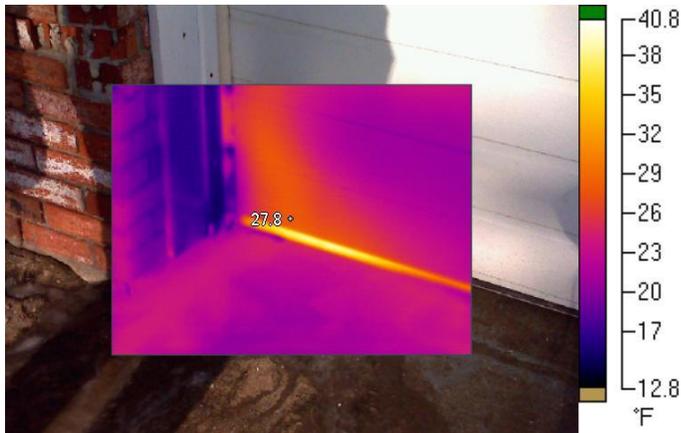
IR000830.IS2
2/24/2011 8:58:33 AM

The bottom of the garage door is showing some heat loss. This heat loss can be addressed with weather stripping.

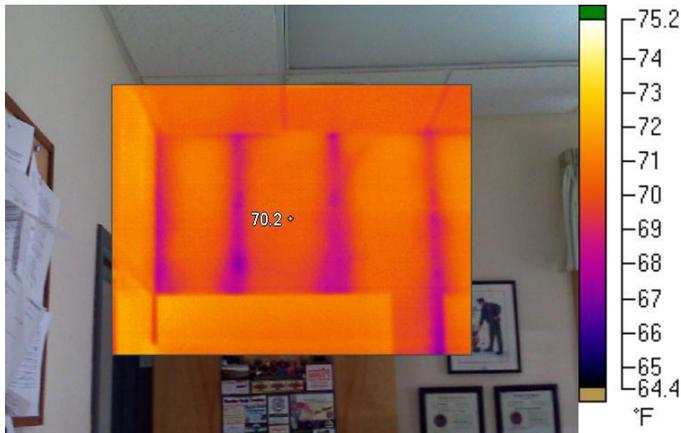
Rear exterior wall. The wood framing members are visible. Cold air is conducting inward through the wood framing members. This is called thermal bridging.

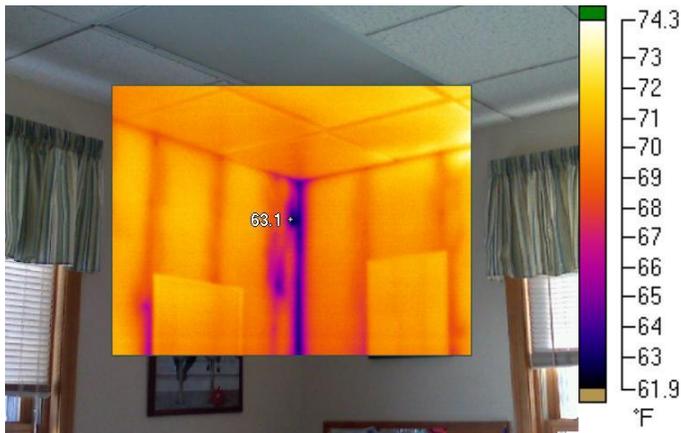
This exterior corner is showing cold conducted to the interior by the framing members at the corner. This is very typical of standard building practices, because there is no room for insulation at the corners. We saw this at several exterior corners in the building.

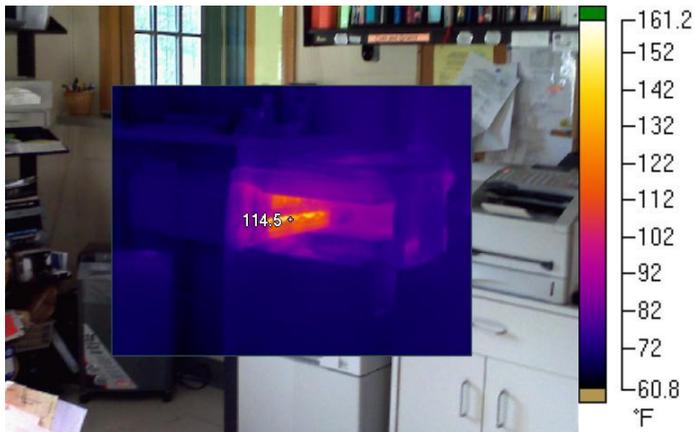
More excess heat from office equipment.

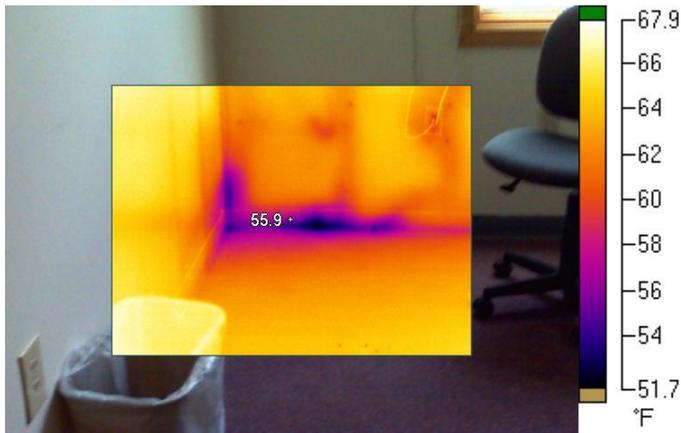
Still in the interview room, we see a very cold area in the corner and at the wall to floor connection. Heat is likely being lost through the bottom plate framing where there is no insulation.

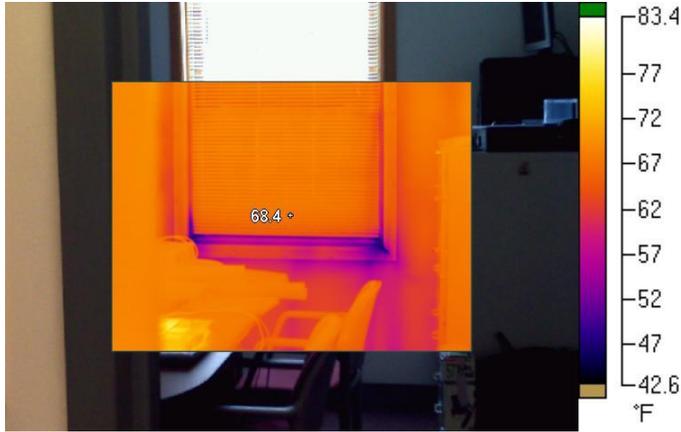
Another image of a window that is cold around the edges.

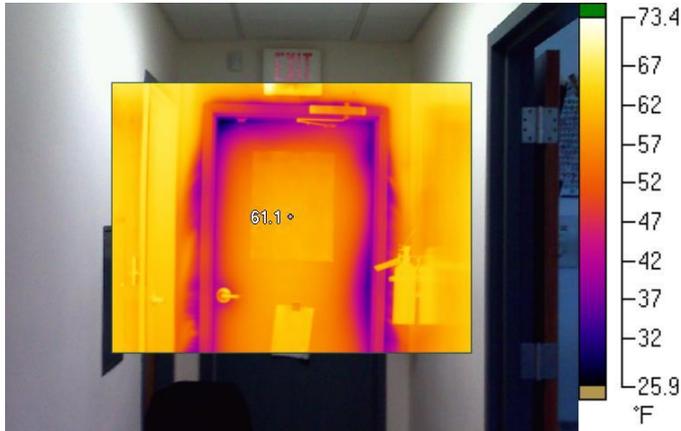
This is the back metal exit door in the hallway off the office area. This door is showing cold air entering around the door.

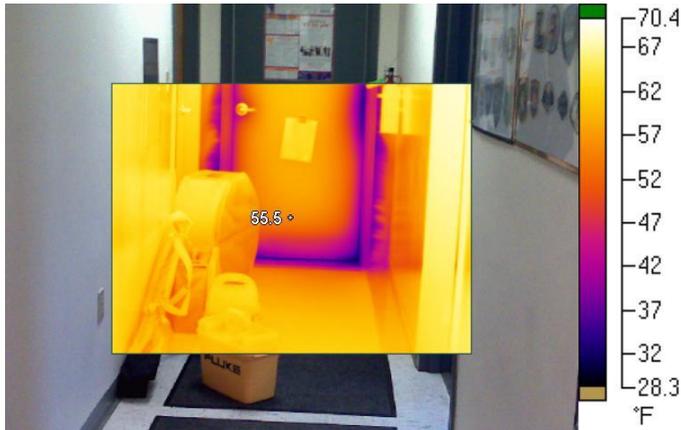
A bottom view of the door.

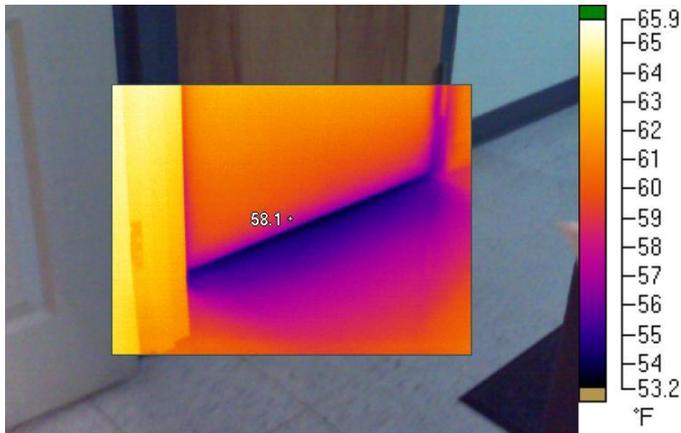
This is one of the doors that leads to the garage with a great amount of cold coming in from beneath the door. There is a large space beneath the door (the other door leading to the garage from the officer work space was weather stripped). There is also the concern of carbon monoxide making its way into the officer workspace from the garage. Adding weather stripping to this door would prevent the cooler air from the garage (and any carbon monoxide) from entering into the officer workspace.

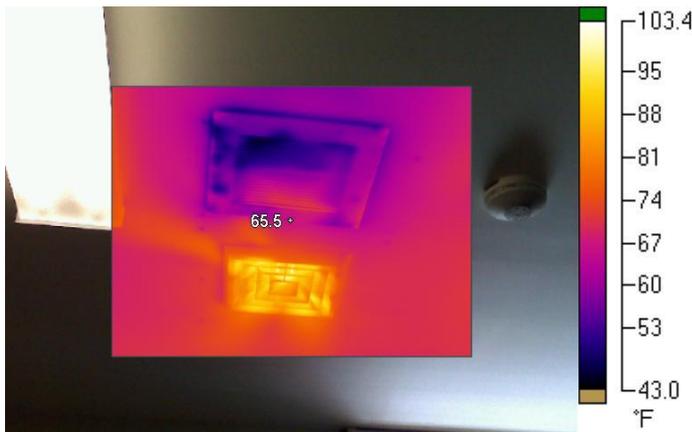
Image of a supply and a return vent that are located too close to one another. You can see heat going right to the return.

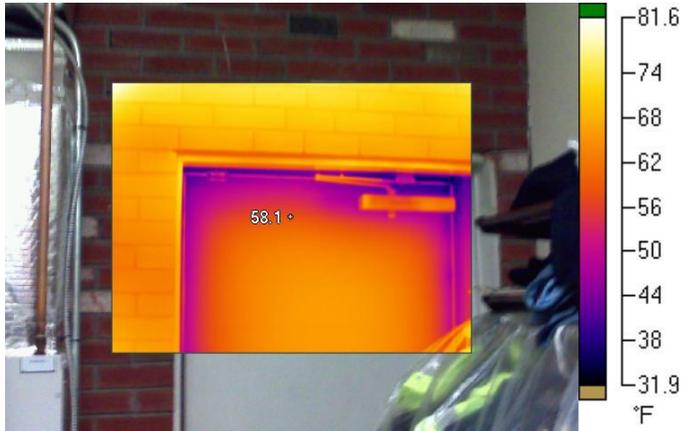
Another exterior door that is showing cold entering around the edges.

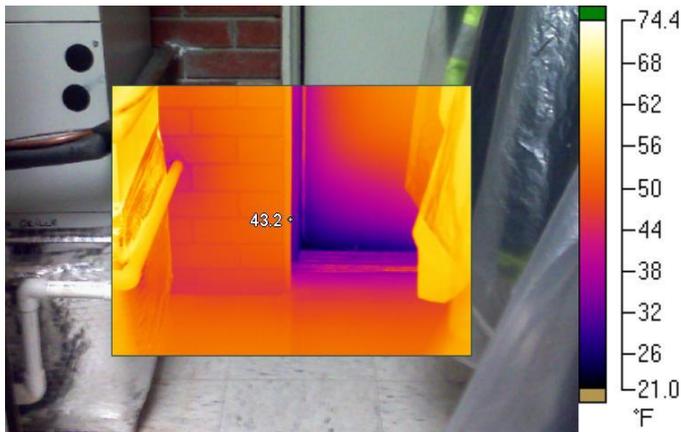
Bottom view of that door.

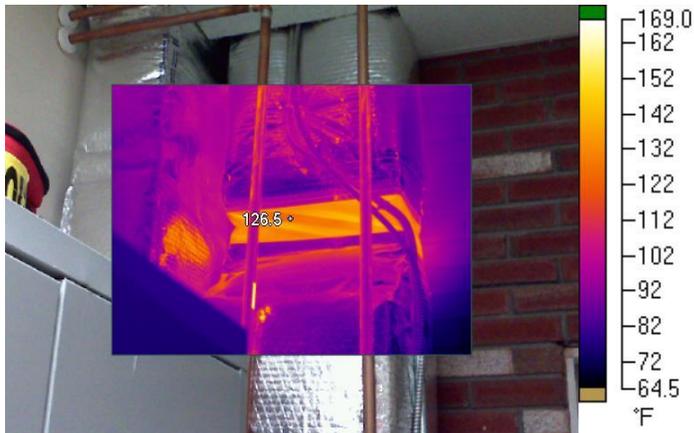
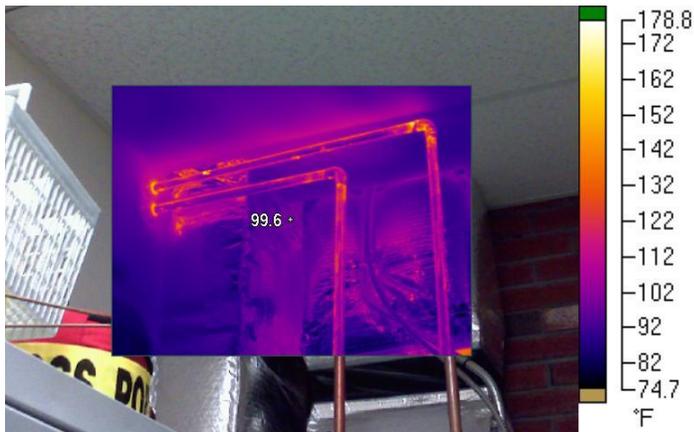
Exposed hot water pipes should be insulated. Leaving hot water pipes un-insulated reduces the efficiency of the heating system due to the heat loss.

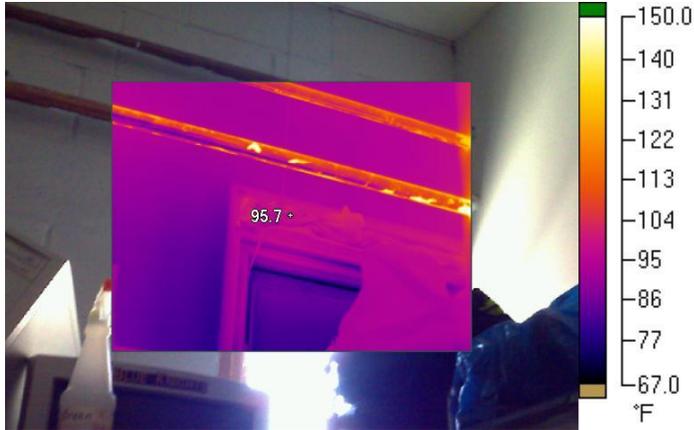
More water pipes that could be insulated.

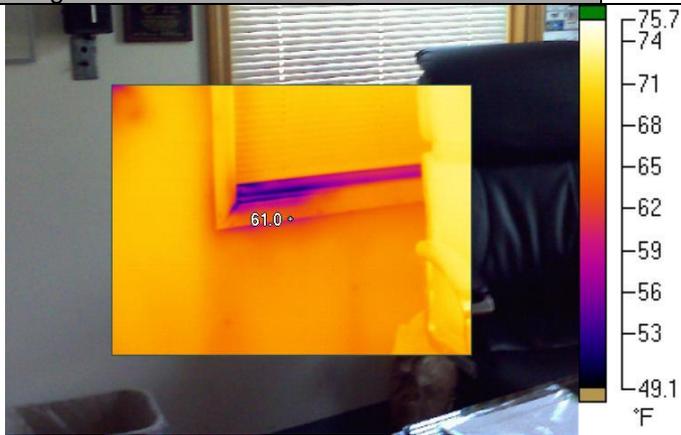
Cool window corner located in the Chief's Office.

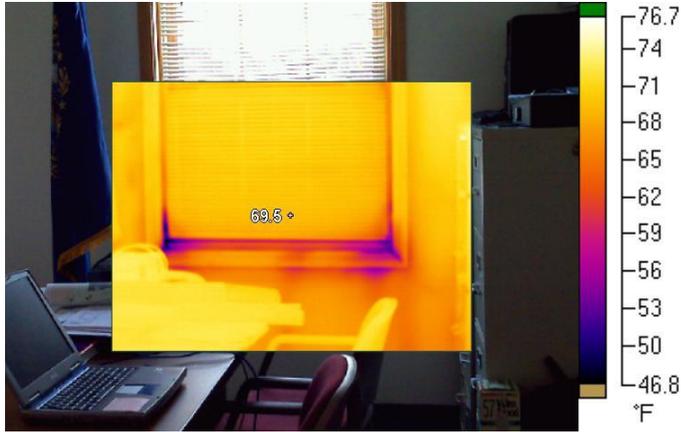
Another window showing cold corners.

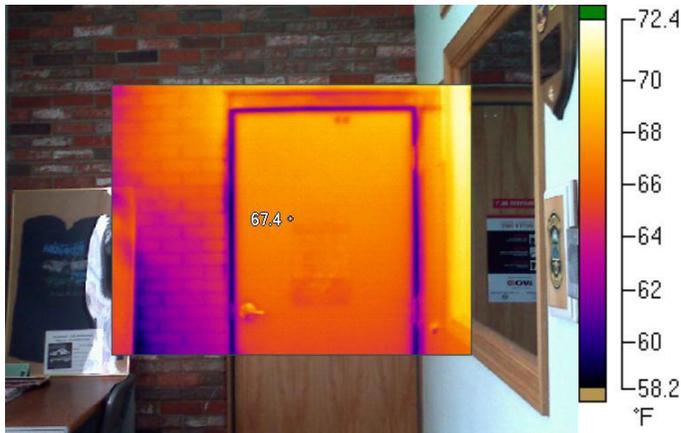
Door leading from the lobby the garage. Shows that air is able to move into the lobby. Doors to the Garage are very important to weather strip for indoor air quality reasons as well.

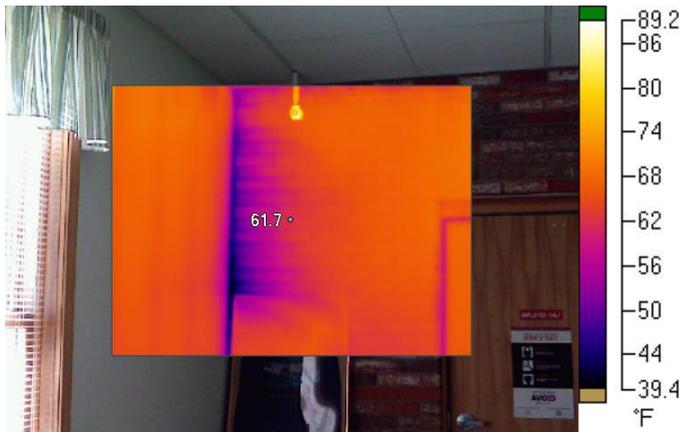
Exterior wall and the shared wall between the lobby and garage. Air movement is occurring at the connection.

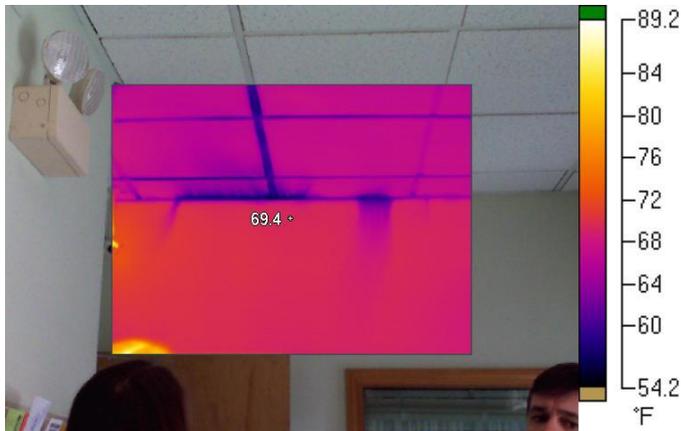
More air movement from the cold attic above the drop ceiling.

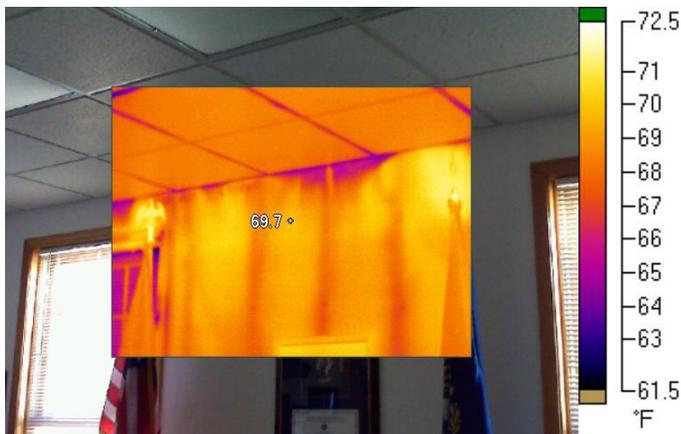
A wall in the Chief's Office. There are issues with air movement from the attic space above. Cold air is able to enter the area between studs and move around the fiberglass batts. This is due to an unsealed top plate.

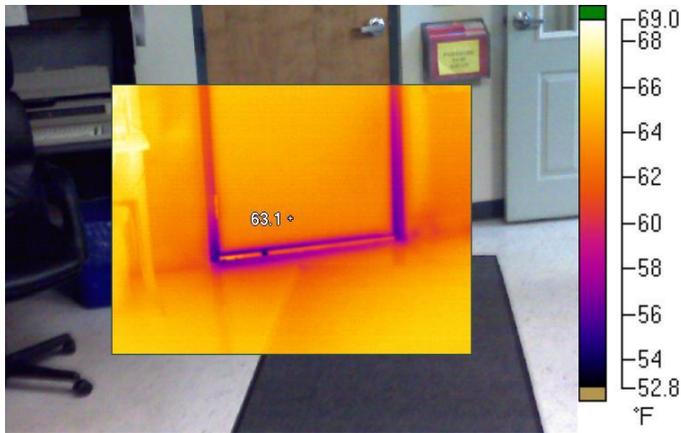
Door leading to the garage from the officer work space. This door **is** weather stripped.

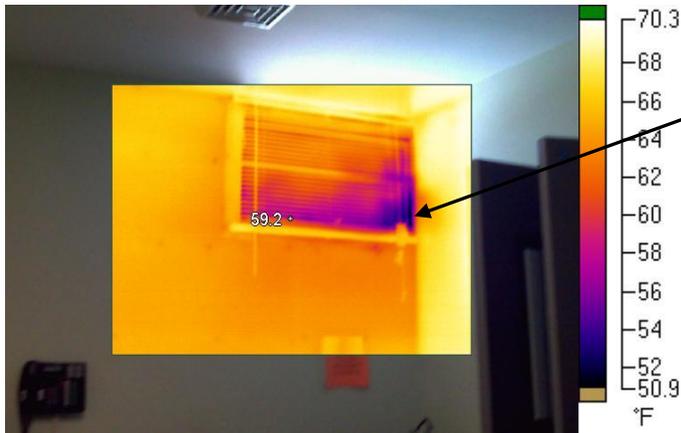
Window in the holding area. This window shows more cold air coming in around the right corner.

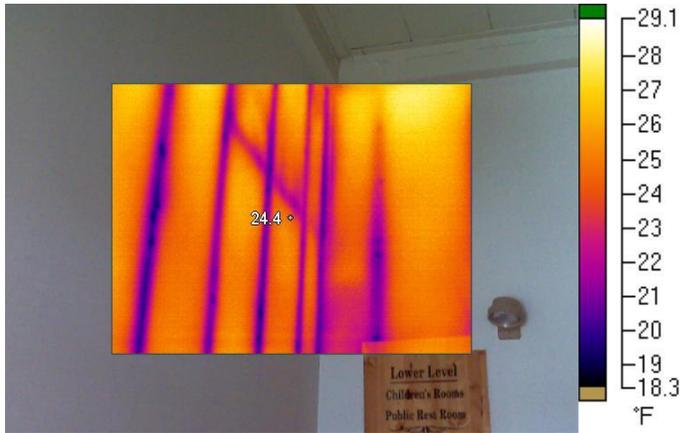
In the walls of unconditioned stairwell the studs are conducting cold from the outside inward. Placement of the fiberglass bats is also visible in the picture.

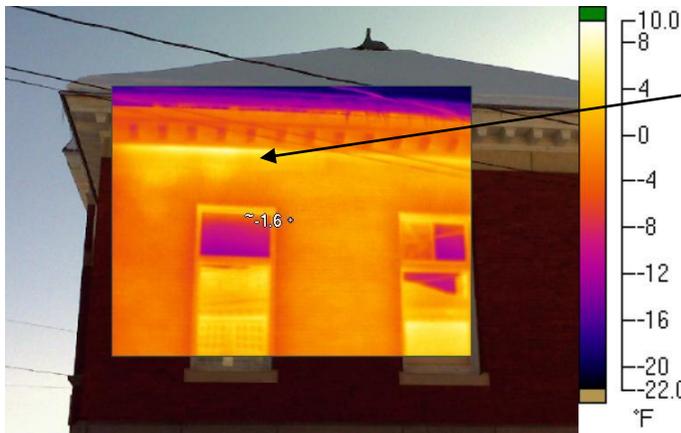
Exterior view of non-fiction room. Note the heat loss occurring at the wall to roof connection.

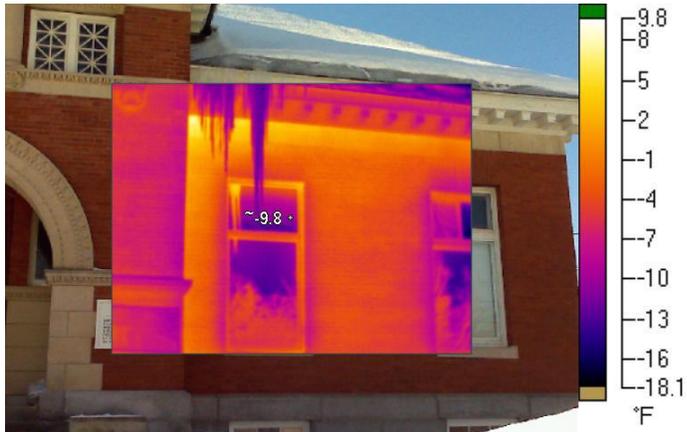
Note the heat loss at the tops of the wall, enabling the ice dams.

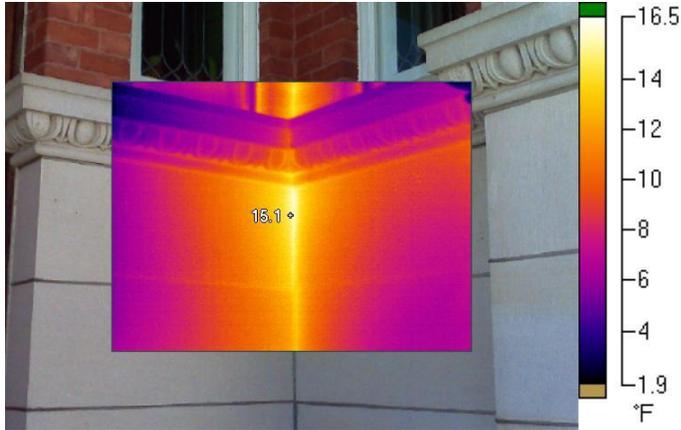
Here the corner connection is losing heat to the outdoors.

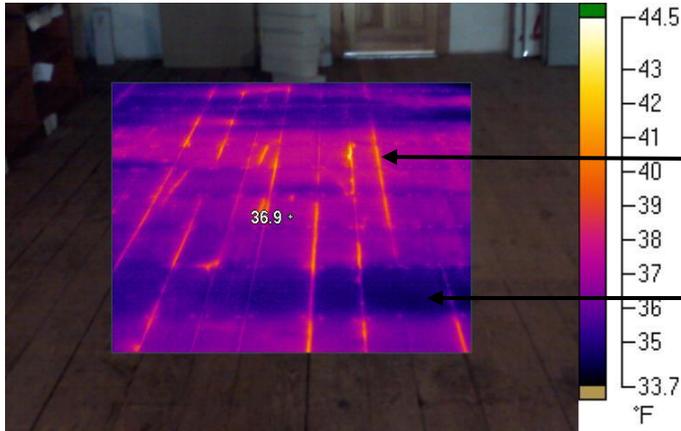
Attic floorboards showing heat loss from the lower level and showing a variance in the level of insulation.

Heat escaping from the space below.

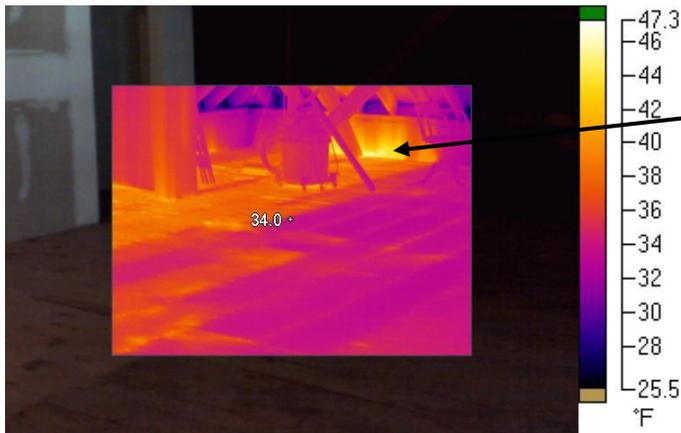
Heat is escaping up into the attic from the floor below. This is especially occurring along the wall to floor connection, shown in the top right portion of the photo.

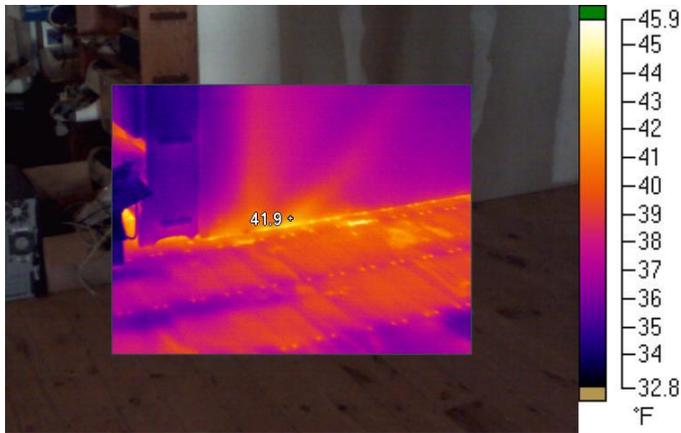
More heat loss is occurring at the connection of the attic floor and wall. These areas should be air sealed to prevent this.

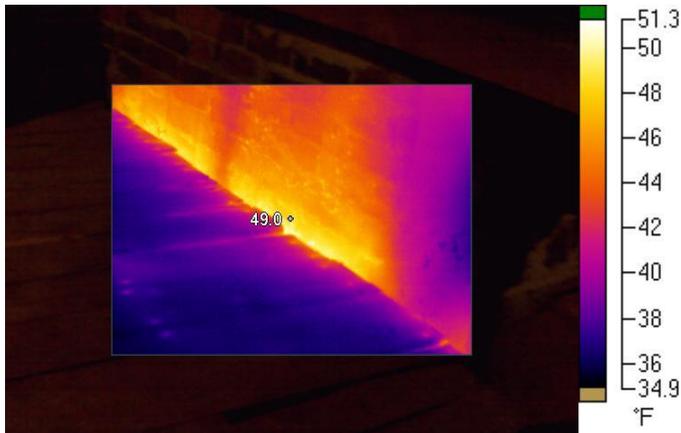
Heat loss is occurring at all floor to wall connections, this is the chimney to the fireplace where it meets the floor. Heat loss is occurring here as well.

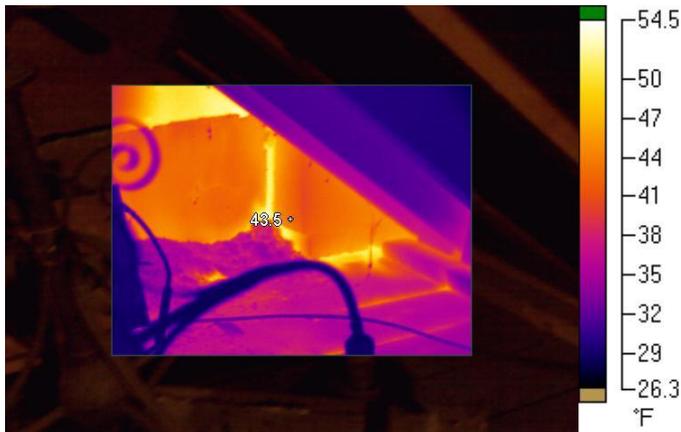
From behind the chimney we see a great deal of heat loss at the chimney. The fireplace is not being used. The heat shown here is space heating traveling up the chimney.

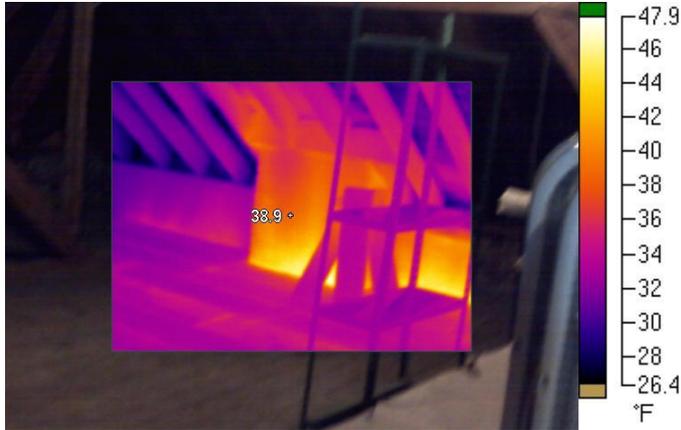
Where the chimney is penetrating the attic floor heat is coming in around the chimney from the main floor.

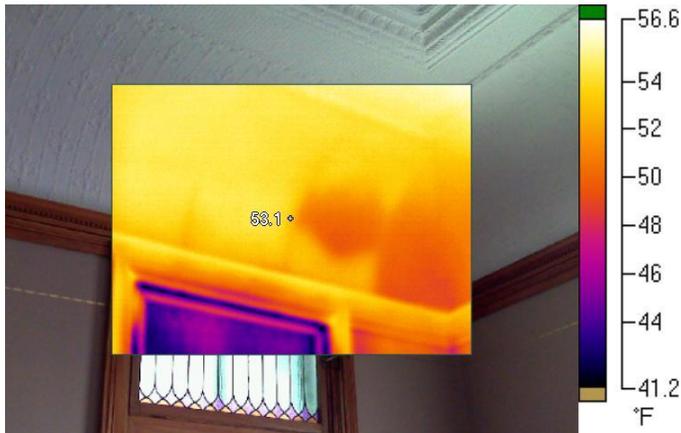
Curved section of ceiling in the New Hampshire Room. The cooler spots may indicate areas where insulation levels are lower, due to the difficulty of getting insulation in the tight curved area.

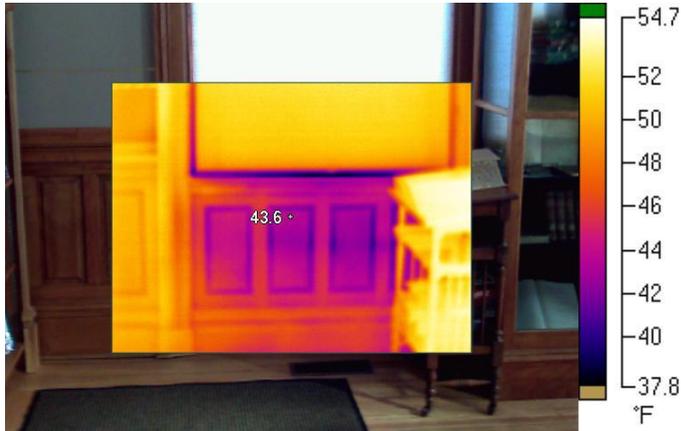
The area below the window is showing cold.
