Appendix A

Town of Henniker Municipal Buildings IR Report

*As part of the Level II Energy Audit for the
Town of Henniker*

Town Hall IR Report

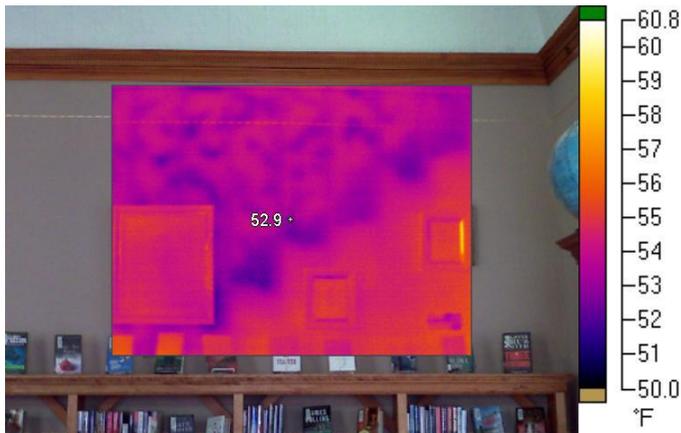
New Hampshire room. Behind this wall is the unconditioned stairwell leading to the attic. Below the stairs is showing warm because it is a heated space below (the stairwell to the lower level) and the cold above is to the unconditioned attic.

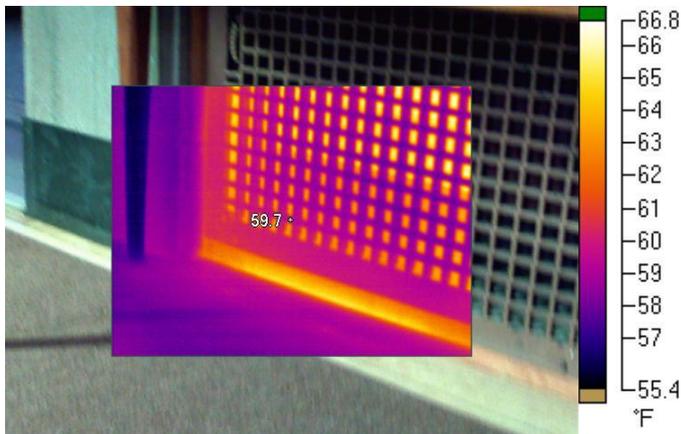
IR001146.IS2
3/3/2011 9:08:13 AM

Warm showing behind the vent indicated that warm air is entering these ducts as well.

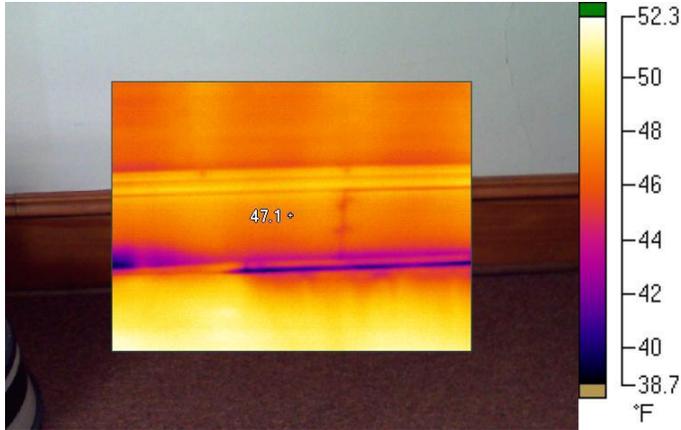
IR001167.IS2
3/3/2011 9:17:56 AM

Cold air moving up the baseboards.

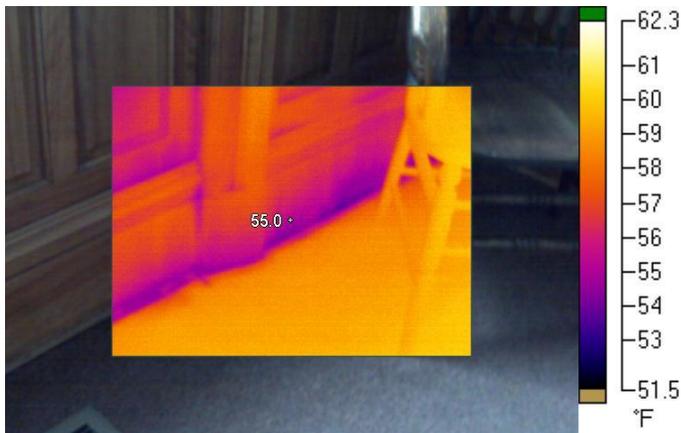
IR001468.IS2
3/7/2011 8:54:18 AM

More cool air coming in around the baseboards.

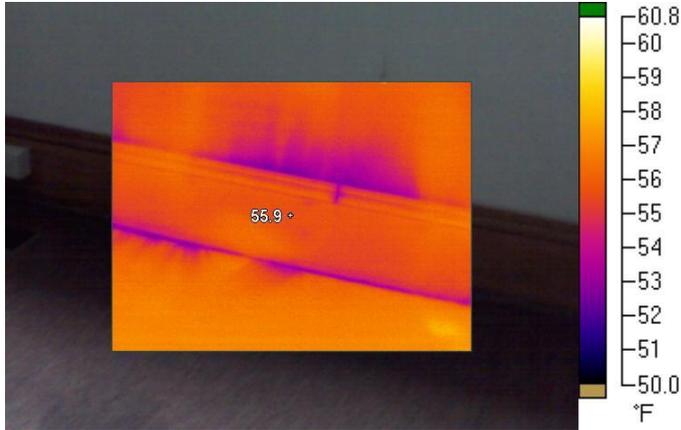
IR001474.IS2
3/7/2011 8:56:24 AM

More air movement around the baseboards, indicating air movement within the walls and/or between floors.

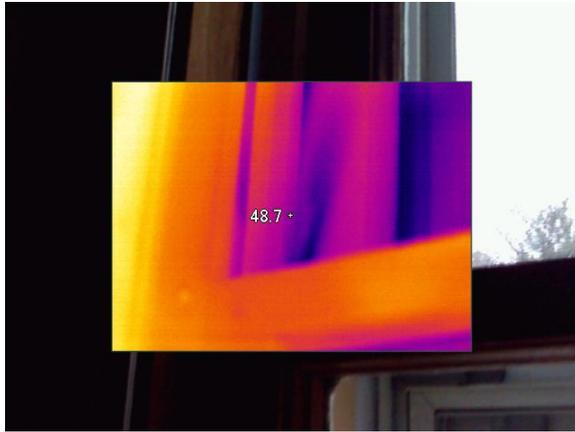
IR001477.IS2
3/7/2011 8:57:46 AM

Cold air moving up the bottom of the wall.

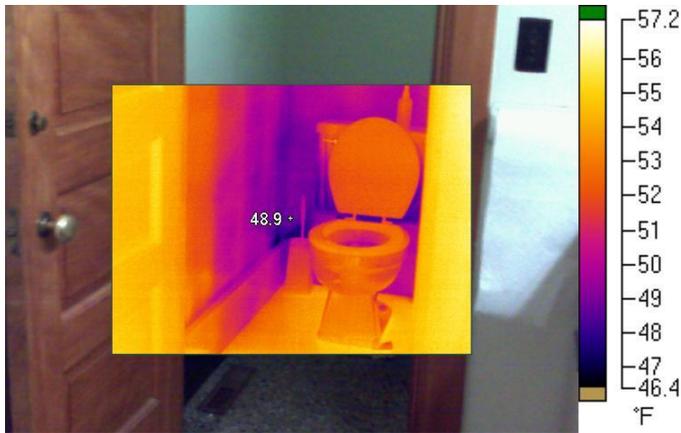
IR001499.IS2
3/7/2011 9:06:04 AM

Window above the toilet in the ladies room. Note the cold around the edges.

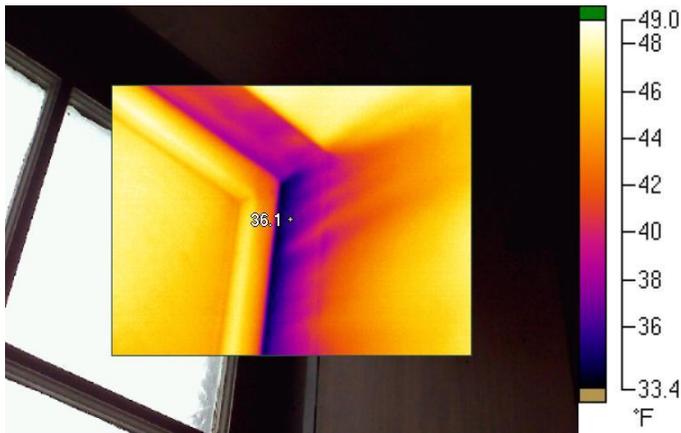
IR001514.IS2
3/7/2011 9:11:49 AM

Corner of the Kindergarten room showing cold conducting up from the un-insulated slab.

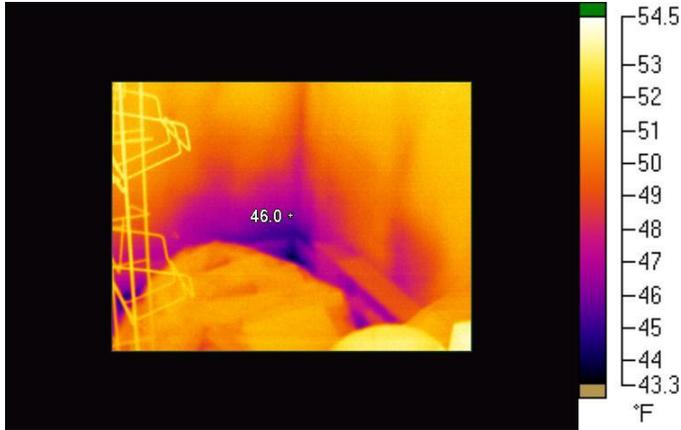
IR001529.IS2
3/7/2011 9:18:29 AM

Exterior door of the Kindergarten room shows a lot of air movement around the door and around the frame.

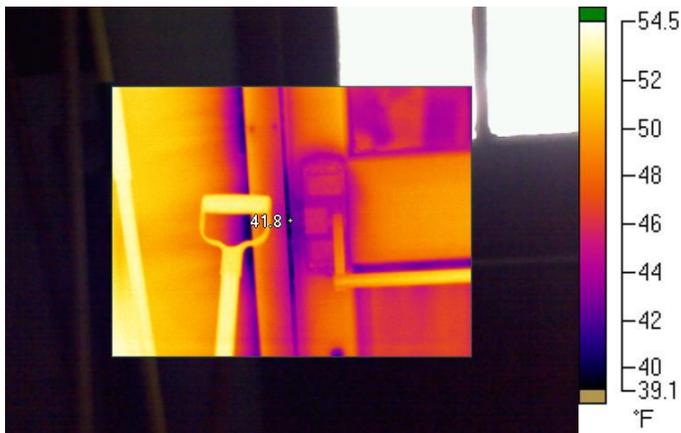
IR001531.IS2
3/7/2011 9:18:47 AM

The cold spot on the wall of the Kindergarten room is an electrical socket. This indicates that air movement is occurring in the wall, and there is likely no insulation in the walls.

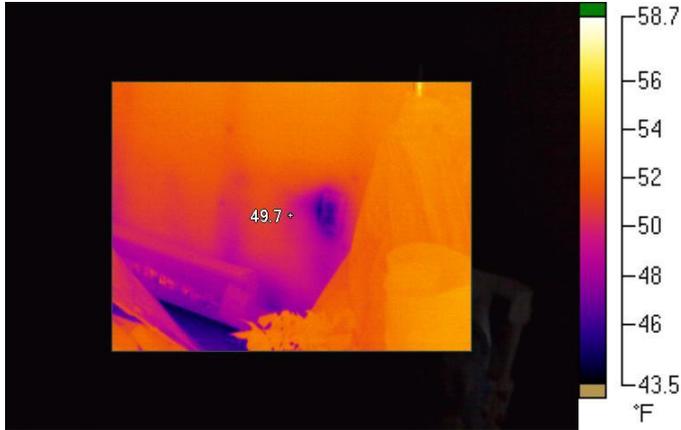
IR001534.IS2
3/7/2011 9:19:44 AM

In the Employee lounge or kitchen area there is a semi-hidden window that could be removed to prevent heat loss.

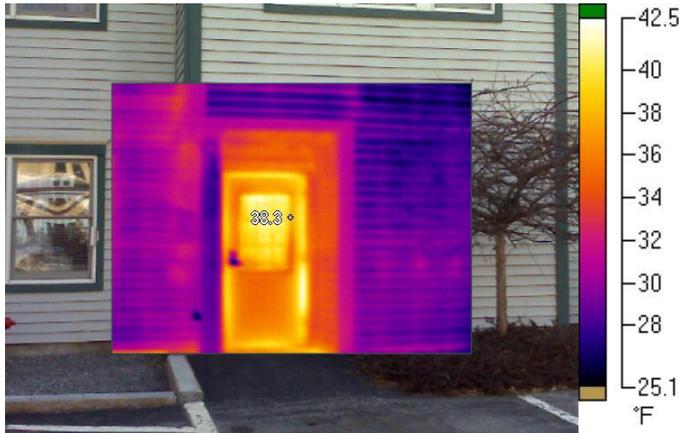
IR002439.IS2
3/24/2011 7:05:57 AM

Looking at the front façade of the Fire Station, we see heat loss through the main entrance door and the surrounding overhang.

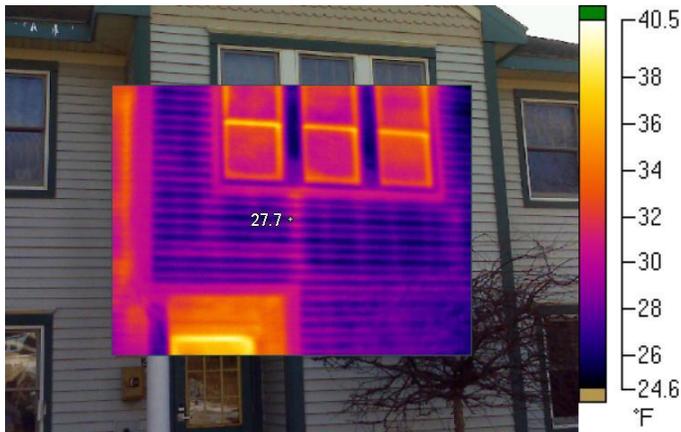
IR002440.IS2
3/24/2011 7:06:09 AM

Again looking at the front façade of the building, heat is being conducted out of the building via framing members and around the windows.

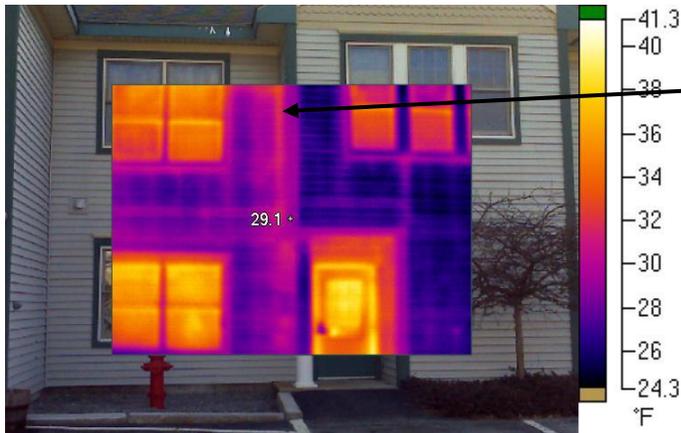
IR002441.IS2
3/24/2011 7:06:43 AM

Note the high level of heat loss at the corner of the building.

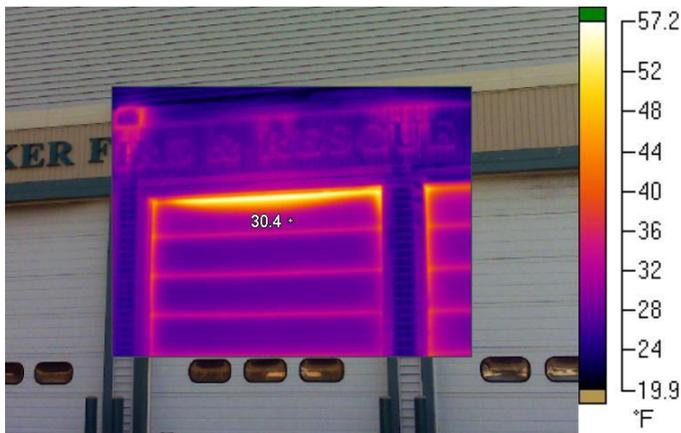
IR002446.IS2
3/24/2011 7:09:00 AM

Here heat is being lost through the top and sides of the front garage doors.

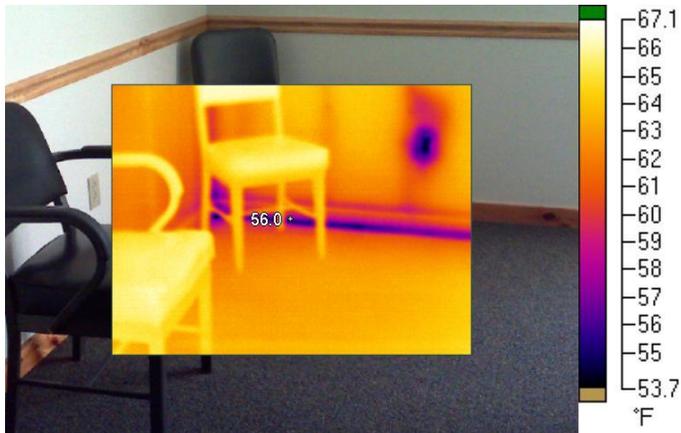
IR002472.IS2

Cold electrical outlet and floor edge. Floor edge is likely cold because the slab is conducting cold from the exterior into the room.

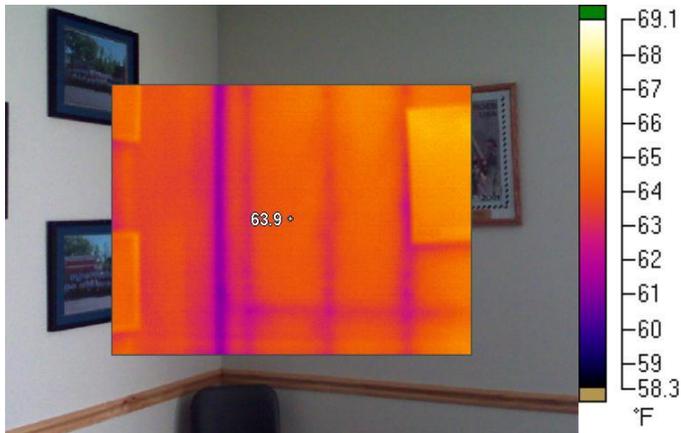
IR002473.IS2
3/24/2011 7:27:23 AM

This corner shows cold from the lack of insulation in corners due to traditional framing that does not allow for insulation at the corners.

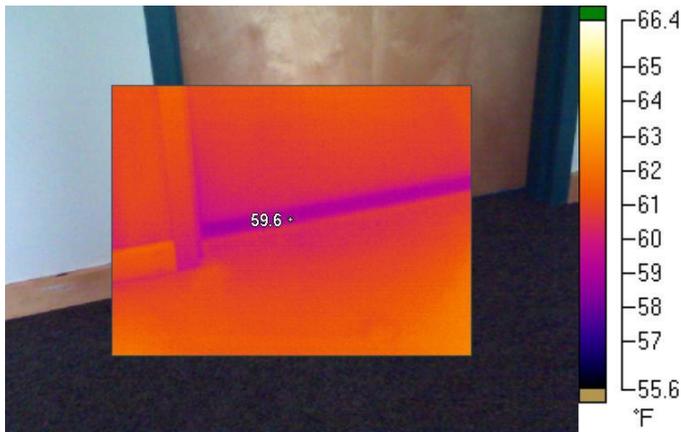
Door between the garage and the fire station appears to be doing a good job of keeping the spaces separated. There is not much cool air coming in from the garage.

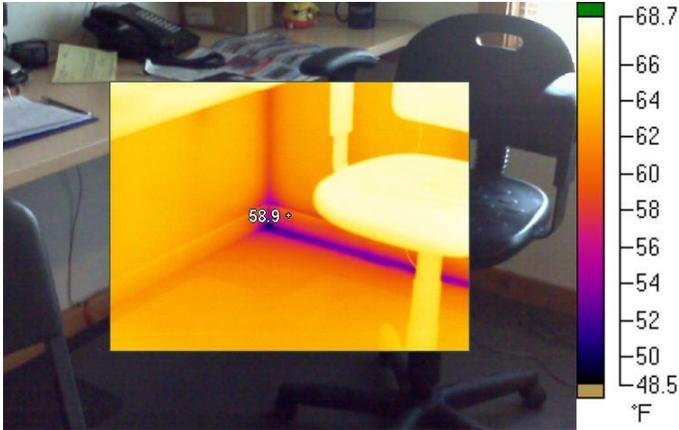
Corner of the radio room. The exterior wall is showing cold along the bottom. This is the interior spot that coincides with the slab heat loss on the western façade.

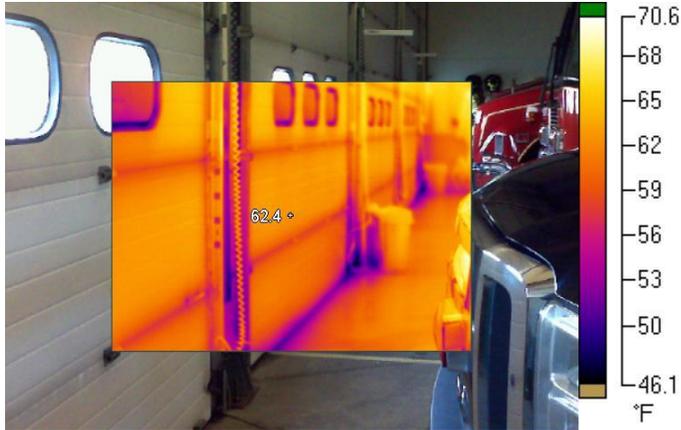
Interior view of multiple garage doors. There is a pattern of cold air coming in around the corners of the doors and along the bottoms. Weather stripping is needed here.

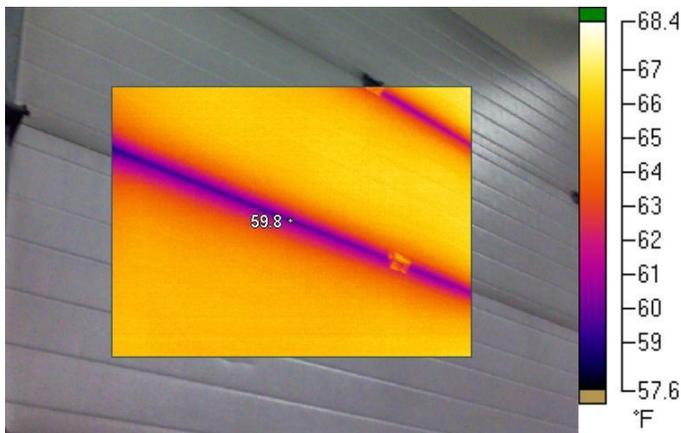
Where the doors hinge is also an area where cold is coming in.

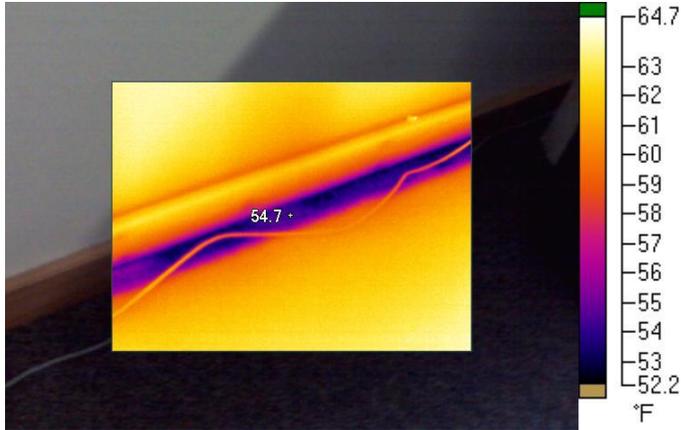
A lot of cold appeared to be coming in along the floorboards of the Southwestern office space. Cold is being conducted inward by the slab because there is no thermal break between the foundation and the framing.

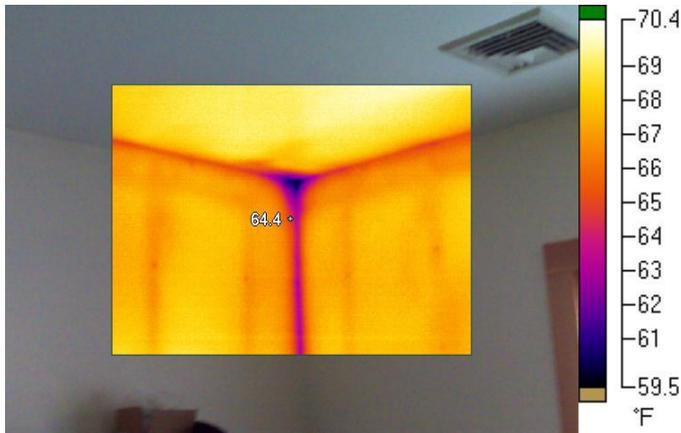
Exterior corner of the southwest office. Here we see the cold corner as well as framing members that are conducting cold into the building.

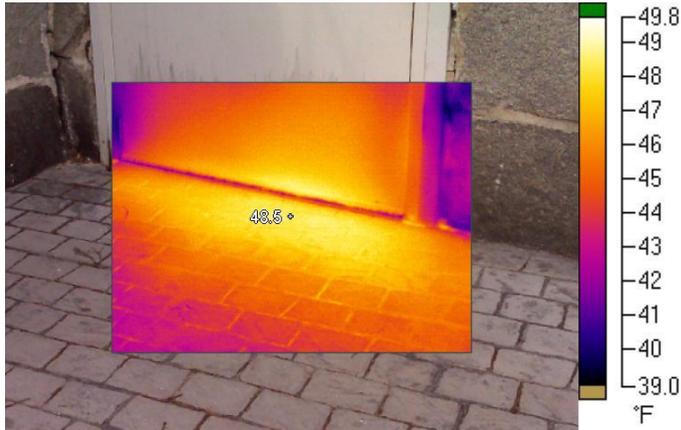
This is the entrance door to the Teen Center on the front façade of the building. Heat loss is occurring at the base of the door and heating brick walk way. This is an example of wasted heat.

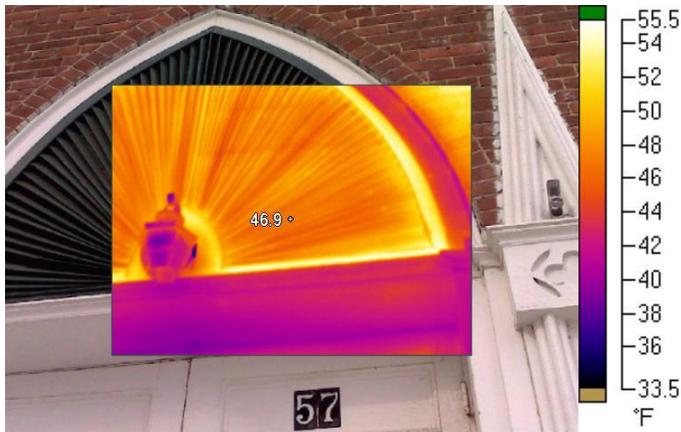
Decorative section above the doorway. From the exterior these areas are warm meaning they are conducting heat to the outdoors. From the interior we could see where these decorative triangle archways were located on the exterior indicating they are an area where heat is escaping the building.

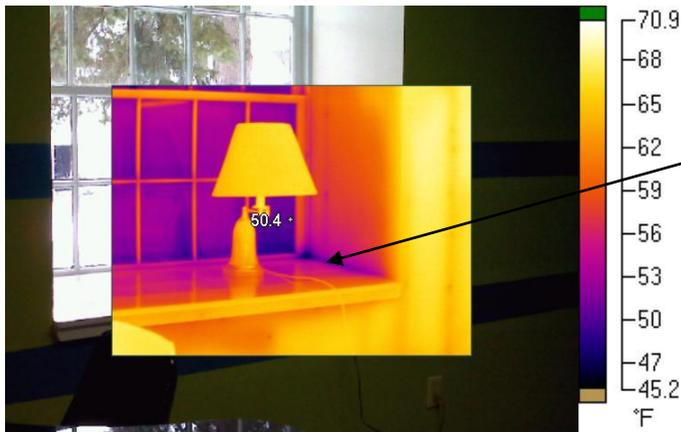
Teen Center window. There is cold air in the corner of the large window sill. We saw this throughout the space.

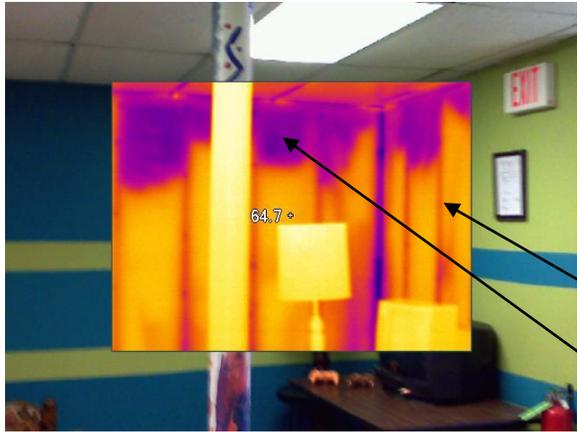
This image of two exterior walls shows the framing members as well as the insulation within the walls. These fiberglass batts appear to be settling within their bays. Note the colder temperatures visible in the top portions of the bay; this indicates that the batt is either pushed back or has settled. This settling is usually caused by improper installation. Settling batts lose their full effectiveness and R-value (insulating value).

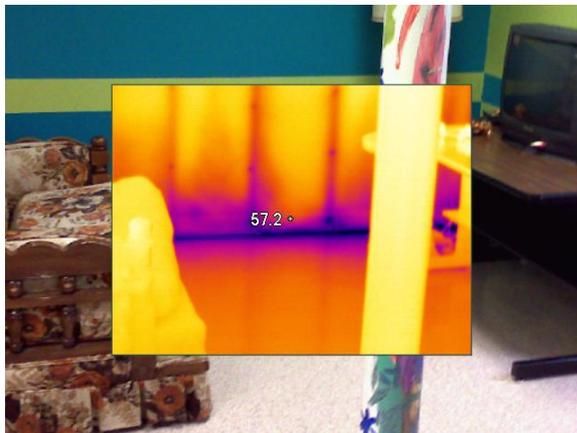
Lower portion of a wall. The cold is likely do to the slab conducting the cold up to the bottom of the wall where the un-insulated sill plate is located.

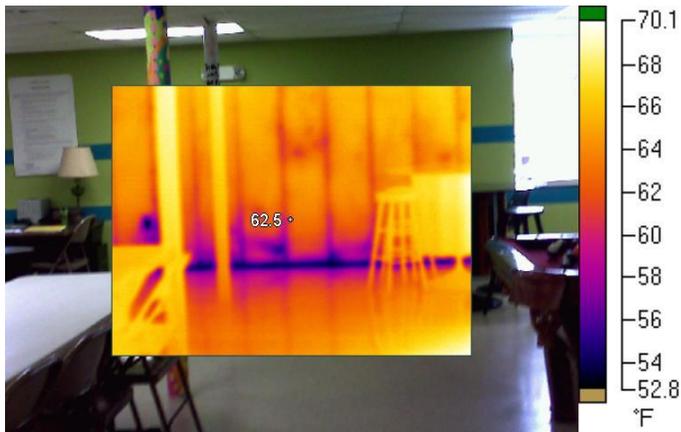
Another image of the cold wall to floor connection and poorly performing batt insulation.

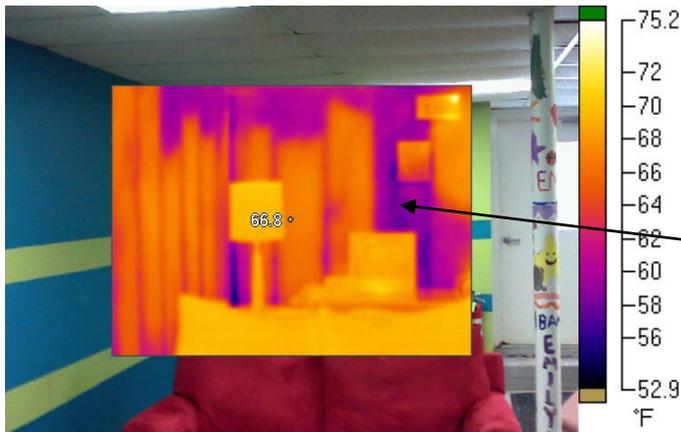
More evidence of settling fiberglass batt insulation. Again, the cold (purple) areas are without insulation or the insulation is pushed back.

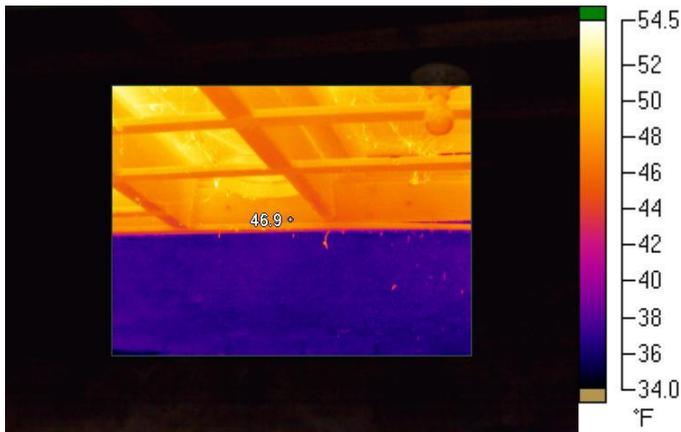
View inside of crawlspace. This shows heat loss occurring from the community space above- large source of wasted heat.

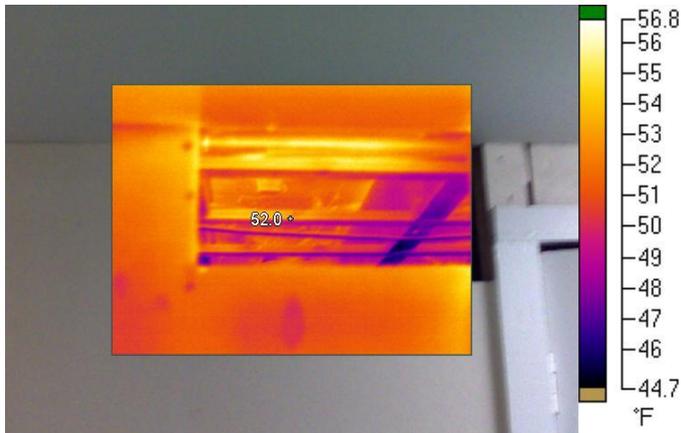
Hole in closet wall leading to crawlspace. This space should also be closed off and any necessary venting of the crawlspace should be to the outdoors.

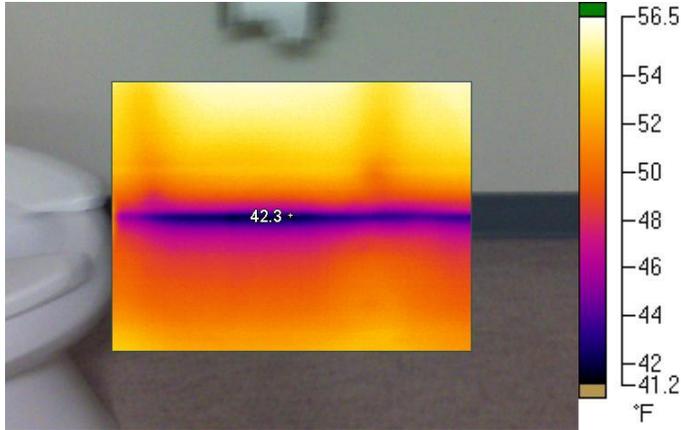
Main floor bathroom. Cold is being conducted inward by the slab.

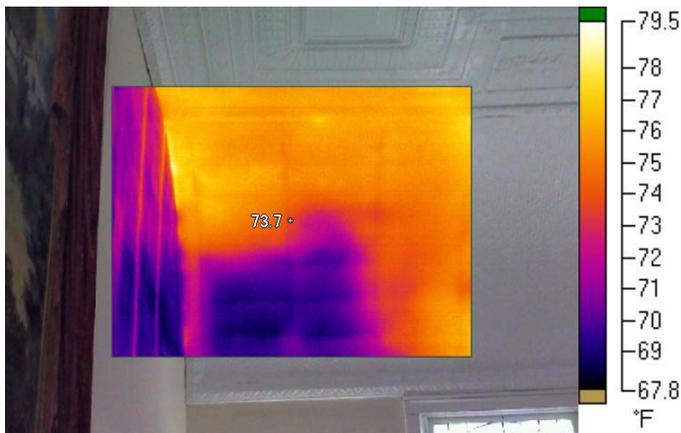
View of the wall to ceiling connection in the main community space. It seems that the blown in insulation previously done did not make it to this area, resulting in heat loss at this area.

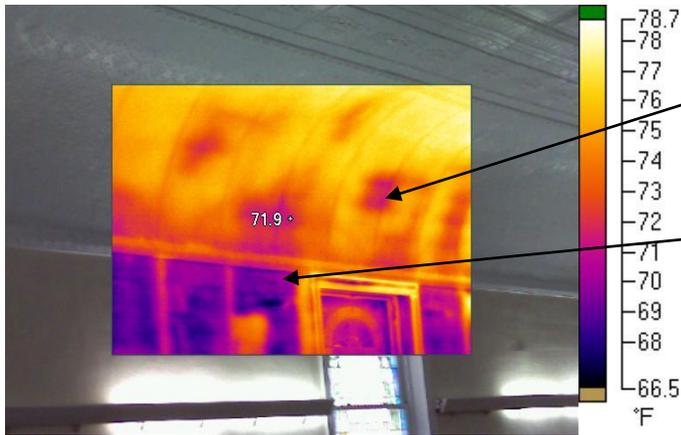
Note the spotty insulation along the curved area of the ceiling.

The dark areas indicated there is no insulation in the walls.

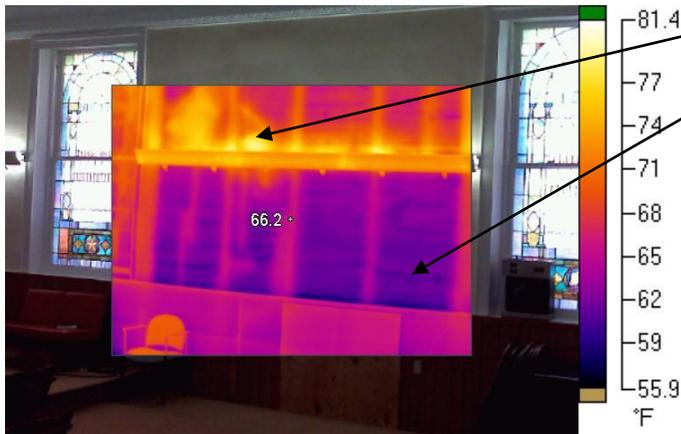
The yellow shows a lighting fixture giving off heat. The dark purple shows heat loss at the walls which are un-insulated.

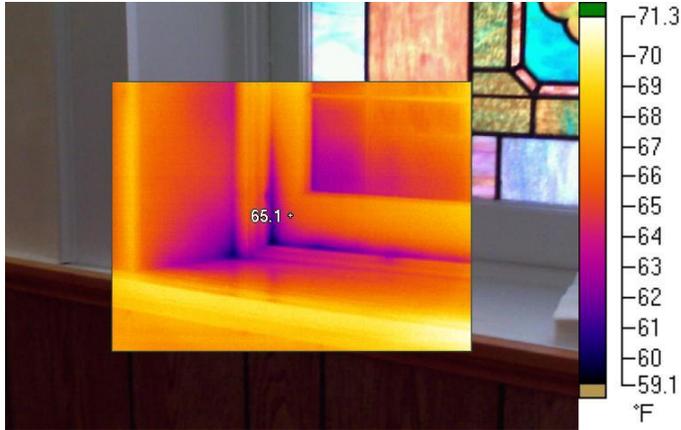
View of a window corner. Cold air is entering. The windows are not air tight.

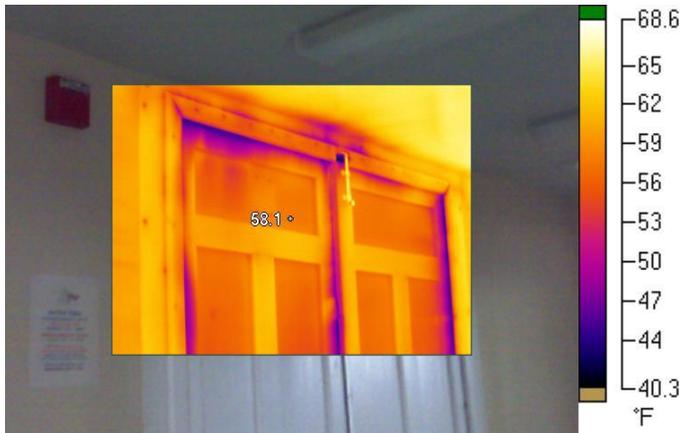
Top of the double doors to the main entrance. Note the cold behind the trim. This means it is not air sealed or insulated well behind the trim.

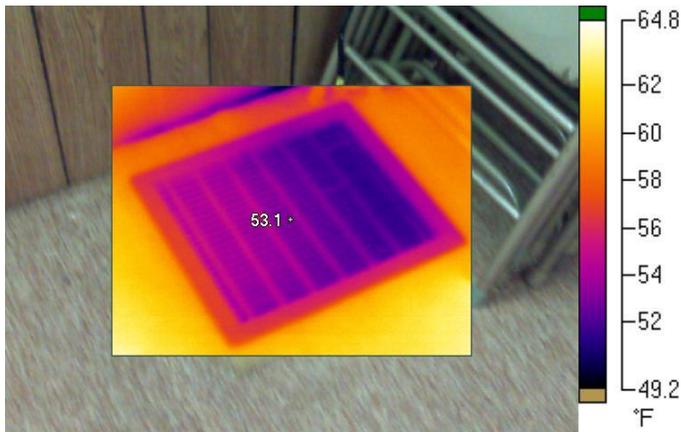
Image of the vent that is over the crawlspace in the basement. The air coming out of here is very cold. Note the high indoor temp of 64 degrees (indicated on scale to the right) and the 50 degree temperature coming from the vent with the damper **closed** on the vent.

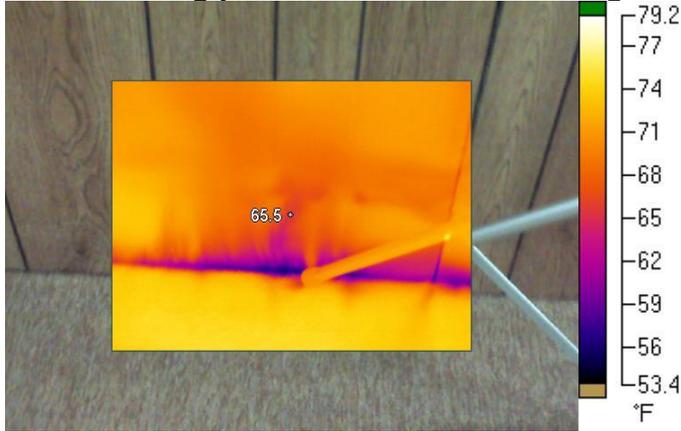
Air movement is visible along the floor to wall connections. Meaning air is able to move up from the space below.

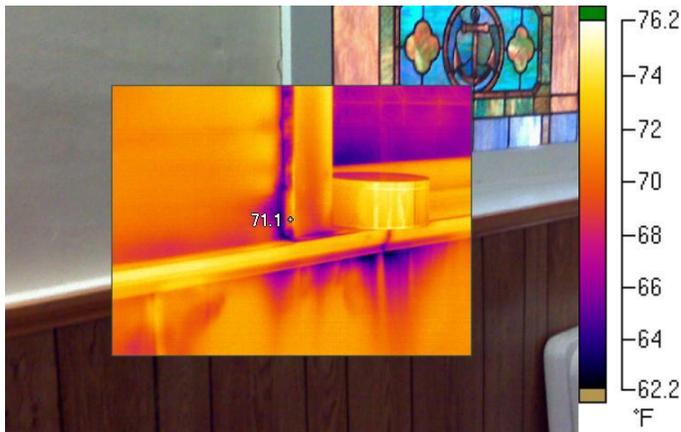
Air movement is now more visible around the window trim and below the window sill.

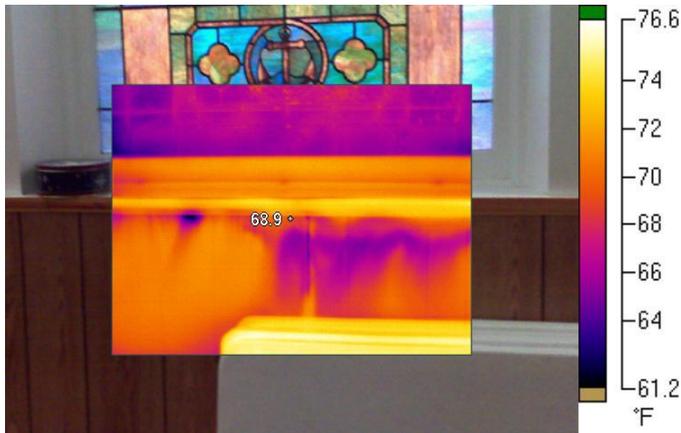
More air movement around the wood paneling from the window.

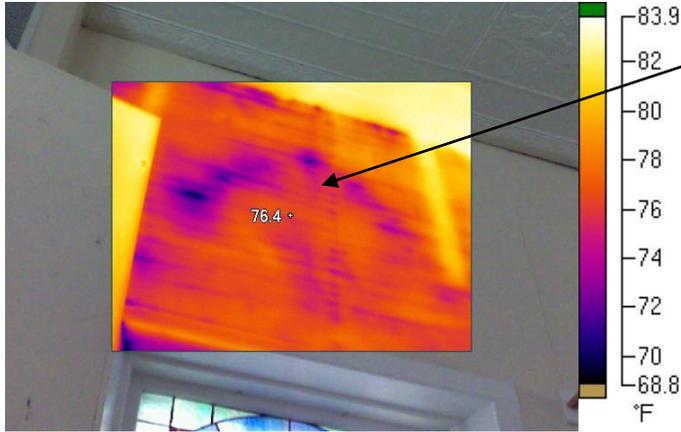
The arches above the windows are visible from the interior.

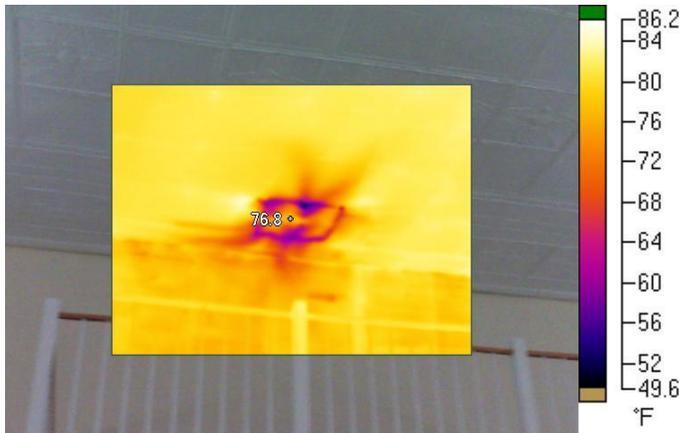
Cold air is able to move from the cold attic via the attic hatch that is not sealed.

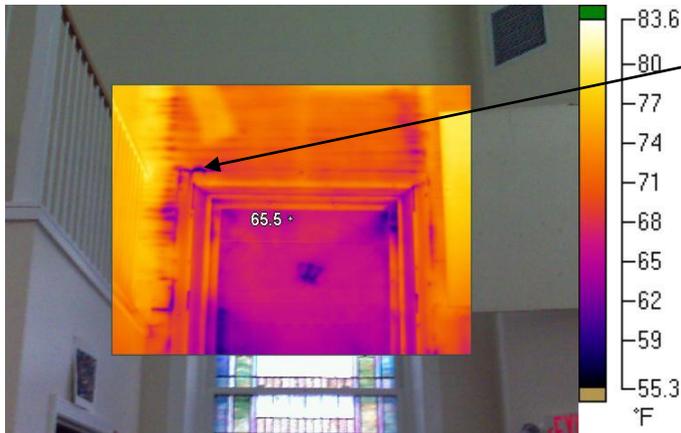
Cold air is behind the trim around the windows.

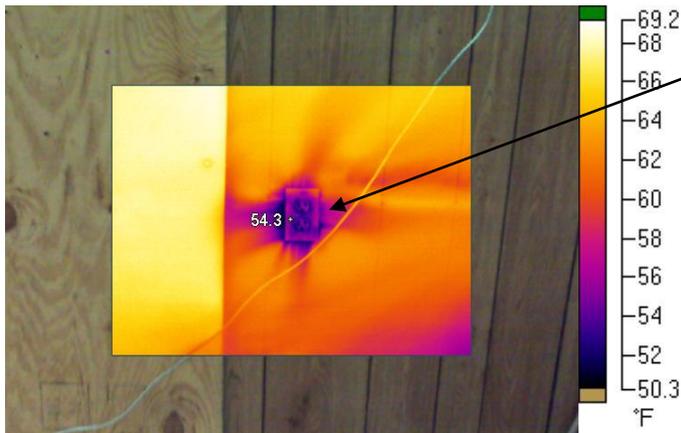
Evidence of cold air movement within the walls shows at the electrical sockets.

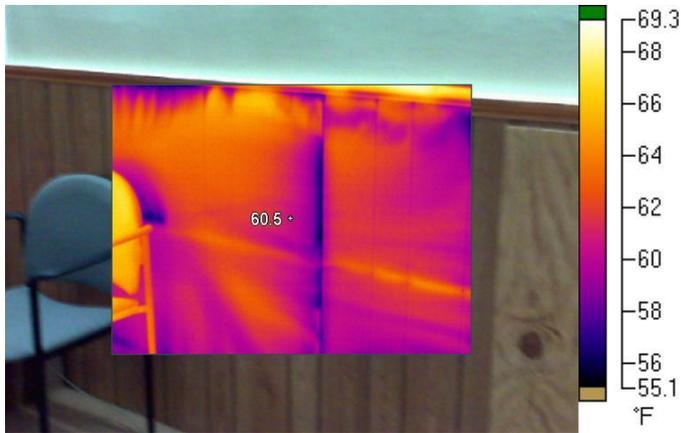
More cold air movement behind the wood paneling.

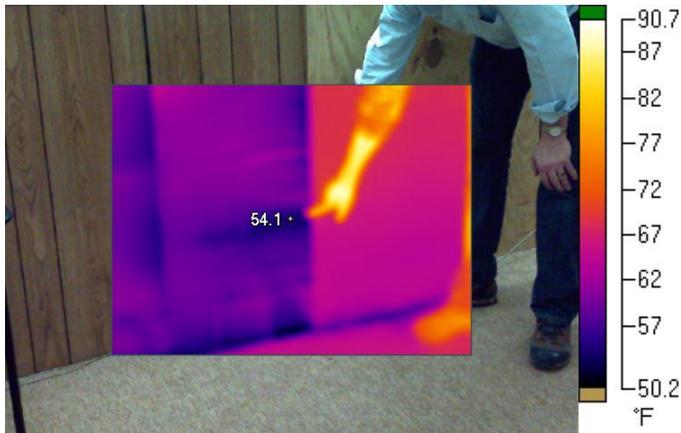
There was a part of the wall that was boarded up and during the blower door test air movement was felt around that boarded up area.

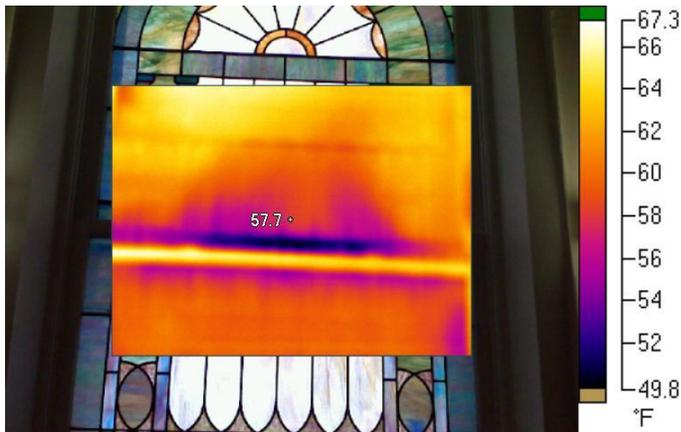
Another window sash allowing a lot of cold air movement coming inside.

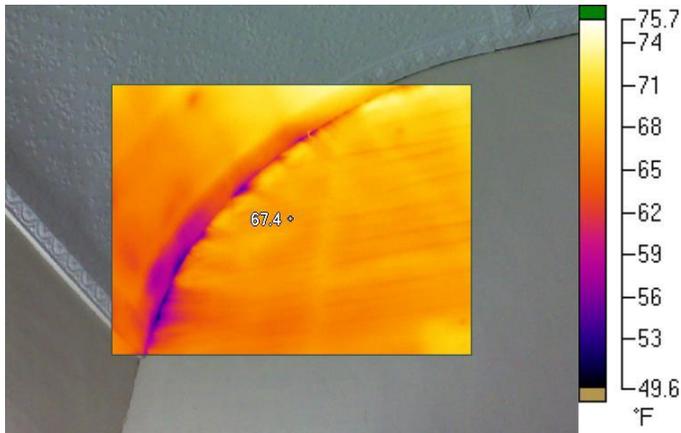
Wall to ceiling connection along the tin ceiling. Air movement was present here.

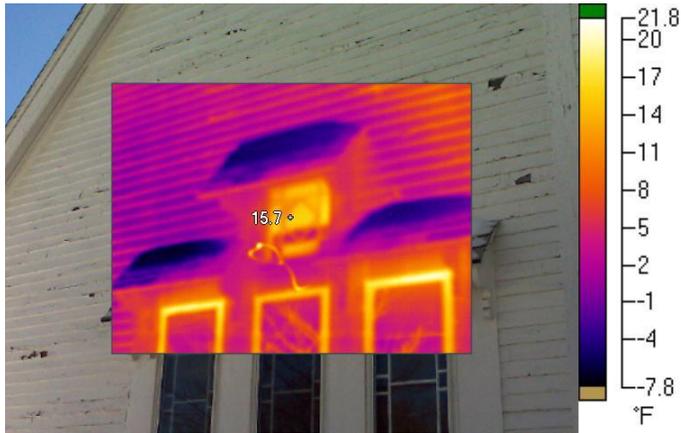
A view of the outside of the Grange Building shows where heat is loss is occurring at the windows.

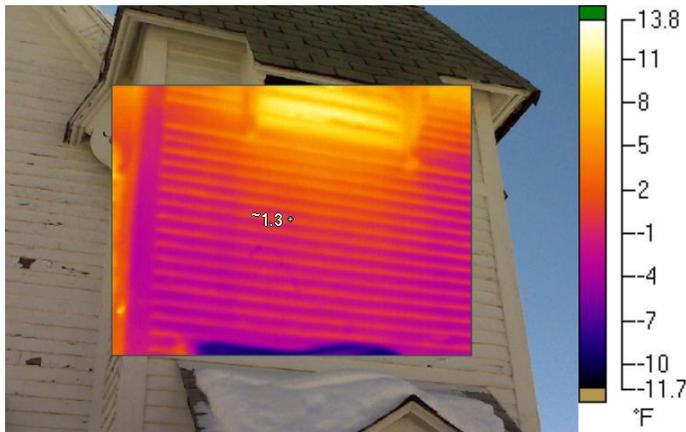
A Vent above the front entryway where heat is escaping meaning that heat is making its way into the attic.

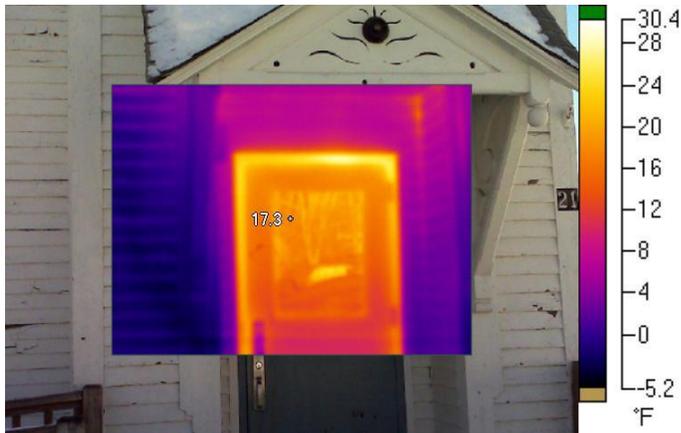
There is a lot of heat loss through and around the front door of the Grange Building.

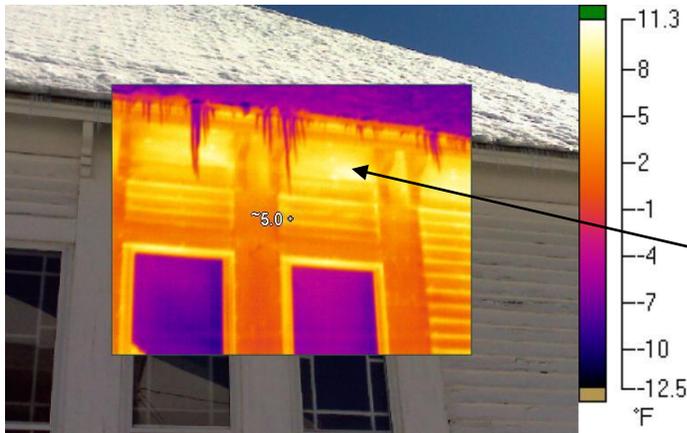
Heat loss is occurring at the top of the wall. Note the white areas.

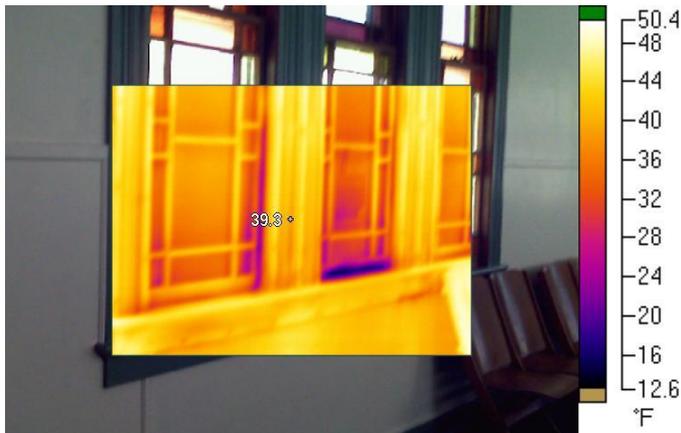
A view of three windows from inside. The middle window does not close properly. It shows cold air entering around the base. We have been informed that due to the moving of the building, many of the windows do not properly function in the Grange Building.

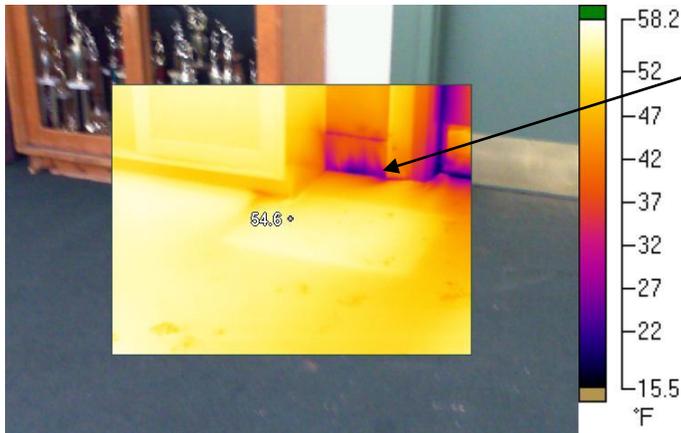
IR001273.IS2

Note cold air at the base of the wall, cold air is moving up from the space below.

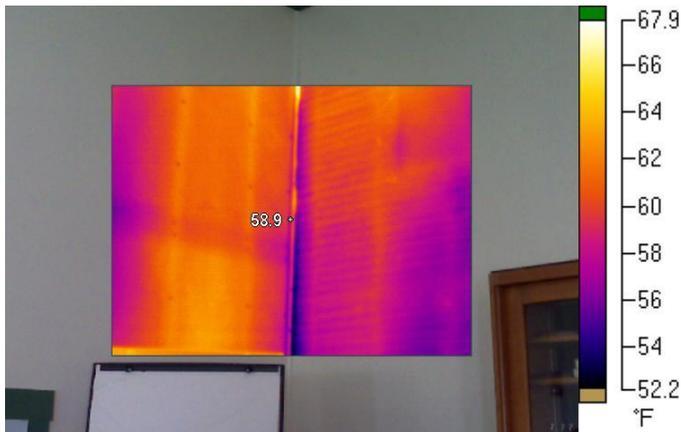
IR001274.IS2

Joining of an exterior wall and a newer built interior wall. The interior wall on the left is to an office space. Note the pattern of the lathe that is visible, indicating there is no insulation in the exterior walls. The exterior wall is showing warm here because the sun was shining on this side of the building at the time the photo was taken.

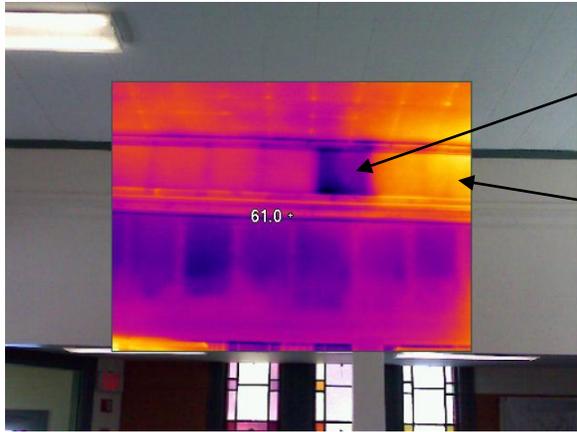
Area where cold air from attic is able to move.

Area heated from FHA Register on floor below.

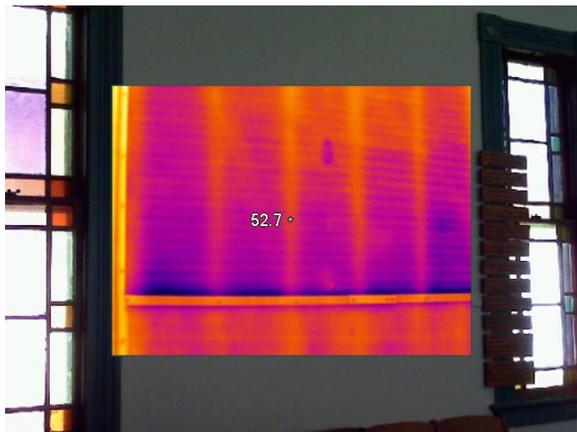
IR001279.IS2
3/3/2011 11:28:30 AM

The area above the chair rail along the wall is showing much colder than the rest of the wall because the added wood of the chair rail adds slightly to the R-Value of that wall area.

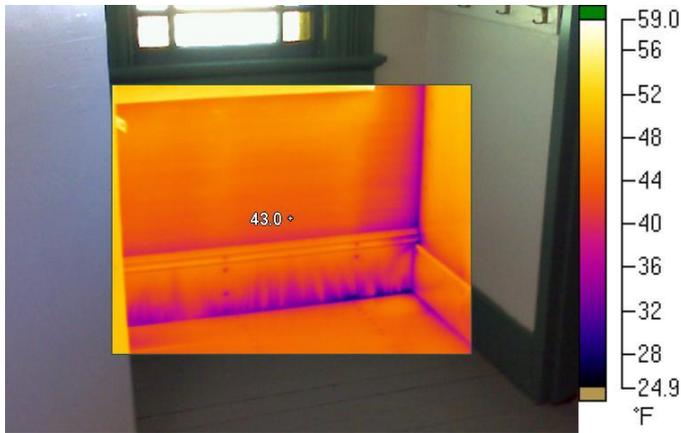
IR001285.IS2
3/3/2011 11:29:38 AM

This image along the floorboards shows air movement from below.

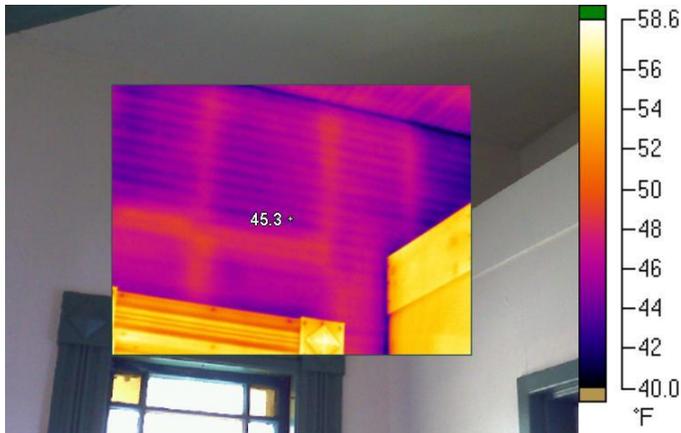
IR001286.IS2
3/3/2011 11:29:44 AM

Here the framing structure is very visible. The wood framing has a higher R-value than the lathe and plaster.

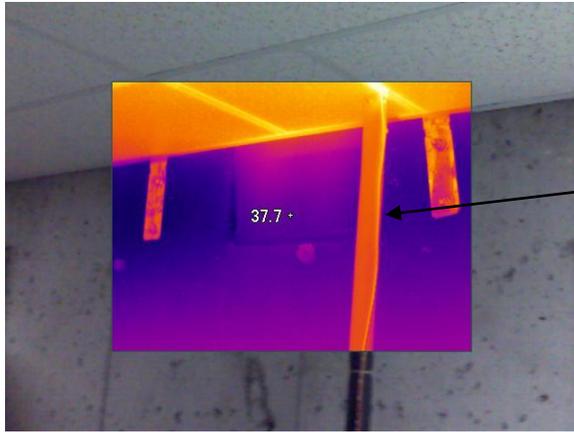
Basement foundation wall and drop ceiling. Ceiling is warm due to heat loss from room above.

Hot water pipe coming off of the hot water heater.

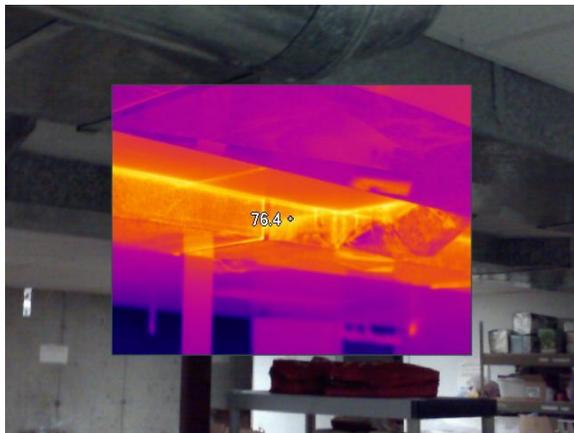
IR001299.IS2

Un-insulated duct work is unintentionally heating the basement space and losing efficiency along the way.

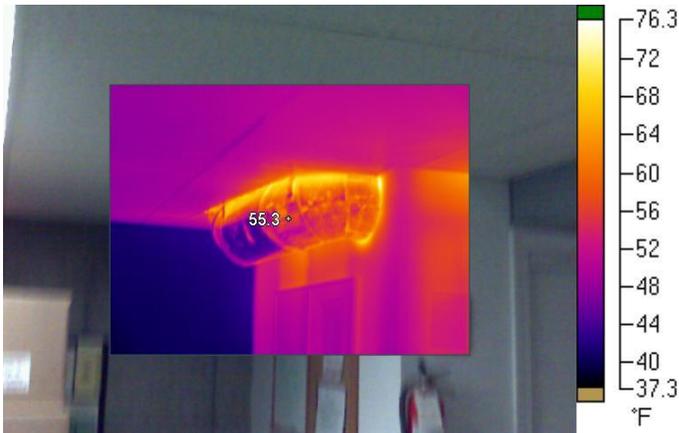
IR001300.IS2

More un-insulated duct work.

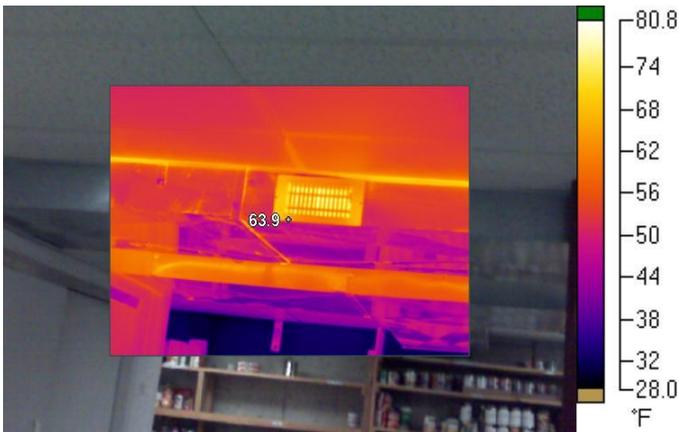
IR001301.IS2

More un-insulated duct work and the vent used to heat the food pantry.

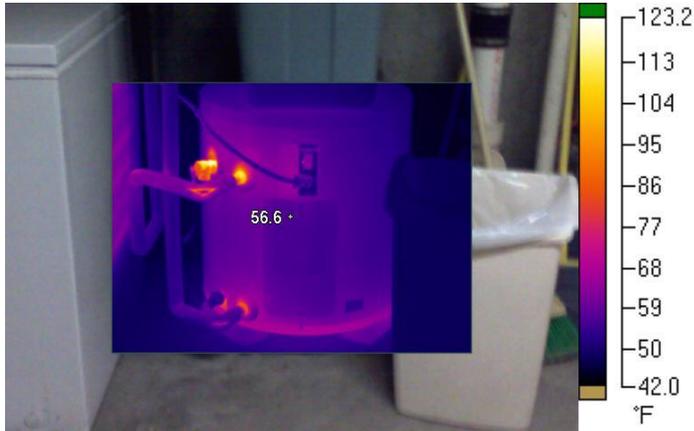
IR001302.IS2

Hot water tank. It is well insulated and properly sized.

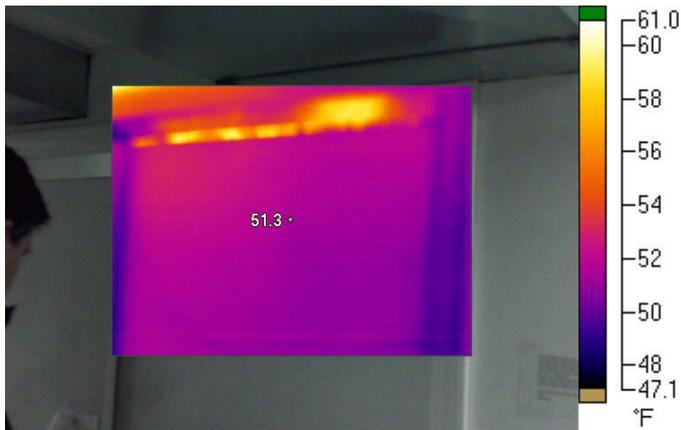
IR001303.IS2

Above the door to the mechanical equipment is allowing heat to escape the mechanical closet, acting as additional heat for the food storage area.

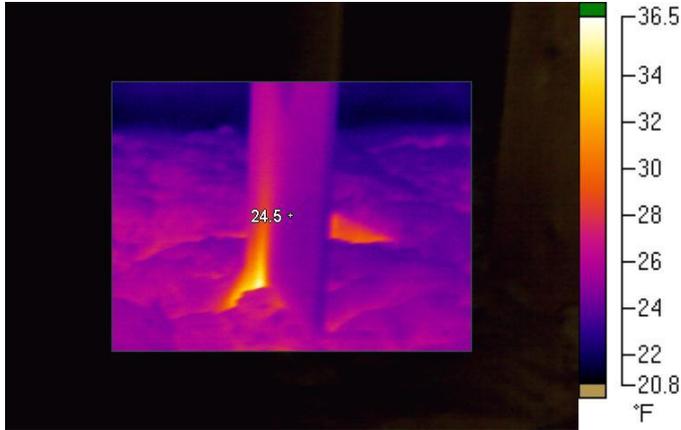
IR001319.IS2
3/3/2011 11:58:58 AM

Heat being conducted up into the attic space via the framing members and gaps in insulation around the framing members.

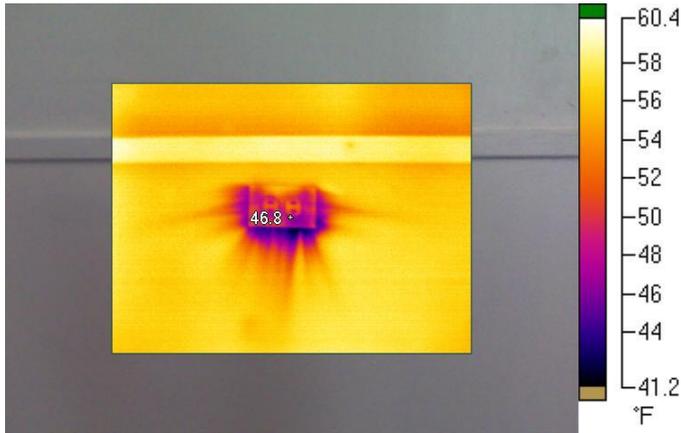
IR001323.IS2
3/3/2011 12:28:24 PM

This image was taken during blower door testing. It is apparent that there is air movement within the wall.

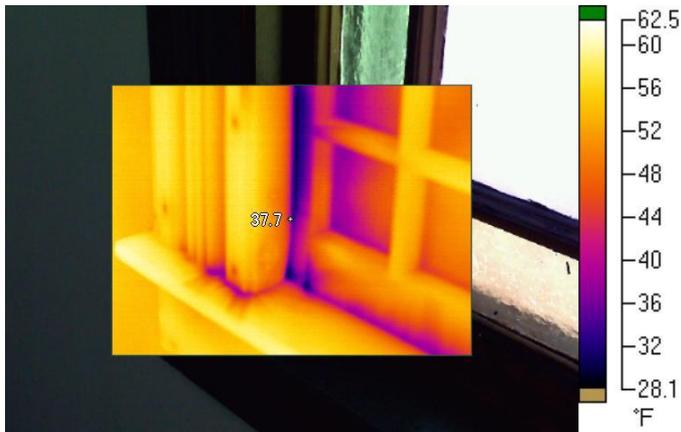
IR001324.IS2
3/3/2011 12:28:30 PM

Corner view of a window where cold air is coming in.
