Appendix A

Town of Henniker Municipal Buildings IR Report

*As part of the Level II Energy Audit for the
Town of Henniker*

Town Hall IR Report

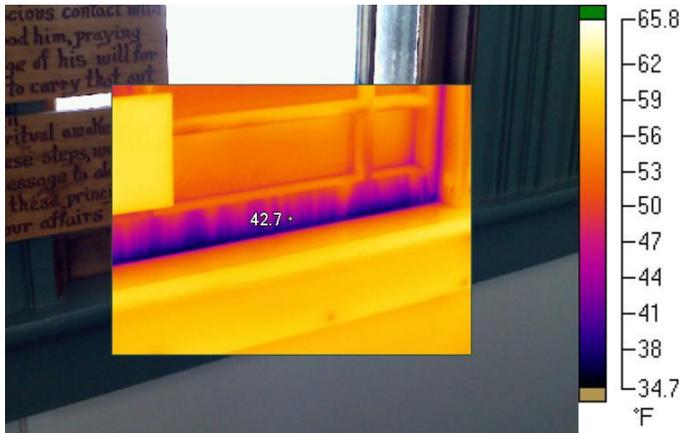
IR001325.IS2

This is a different window showing a great deal of air movement around the bottom. It is likely one of the windows that does not properly open and close.

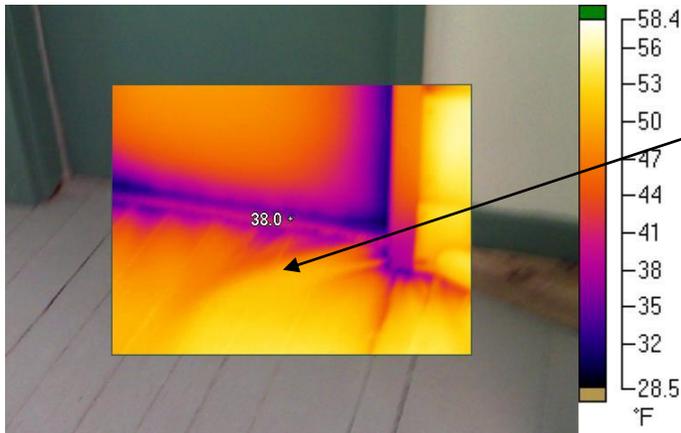
IR001327.IS2

Front entrance door to the building. Air movement is visible across the floor.

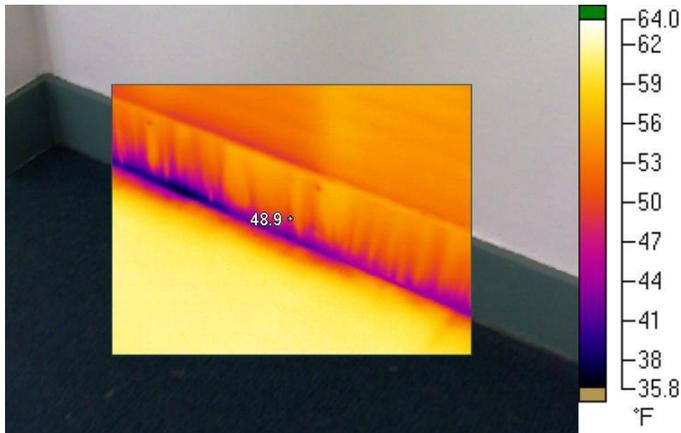
IR001329.IS2

Another view of the base board.

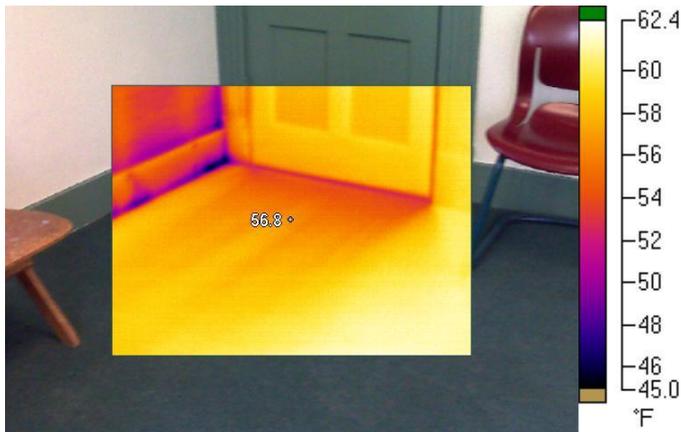
IR001330.IS2

Door leading to the basement. While there is a bit of cooler air coming in from the basement, the door to the attic space poses more of an issue.

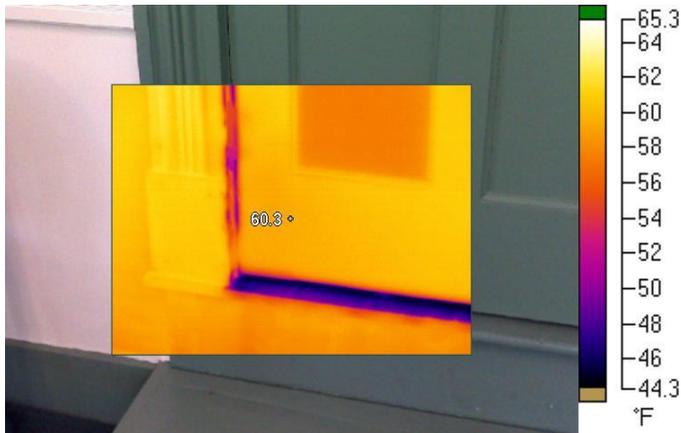
IR001332.IS2

Door leading to the attic. This door is allowing more cold air through than the door to the basement. The air coming from the basement is also colder than the air coming from the basement.

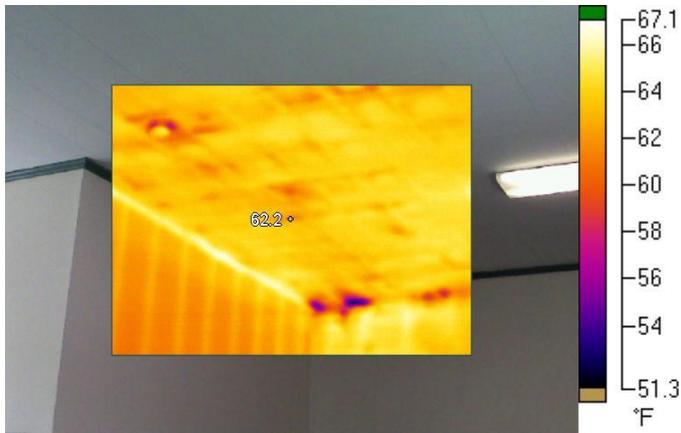
IR001340.IS2

Cold spots on ceiling where there are gaps in the attic insulation.

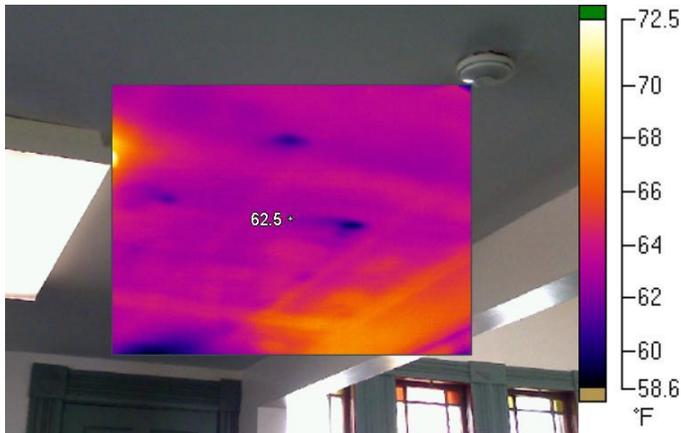
IR001342.IS2

Ceiling shot below the storage area holding sports equipment. Some cooler spots are present on the ceiling.

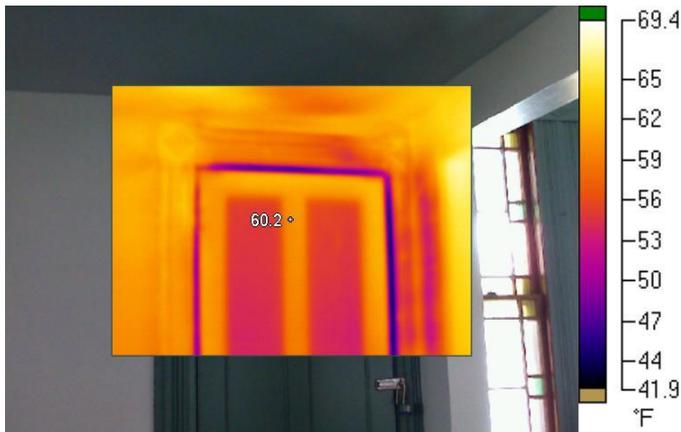
IR001343.IS2

The door to the attic. Around the door there is cold air moving from the attic into the main floor.

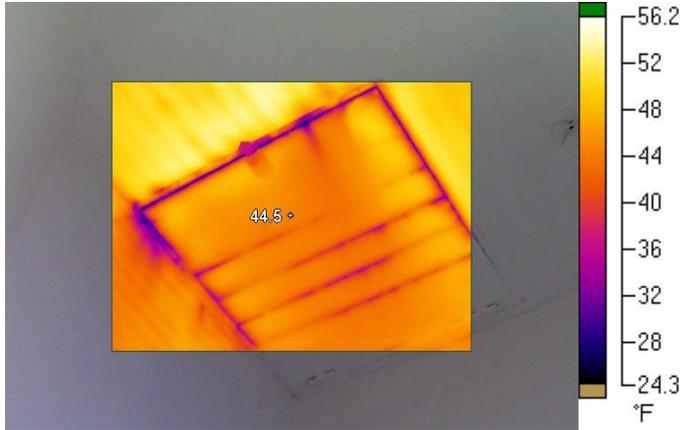
IR001346.IS2
3/3/2011 12:32:35 PM

Hatch in the front entrance area of the Grange Building. Cold is entering the building.
